FIRE STATION NO. 2 LONG TERM NEEDS ASSESSMENT

EXISTING FACILITY ASSESSMENT

On November 8, 2013, Sidock Architects conducted an on-site inspection and analysis of Fire Station No. 2 with the assistance of the Novi Fire Department administration and staff, and representatives from the City of Novi Facility Operations. The inspection included brief discussions with the fire fighters and staff at the station and a general inspection tour of the facility.

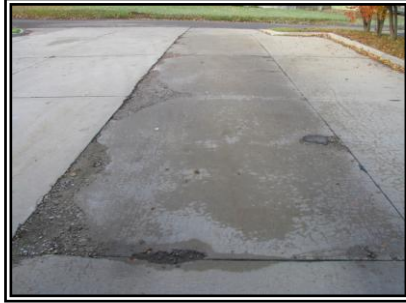
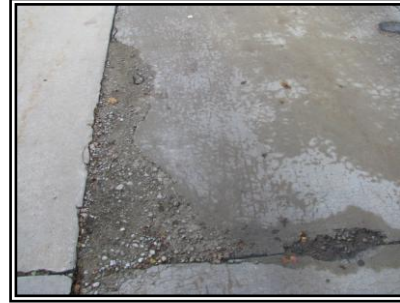
1. Parking is adequate for the current staffing.
2. The concrete drive at the egress side (west end) of the Apparatus Bay is adequate in length, but is in fair to poor condition.

- The west concrete drive and the east asphalt entry drive paving have cracking, spalling and are in poor condition. This may be addressed in the City's pavement assessment/replacement program.
- Minor brick tuckpointing is needed on the west elevation adjacent to the overhead doors.

1. Create New Office	\$ 22,800.00
New door and frame, enclose former sleeping space.	
2. Vehicle Exhaust Drop	\$ 5,000.00
New Plymovent exhaust drop	
3. Parking Lot Repair & Drive Replacement	\$ 53,600.00*
Crack repair and concrete replacement	
	<hr/>
High Priority Total	\$ 81,400.00

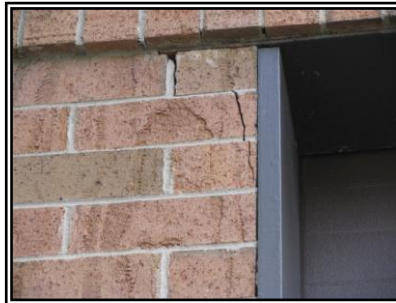
- a. Brick veneer appears to be in good condition.
- b. Steel angles at base of jamb at the overhead doors show some signs of rusting.
- c. On the west elevation the overhead door lintel needs some tuckpointing repair.

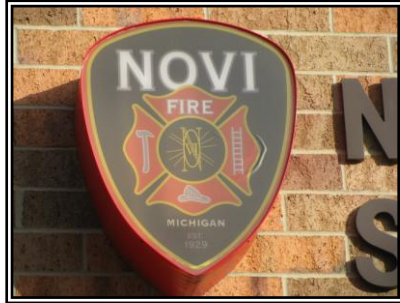
- c. On the south elevation, the Novi Fire Department lighted badge is not working and the artwork appears to be faded.

- 1. The exterior wall-mounted "badge sign" needs to be repaired and/or replaced.
- 2. A number of receptacles for chargers for portable electronic devices are needed to avoid devices laying on the floor.

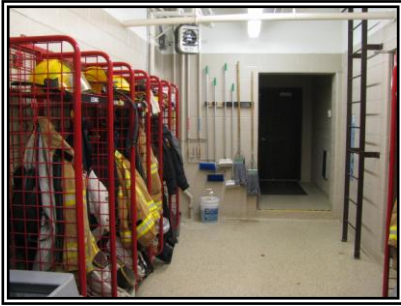
2. Hose Drying/Work Space

- a. This space incorporates multiple activities:
 - (1) Emergency eyewash
 - (2) Turnout Gear Lockers
 - (3) Roof hatch ladder access
 - (4) Work counter
 - (5) Miscellaneous storage

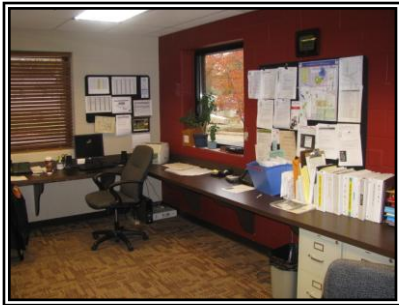
3. Watch Room/Control Room

- a. Includes computer and communications equipment.
- b. Viewing window into Apparatus Bay with fire shutter.
- c. Several chargers are scattered about and on the floor for various devices.

1. New telephone line in Exercise Room	\$ 350.00
2. Café-style doors for sleeping spaces (3)	\$ 800.00
3. Wall-mounted plug strip for chargers	\$ 2,500.00
4. Overband crack seal	\$ 1,100.00*
	<hr/>
Medium Priority Total	\$ 4,750.00

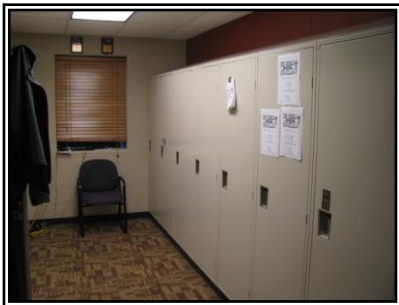
5. Locker/Sleeping Room

- a. The locker room is combined with the sleeping area.
- b. There is no separation of male and female lockers or bunk spaces.

- c. One sleeping space has been converted into a Lieutenant's Office.
- d. Curtains have been added in the opening to each bunk space. A café style door for more privacy was requested.
