CITY OF NOVI
ADA COMPLIANCE TRANSITION PLAN
CITY-OWNED FACILITIES
MARCH 2014

SDA Job No. NV13006.0C

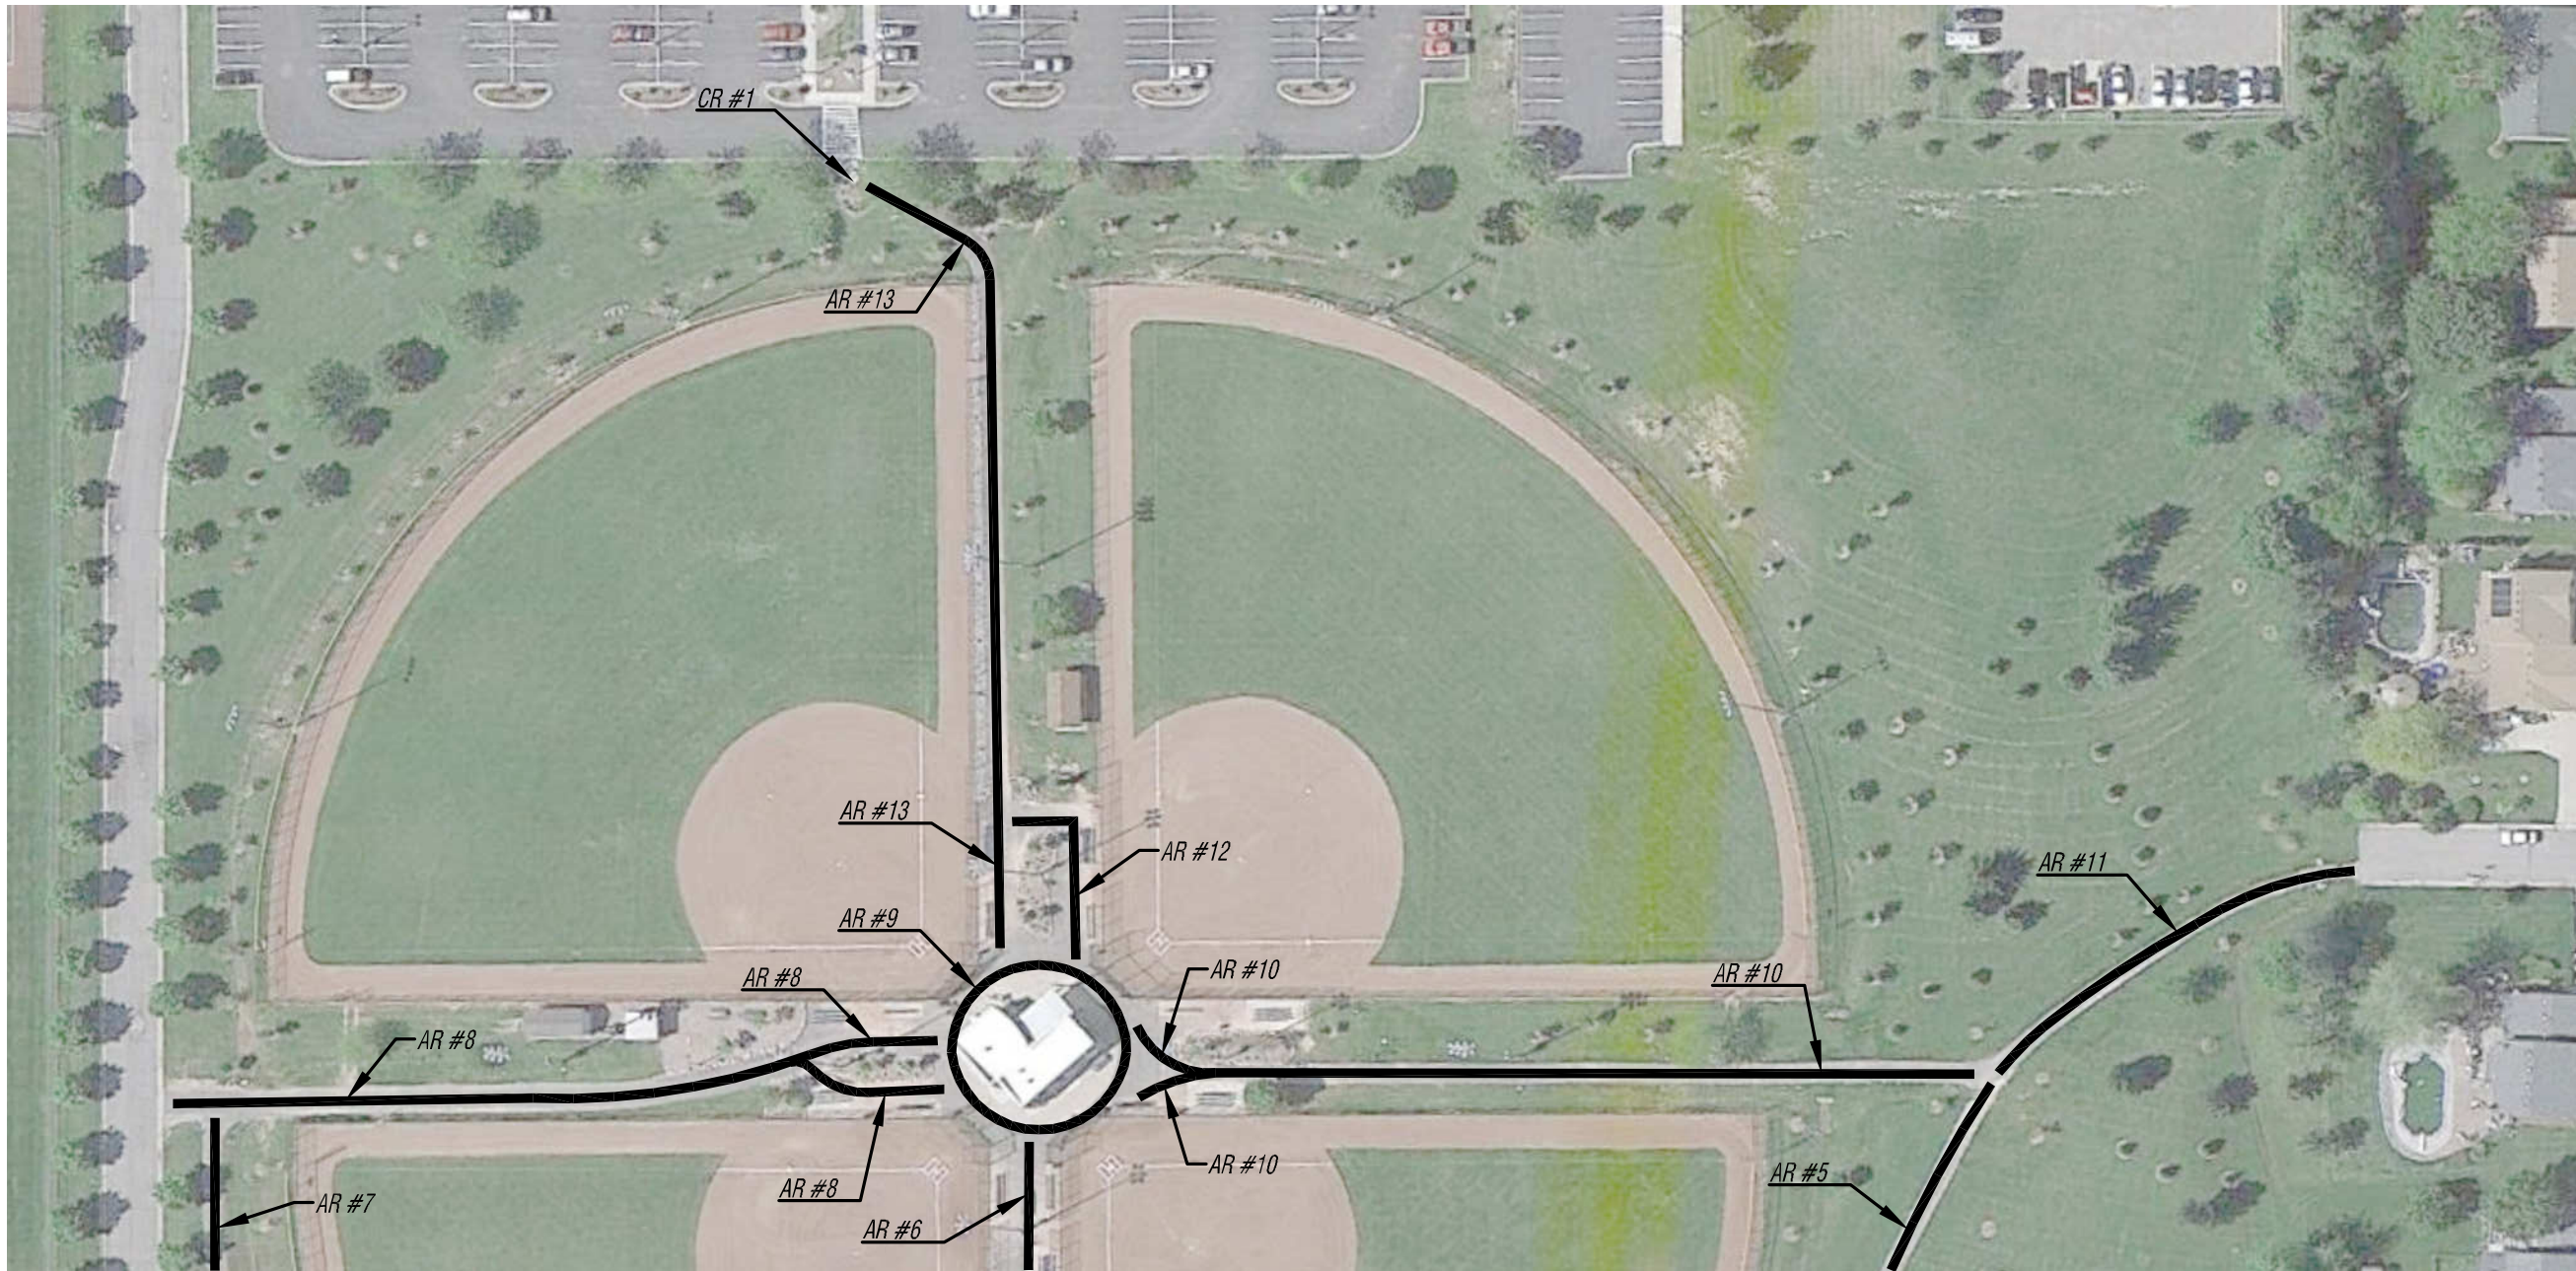
JOB No. NV13006	DRAWING No. ELLA MAE
SCALE: NONE	SHEET EMPP-1

31	Accessible Route AR#13 - from AR#9 to CR#1	Accessible Route	The north end of the asphalt pathway accessible route has running slopes exceeding 5.0%, measured up to 10%. The north end also has cross-slopes exceeding 2.0%, measured up to 6.0%.	Re-grade the isolated areas of the asphalt pathway to provide maximum running slopes of 5.0% and cross-slopes of 2.0%.	403.3
32	Curb Ramp CR#1 - from AR#13 to Civic Center Parking Lot	Curb Ramp	The curb ramp portion was measured to be level in all directions, thus making it the level landing portion of the accessible route.	No action required.	406.1 & 406.4

Play Areas					
33	Play Area PA#1	Play Area	Play area surface is comprised of woodchips and is surrounded by a raised concrete curb border that does not allow a flush transition surface into the play area.	Install asphalt or concrete path with ADA compliant slopes cut into the existing curb border to allow flush access into the play area. Woodchip surface must be placed flush up against new path entrance into play area as well.	1008.1
34	Play Area PA#2	Play Area	The accessible route leading up to the play area connects to an elevated bridge portion of the structure that leads to a slide down to the play area woodchip surface. Therefore, the play area surface is actually a level lower than the accessible route into the play area. The play area surface is then surrounded by a raised border with no accessible route out of the play area. Furthermore, there is a change in level where the ingress accessible route meets the play structure.	Provide flush transition from ingress accessible route to the elevated bridge portion of the play structure. Provide accessible route path with compliant slopes out of the play area surface that is flush with the play area woodchip surface, free of changes of level.	1008.1

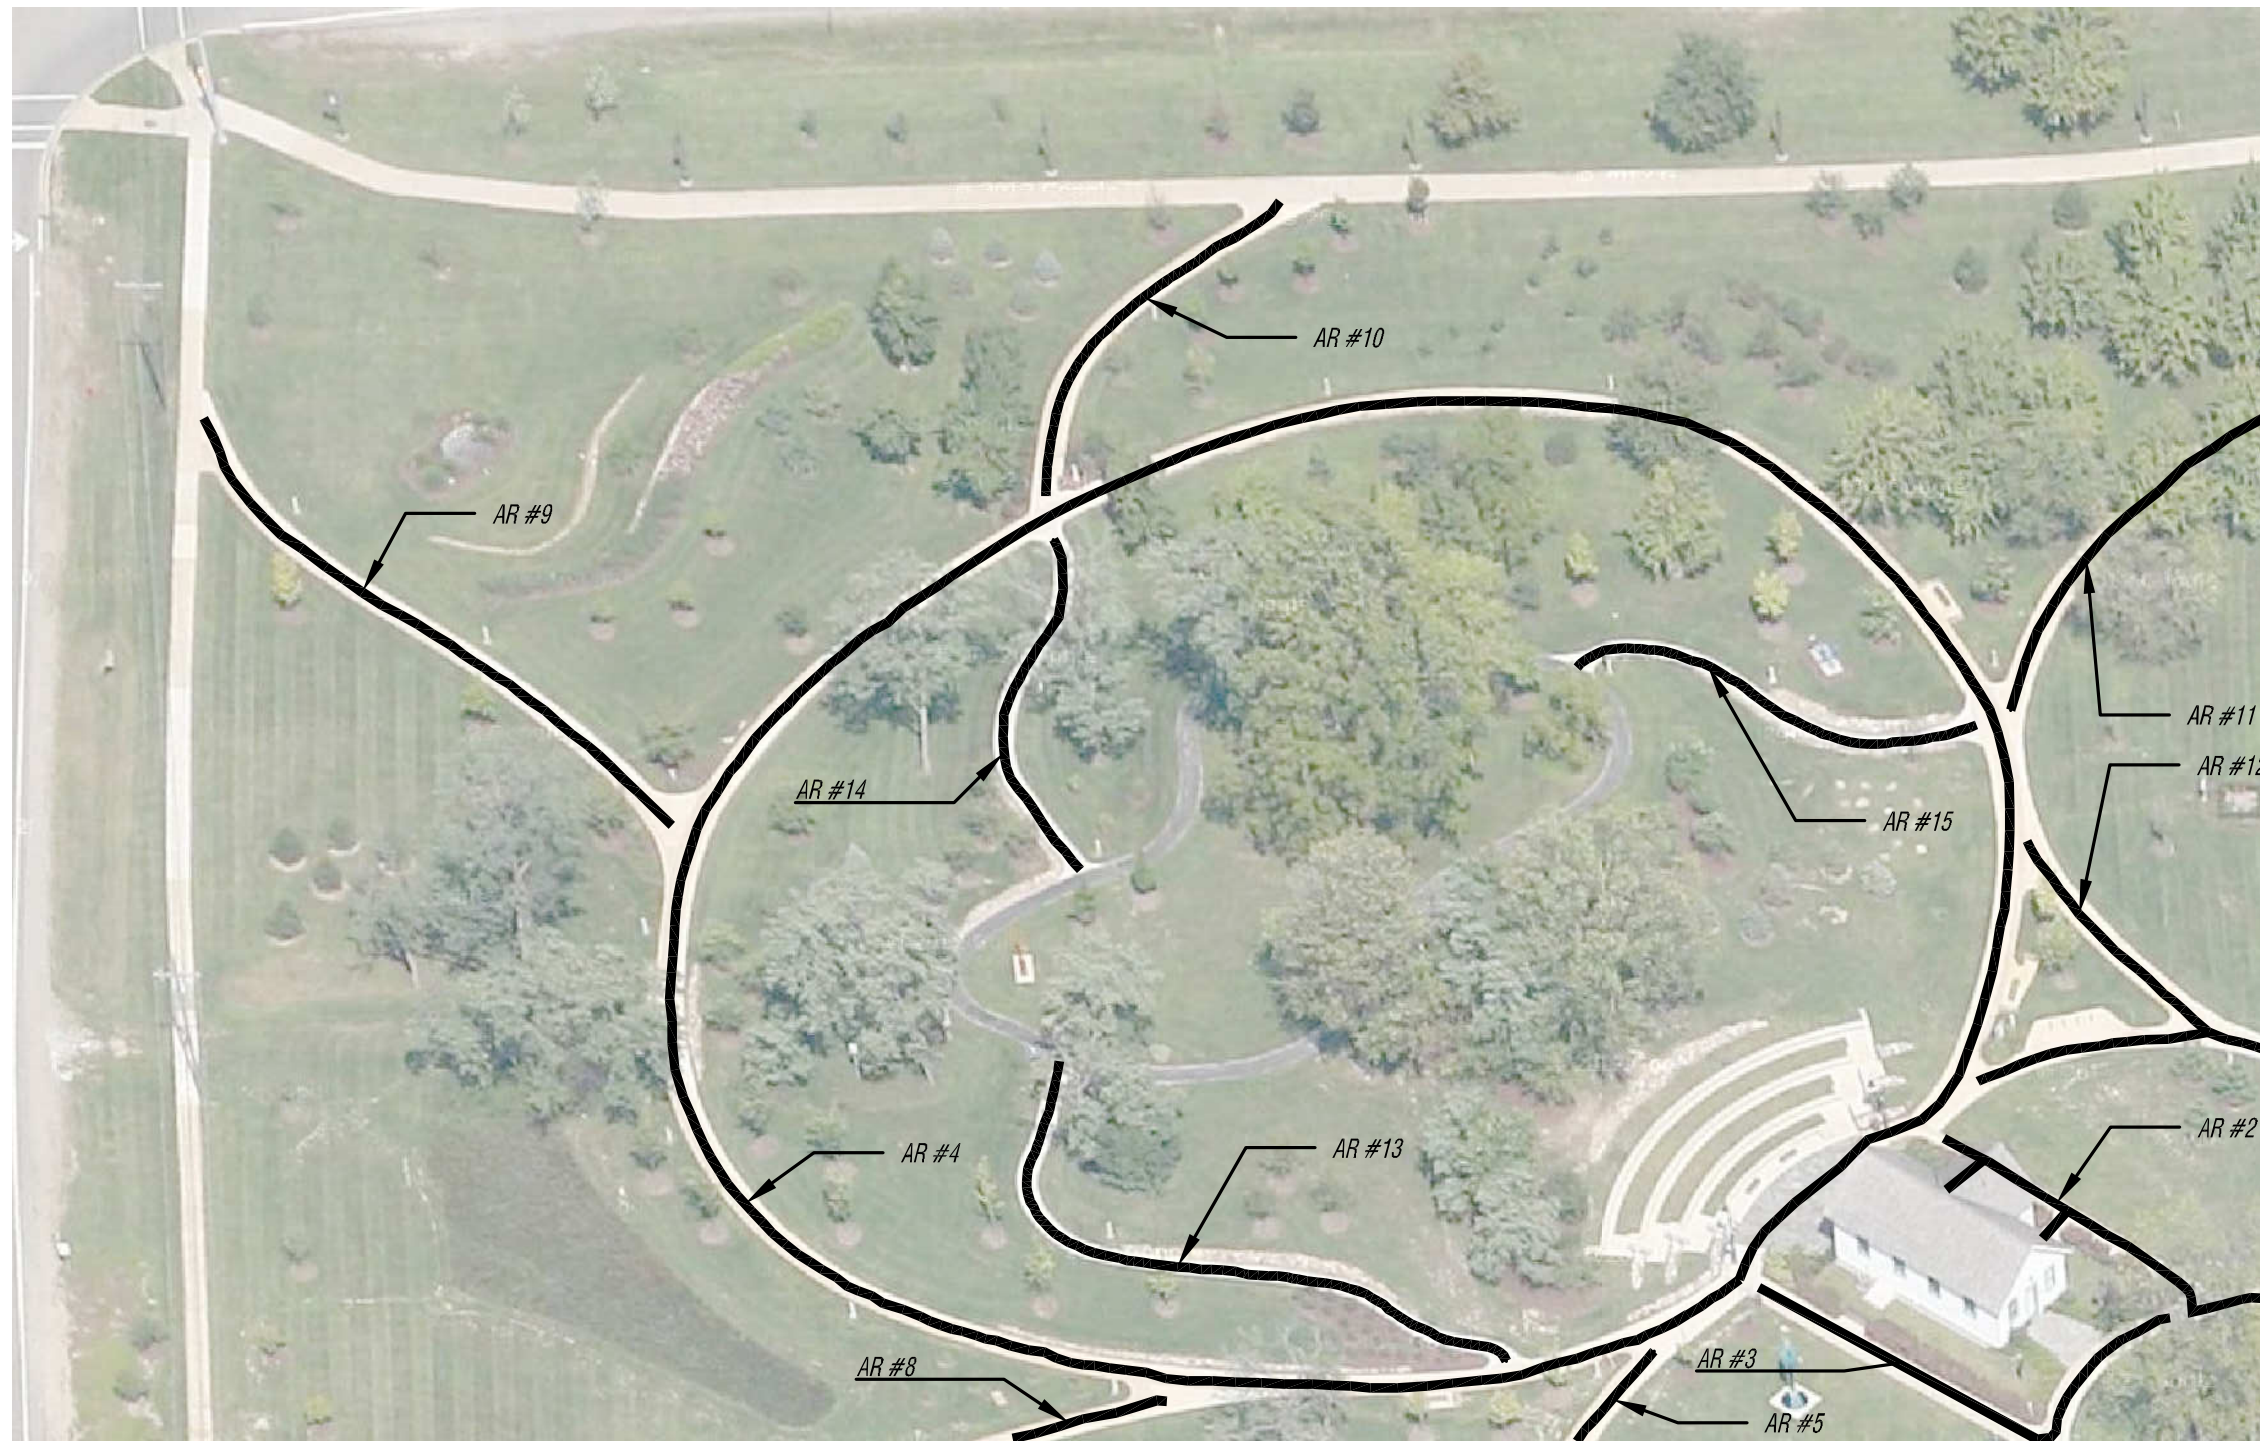
JOB No. NV13006	DRAWING No. FUERST PARK
SCALE: NONE	SHEET FP-1

28	Accessible Route AR#14 - from AR#4 to Center Gravel Pathway	Accessible Route	Running slopes within the concrete sidewalk route are at or below 5.0% and cross-slopes are at or below 2.0%.	No action required.	403.3
29	Accessible Route AR#15 - from AR#4 to Center Gravel Pathway	Accessible Route	Running slopes within the concrete sidewalk route are at or below 5.0% and cross-slopes are at or below 2.0%.	No action required.	403.3
