FIRE STATION NO. 2 LONG TERM NEEDS ASSESSMENT

EXISTING FACILITY ASSESSMENT

On November 8, 2013, Sidock Architects conducted an on-site inspection and analysis of Fire Station No. 2 with the assistance of the Novi Fire Department administration and staff, and representatives from the City of Novi Facility Operations. The inspection included brief discussions with the fire fighters and staff at the station and a general inspection tour of the facility.

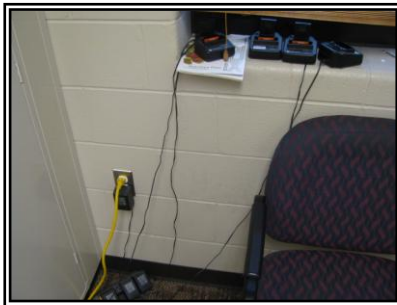
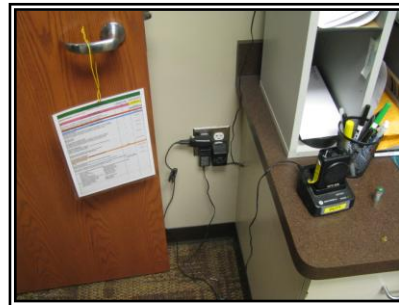
- 1. The exterior wall-mounted "badge sign" needs to be repaired and/or replaced.
- 2. A number of receptacles for chargers for portable electronic devices are needed to avoid devices laying on the floor.

1. New telephone line in Exercise Room	\$ 350.00
2. Café-style doors for sleeping spaces (3)	\$ 800.00
3. Wall-mounted plug strip for chargers	\$ 2,500.00
4. Overband crack seal	\$ 1,100.00*
	<hr/>
Medium Priority Total	\$ 4,750.00
