CITY OF NOVI
ADA COMPLIANCE TRANSITION PLAN
CITY-OWNED FACILITIES
MARCH 2014

SDA Job No. NV13006.0C

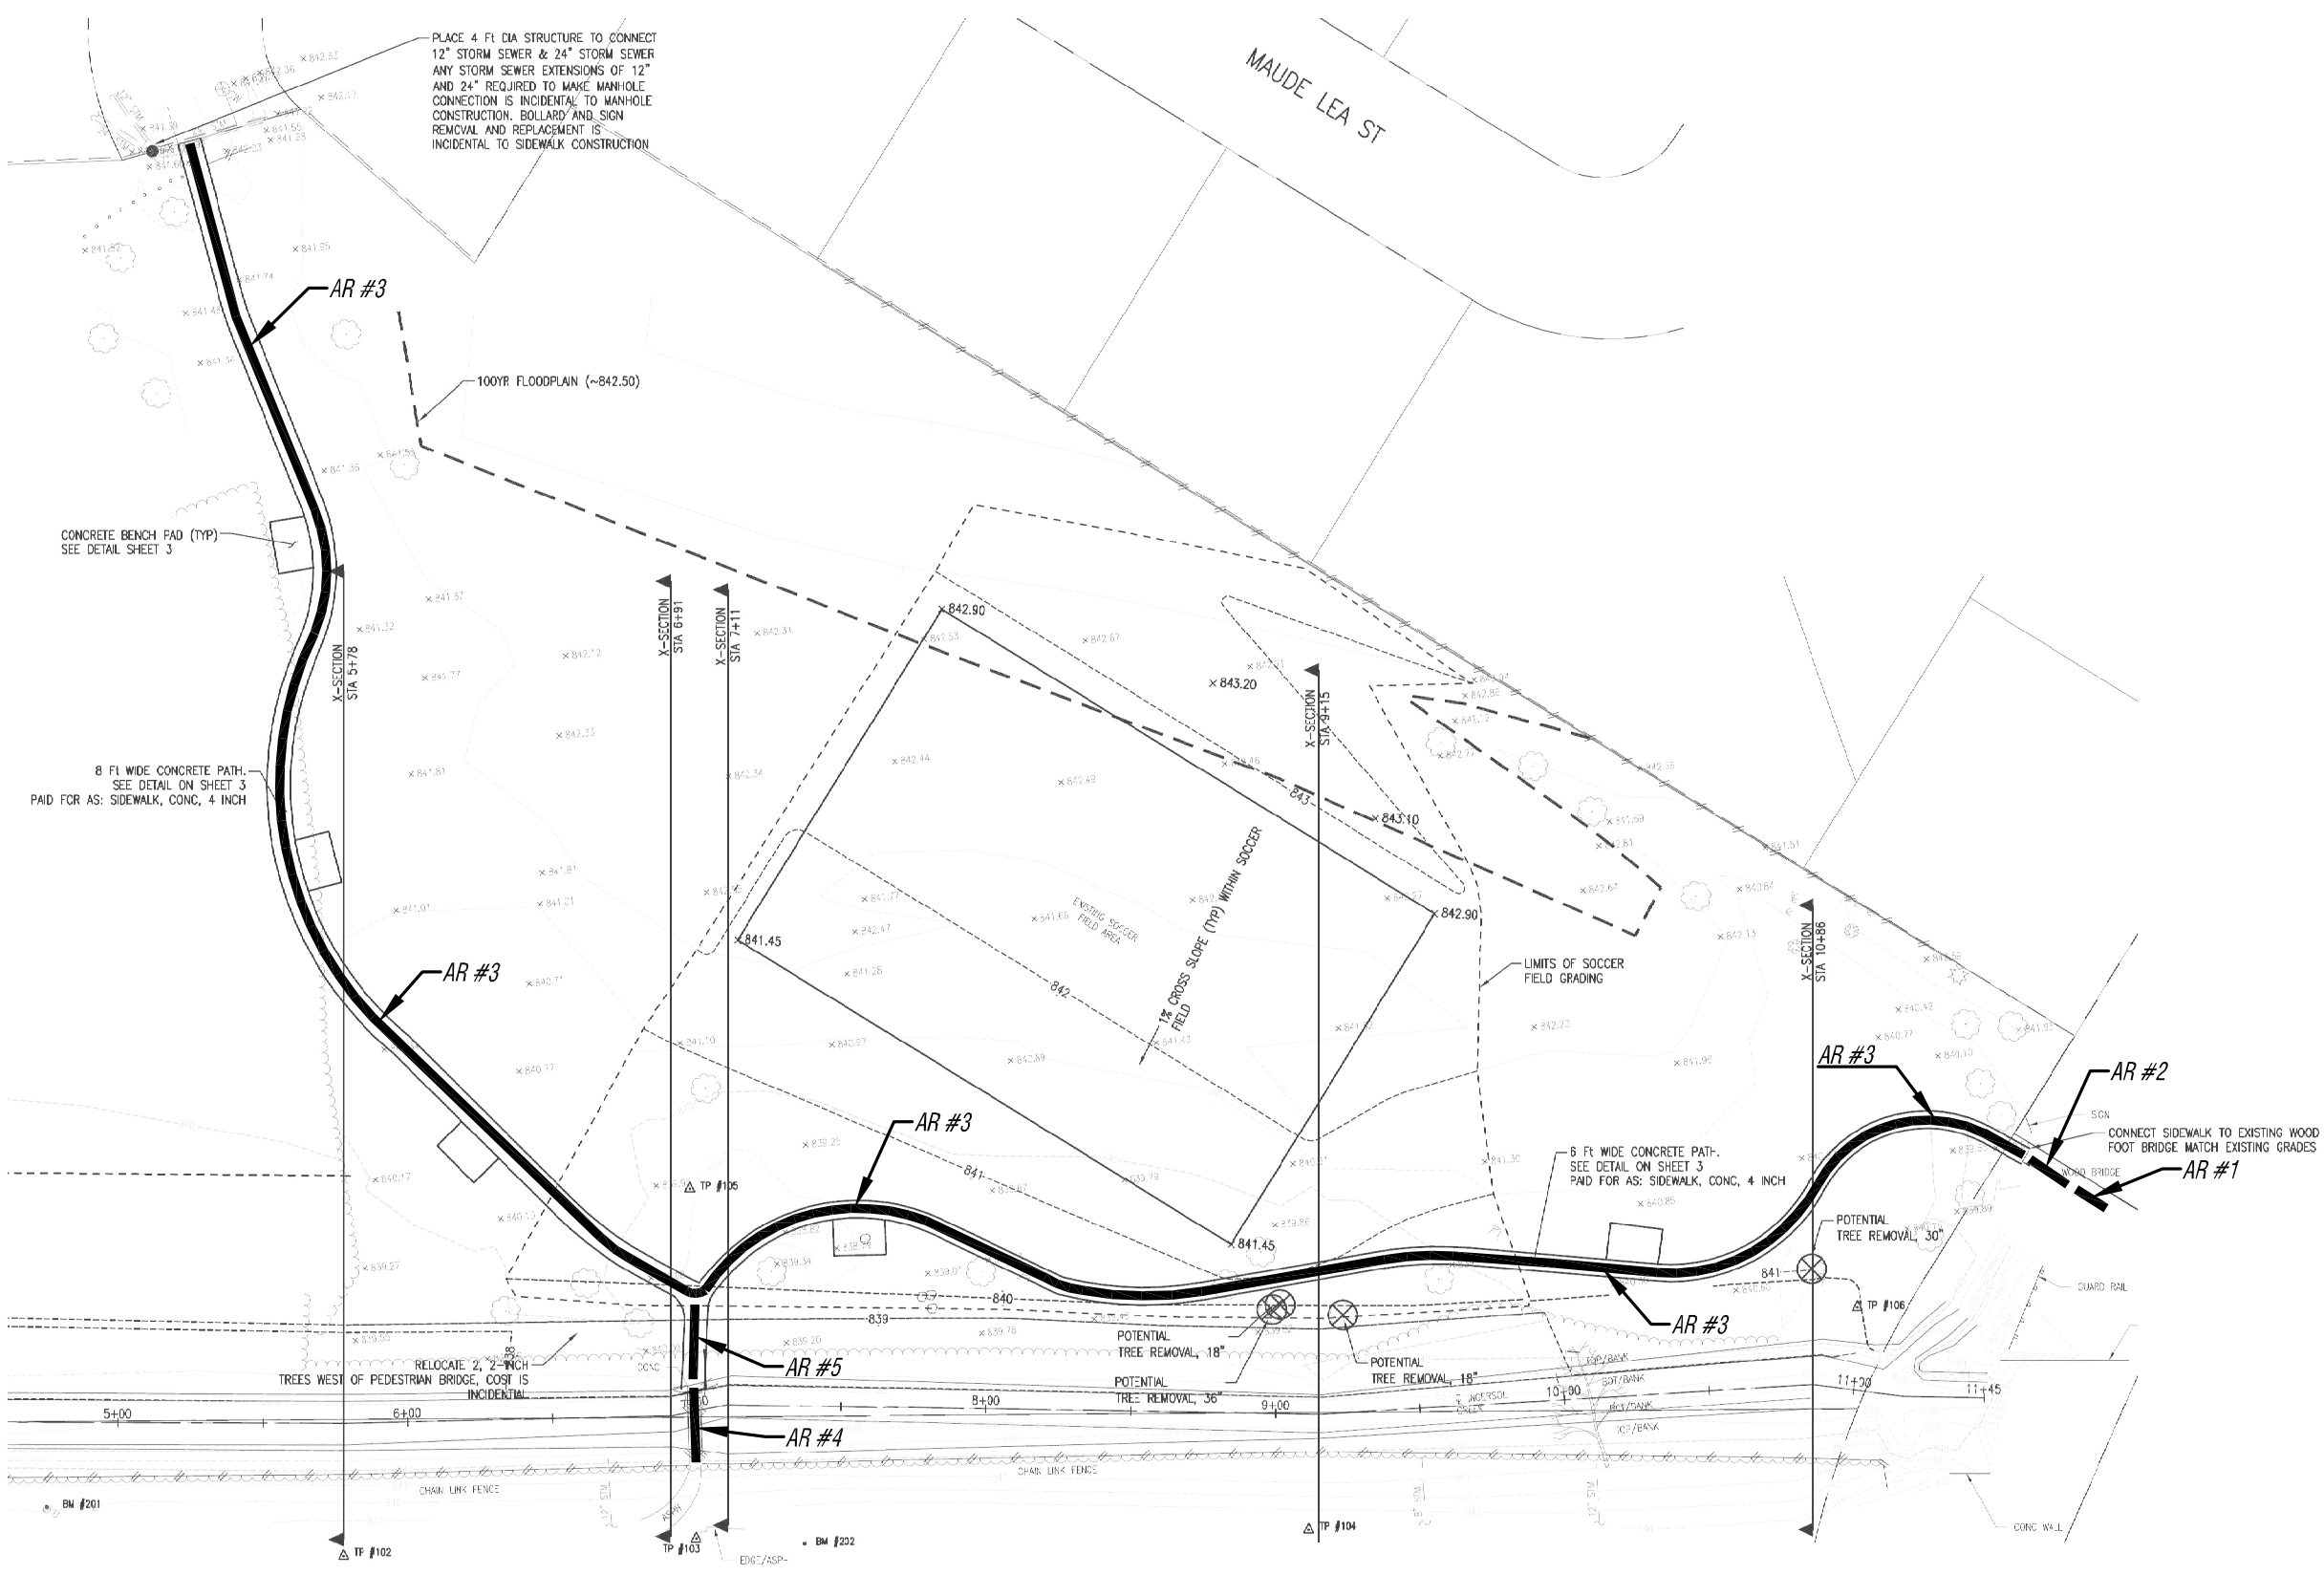
4	Accessible Route AR#2 - from APA#1 to AR#3	Accessible Route	The existing wood bridge contains non-compliant cross-slopes measured up to 5% and contains stairs, which is also non-compliant.	Replace bridge and re-grade surrounding areas to provide a smooth surface free of stairways with compliant ADA slopes. Ensure handrails are ADA compliant.	403.3
5	Accessible Route AR#3 - from AR#2 to Northwest Ripple Creek Public Right-of-Way Park Entrance	Accessible Route	The majority of the concrete sidewalk has running slopes at or below 5.0% and cross-slopes at or below 2.0%. However, there is one small section of walk directly west of the AR#2 bridge that has running slopes measured up to 7.6%.	Re-grade the portion of concrete sidewalk just west of the bridge to have a maximum running slope of 5.0% and a maximum cross-slope of 2.0%, or provide level landings at the top and bottom of the ramp and install ADA compliant handrails along both sides of the walk. Coordinate re-grading of AR#1 to provide compliant slopes for the park.	403.3

6	Accessible Route AR#4 - from Village Oaks Elementary School property to AR#5	Accessible Route	The existing wood bridge connecting the Village Oaks Elementary School asphalt path to the park contains non-compliant slopes and changes in level. Note: The bridge was blocked off and noted as closed at the time of the survey.	Replace bridge and re-grade surrounding areas to provide a smooth surface free of level changes with compliant ADA slopes. Ensure handrails are ADA compliant.	403.3
7	Accessible Route AR#5 - from AR#4 to AR#3	Accessible Route	The concrete sidewalk connecting the bridge to the main sidewalk route around the site has running slopes at or below 5.0% and cross-slopes at or below 2.0%.	No action required.	403.3

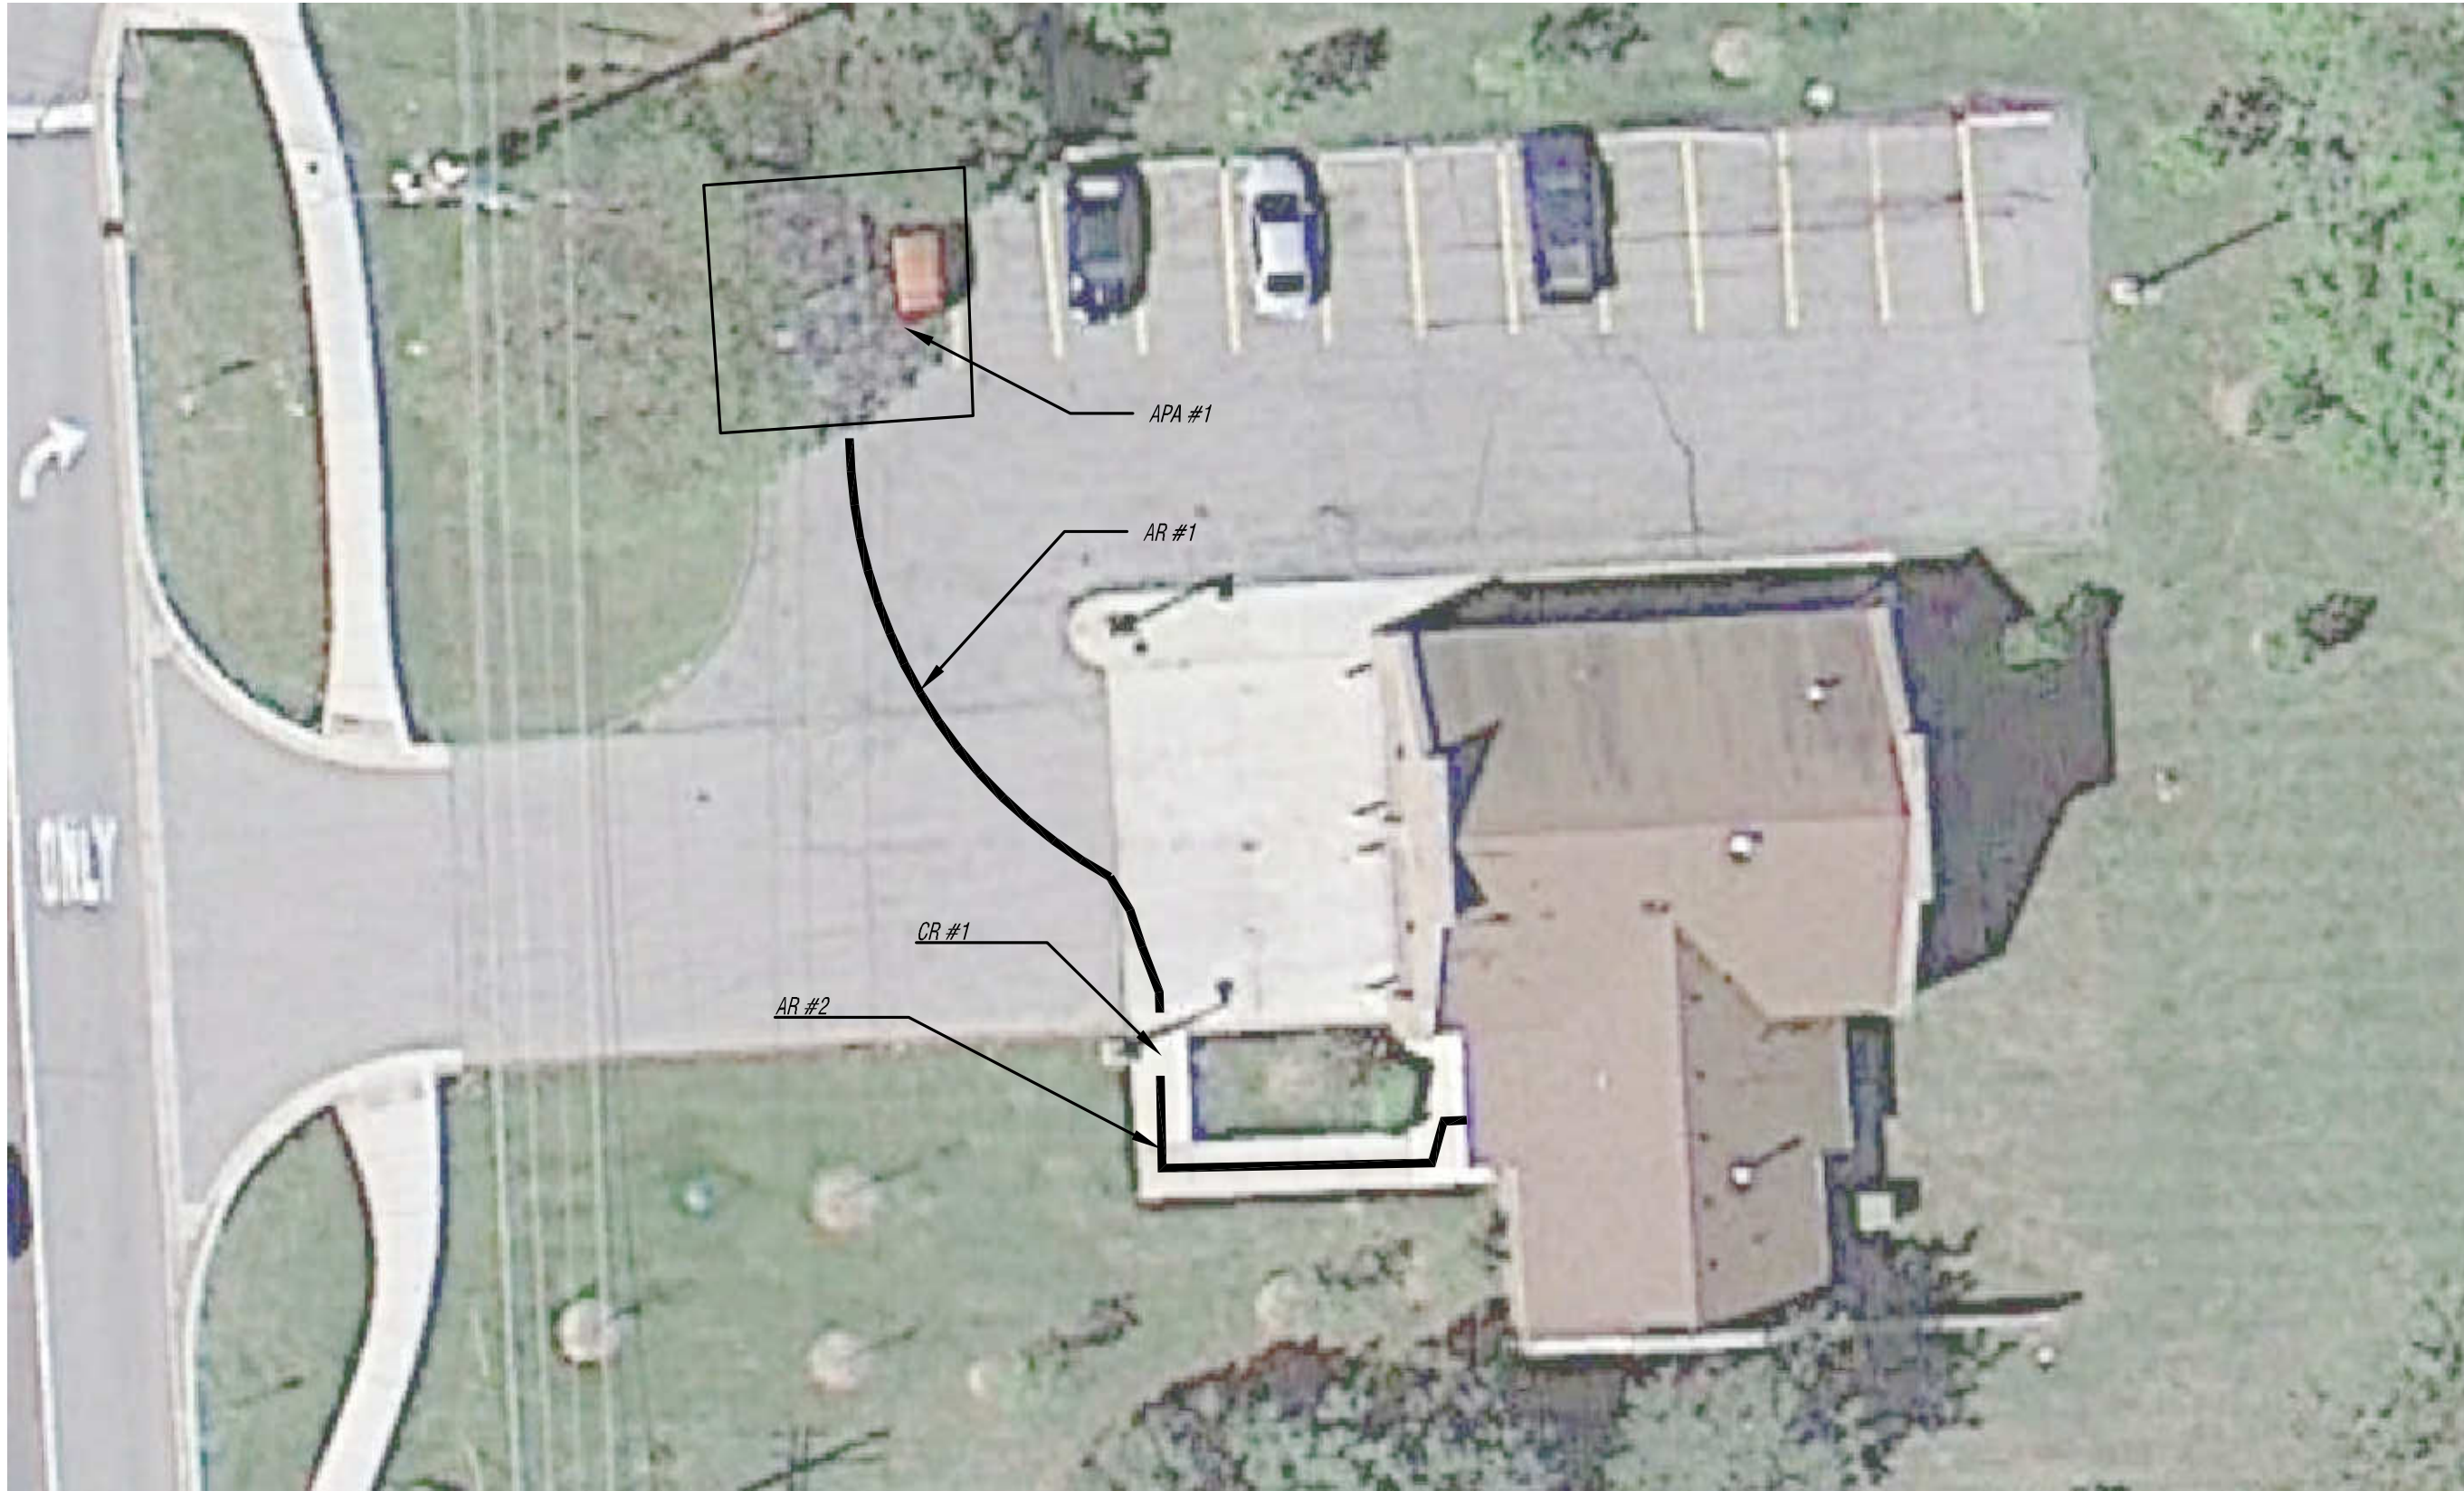
4	Accessible Parking Area APA#1 - Access Aisle A1	Access Aisle	No access aisle is provided for parking space P1.	Stripe an adjacent access aisle with a minimum width of 96 inches to designate P1 as a van accessible space if existing slopes are at or below 2.0% in all directions. If existing slopes are above 2.0%, remove the existing asphalt pavement, re-grade and replace to provide maximum slopes of 2.0% in all directions prior to striping.	502.2, 502.3 & 502.4
5	Accessible Parking Area APA#1 - P1 Signage	Signage	The existing sign has a clearance of 79 inches from the ground surface to the bottom of the lowest sign. There is no sign designating the space as van accessible.	Add van accessible sign to existing post and maintain a minimum of 60 inches of clearance from the ground surface to the bottom of the lowest sign.	502.6
Accessible Routes					
6	Accessible Route AR#1 - from APA#1 to CR#1	Accessible Route	The asphalt pavement accessible route leading from the accessible parking area APA#1 to curb ramp CR#1 was measured to have running slopes at or below the 5.0% maximum and cross-slopes at or below the 2.0% maximum. However, pavement inconsistencies due to the poor condition of the asphalt pavement are creating non-compliant changes in level (lips) and openings.	Re-surface the asphalt pavement within the accessible route to provide a smooth surface free of non-compliant pavement inconsistencies.	403.3

7	Curb Ramp CR#1	Curb Ramp	The concrete curb ramp with rolled sides was measured to have compliant running slopes as well as compliant cross-slopes and a width greater than the minimum of 36 inches. A level landing at the top of the ramp was also noted.	No action required.	406.1 & 406.4
8	Accessible Route AR#2 - from CR#1 to Building Entrance	Accessible Route	The concrete sidewalk accessible route leading from curb ramp CR#1 to the building entrance was measured to have running slopes at or below the 5.0% maximum and cross-slopes at or below the 2.0% maximum. However, moderate severity spalls and cracks within the concrete are creating non-compliant changes in level (lips) and openings.	Replace isolated flags of concrete sidewalk to eliminate lips and openings.	403.3

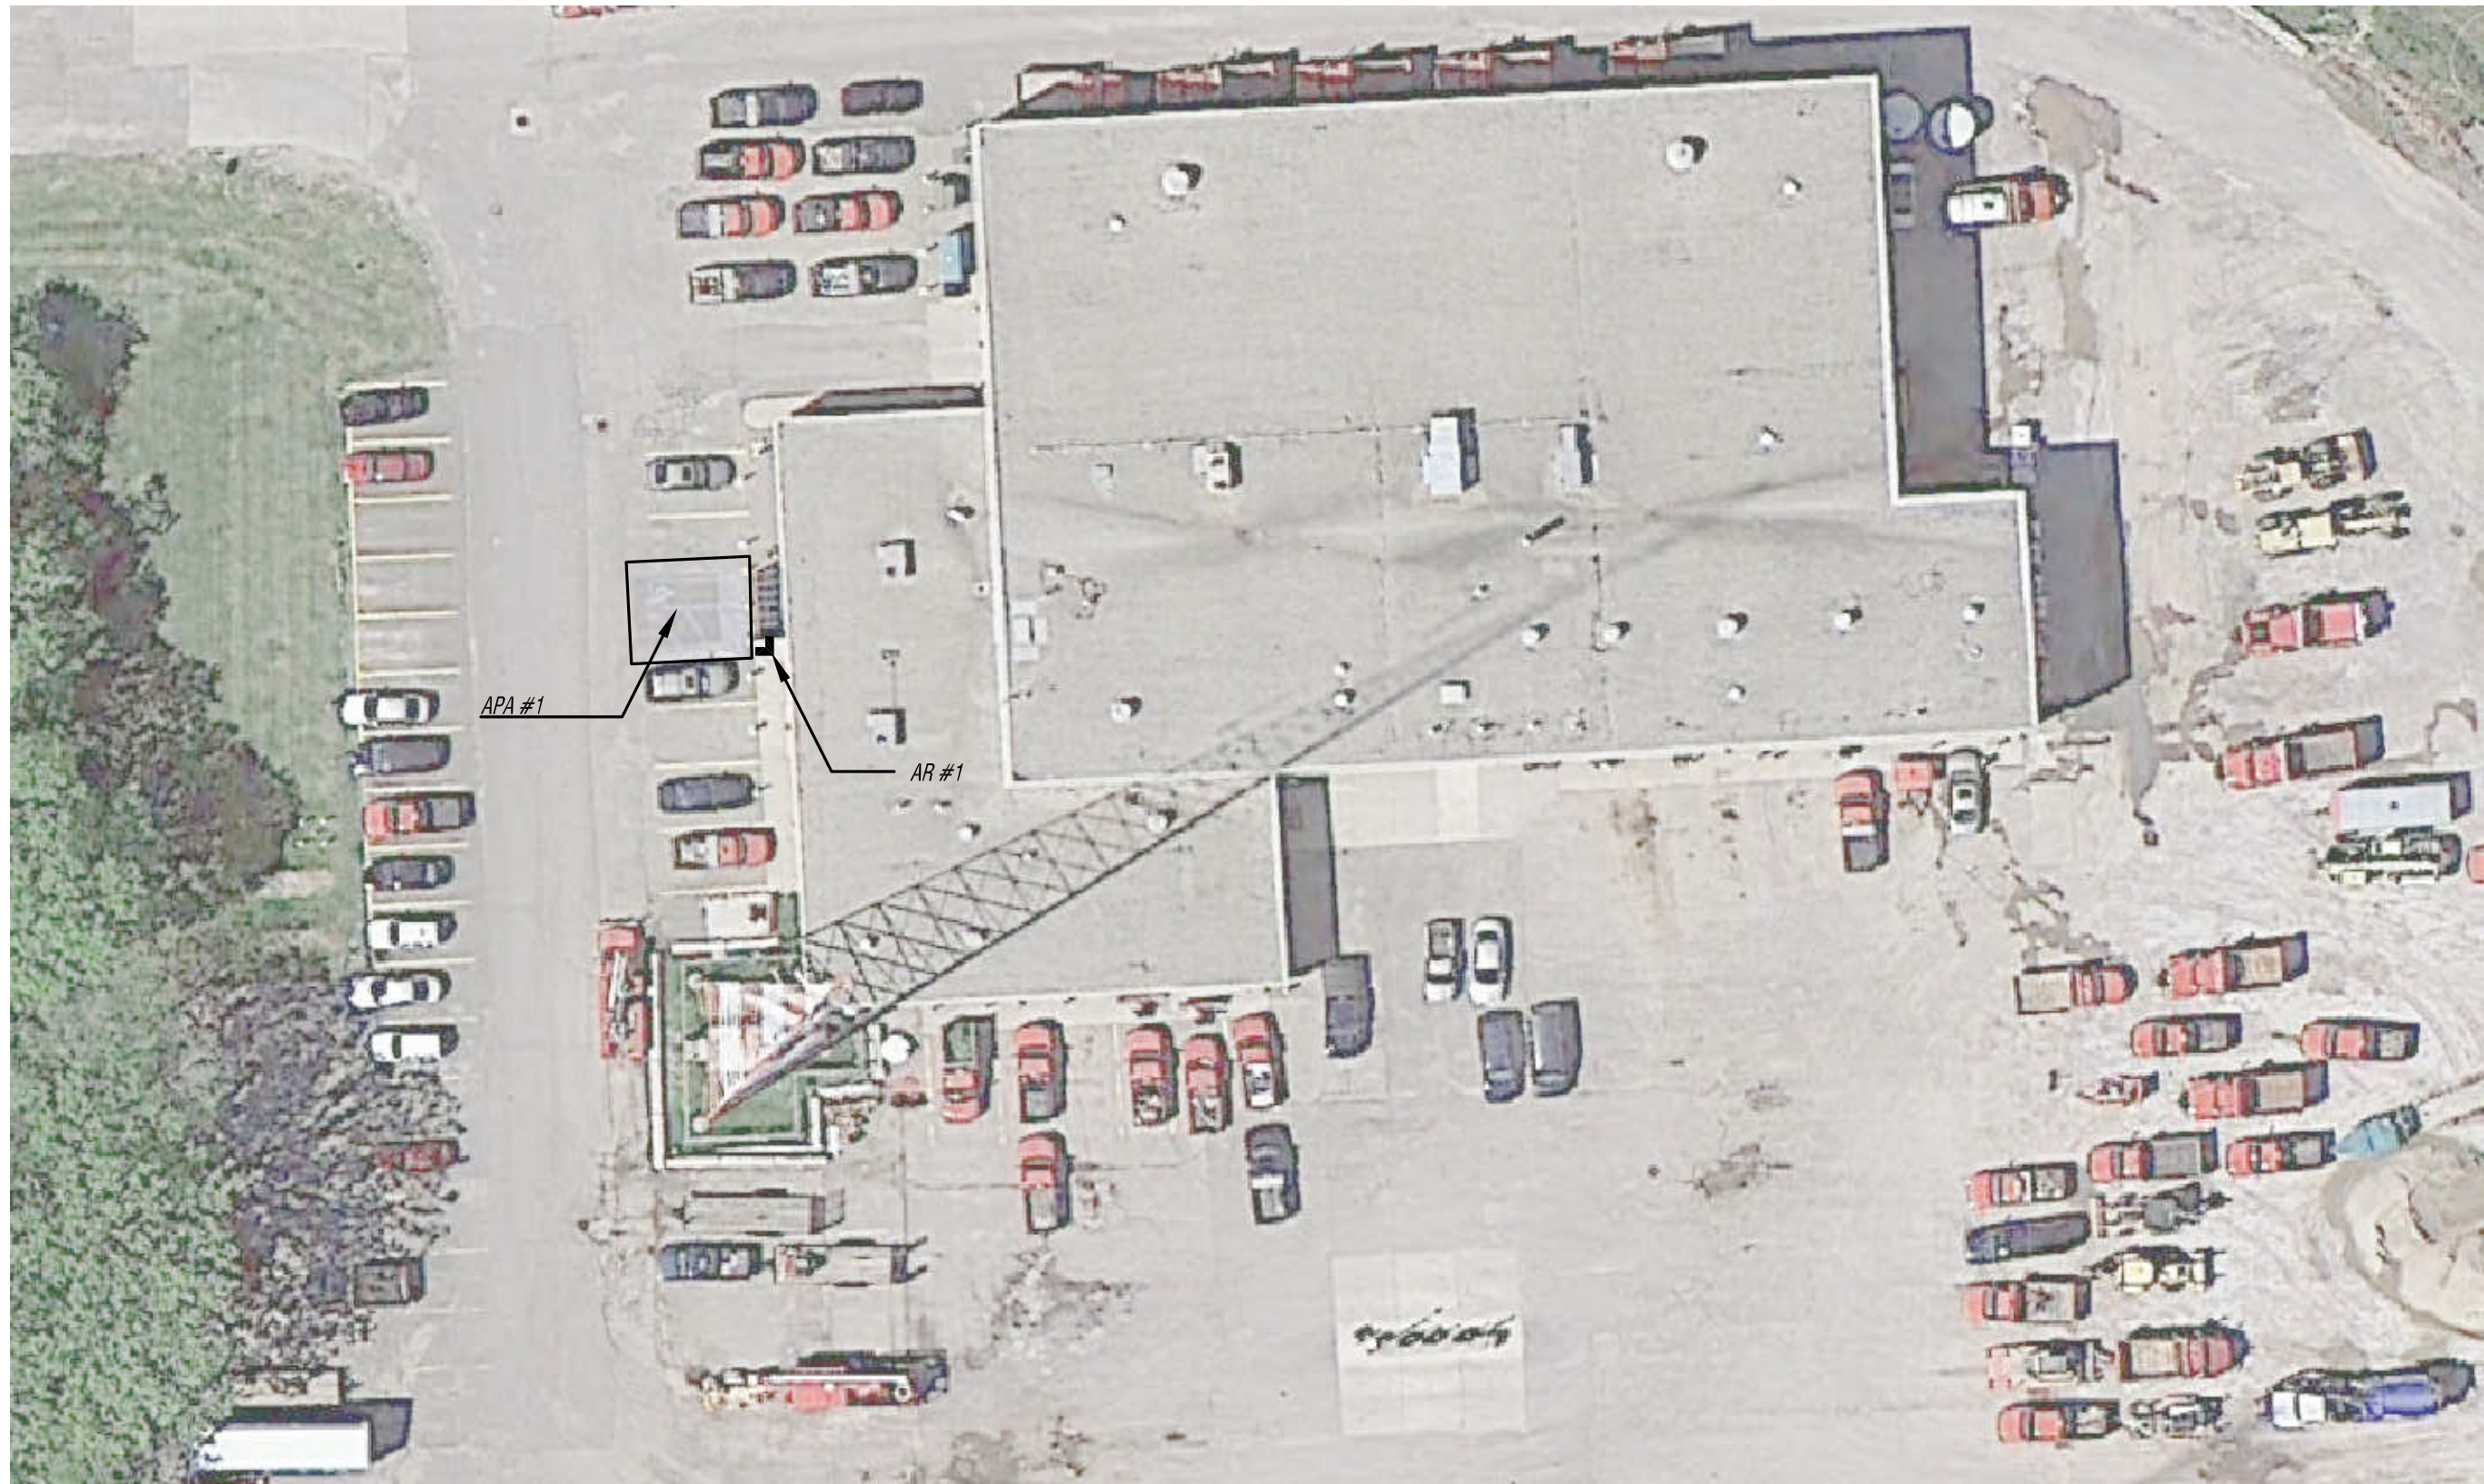
12	Accessible Parking Area APA#2 - Access Aisle A1	Access Aisle	The existing access aisle serving parking spaces P1 was measured to be 60 inches wide and the pavement slopes were measured to be at or less than 2.0%.	Since the sole accessible parking space is required to be identified as van accessible, the access aisle layout needs to be widened to be a minimum of 96 inches wide. If the slopes of the adjacent pavement exceed 2.0%, re-grade the asphalt pavement to provide ADA compliant slopes prior to re-striping.	502.2, 502.3 & 502.4
13	Accessible Parking Area APA#2 - P1 Signage	Signage	The existing sign unit does not include a van accessible sign and has a clearance of 80 inches from the ground surface to the bottom of the lowest sign.	Add a van accessible sign to existing sign post unit and provide a minimum clearance of 60 inches from the top of the ground surface to the bottom of the lowest sign.	502.6

Accessible Routes - Police Firearms Training Center Building					
14	Accessible Route AR#2 - from APA#2 to CR#1	Accessible Route	The asphalt pavement route has running slopes less than 5.0%, but it also has cross-slopes exceeding the maximum allowable 2.0%, measured up to 3.0%.	Remove the existing asphalt pavement, re-grade and replace to provide maximum running slopes of 5.0% and maximum cross-slopes of 2.0%.	403.3
15	Curb Ramp CR#1	Curb Ramp	The concrete curb ramp has rolled sides and cross-slopes at or below the maximum allowable 2.0%. However, the ramp also has running slopes exceeding the maximum allowable 8.3%, measured up to 9.4%.	Replace existing concrete ramp to provide ADA compliant running slopes at or below 8.3% and a level landing at the top of the ramp.	406.1 & 406.4
16	Accessible Route AR#3 - from CR#1 to Building Entrance	Accessible Route	The concrete sidewalk accessible route contains cross-slopes exceeding the maximum allowable 2.0%, measured up to 3.0%.	Re-grade the concrete sidewalk to provide cross-slopes at or below 2%.	403.3

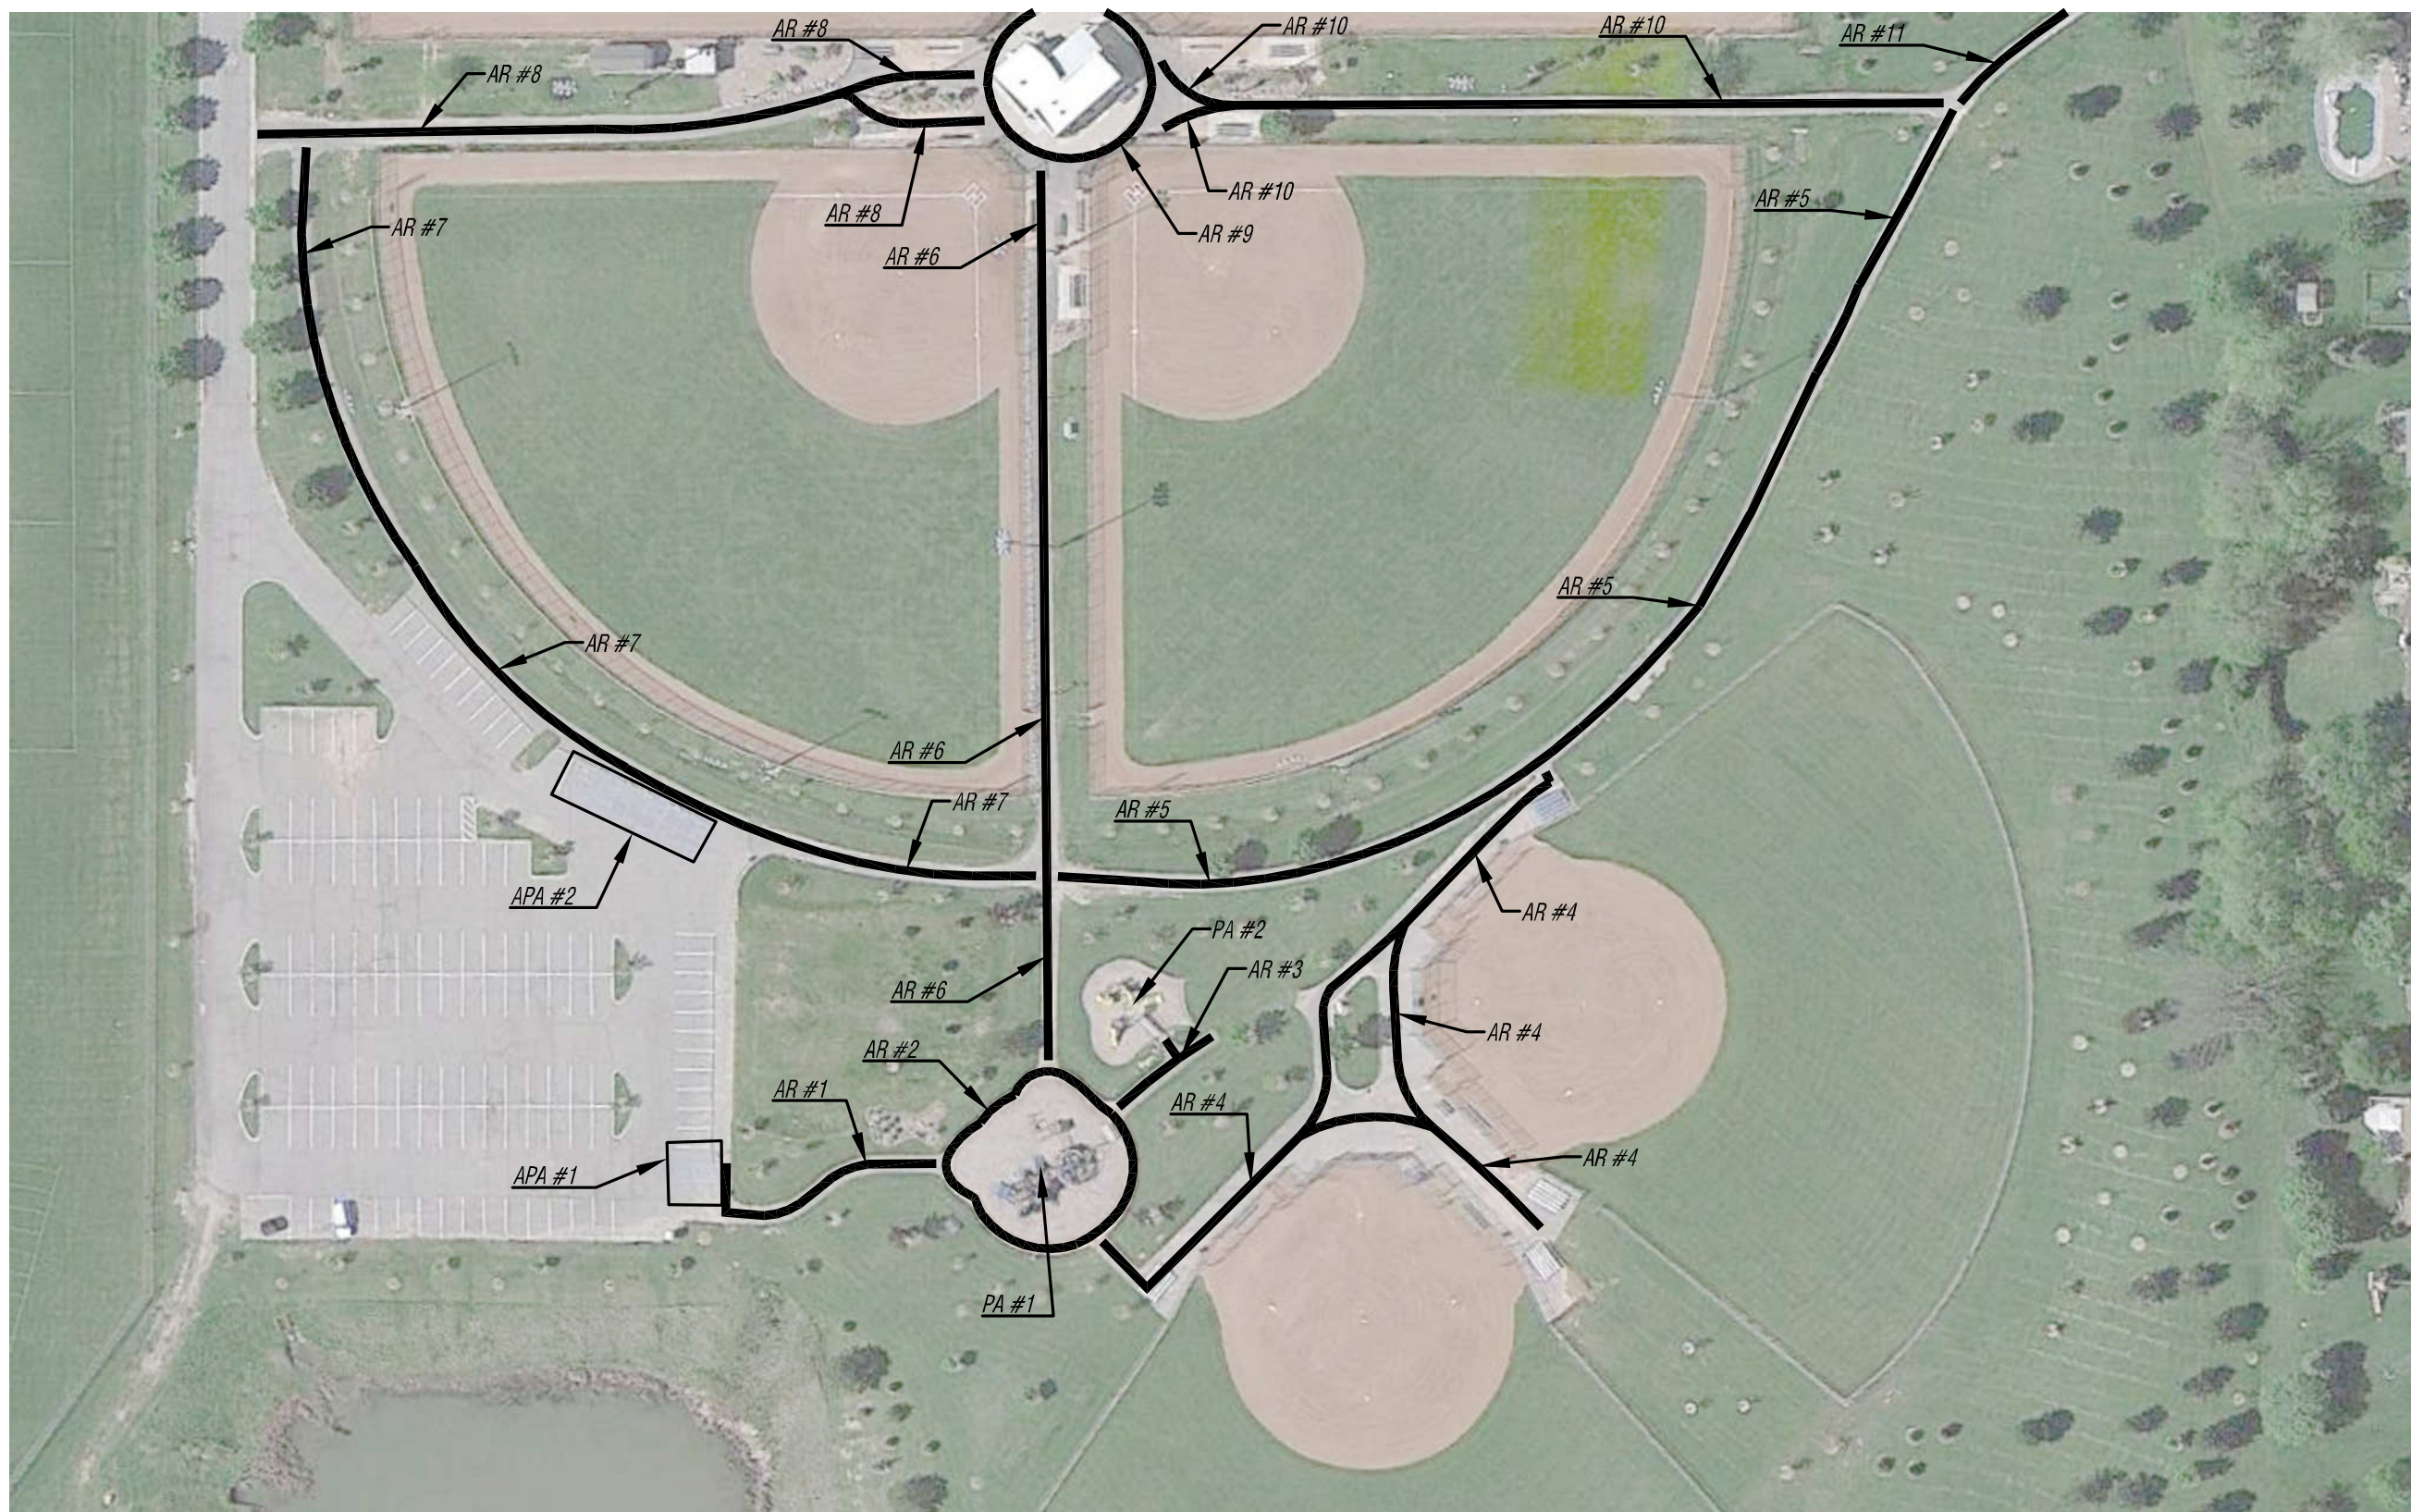
31	Accessible Route AR#13 - from AR#9 to CR#1	Accessible Route	The north end of the asphalt pathway accessible route has running slopes exceeding 5.0%, measured up to 10%. The north end also has cross-slopes exceeding 2.0%, measured up to 6.0%.	Re-grade the isolated areas of the asphalt pathway to provide maximum running slopes of 5.0% and cross-slopes of 2.0%.	403.3
32	Curb Ramp CR#1 - from AR#13 to Civic Center Parking Lot	Curb Ramp	The curb ramp portion was measured to be level in all directions, thus making it the level landing portion of the accessible route.	No action required.	406.1 & 406.4

Play Areas					
33	Play Area PA#1	Play Area	Play area surface is comprised of woodchips and is surrounded by a raised concrete curb border that does not allow a flush transition surface into the play area.	Install asphalt or concrete path with ADA compliant slopes cut into the existing curb border to allow flush access into the play area. Woodchip surface must be placed flush up against new path entrance into play area as well.	1008.1
34	Play Area PA#2	Play Area	The accessible route leading up to the play area connects to an elevated bridge portion of the structure that leads to a slide down to the play area woodchip surface. Therefore, the play area surface is actually a level lower than the accessible route into the play area. The play area surface is then surrounded by a raised border with no accessible route out of the play area. Furthermore, there is a change in level where the ingress accessible route meets the play structure.	Provide flush transition from ingress accessible route to the elevated bridge portion of the play structure. Provide accessible route path with compliant slopes out of the play area surface that is flush with the play area woodchip surface, free of changes of level.	1008.1

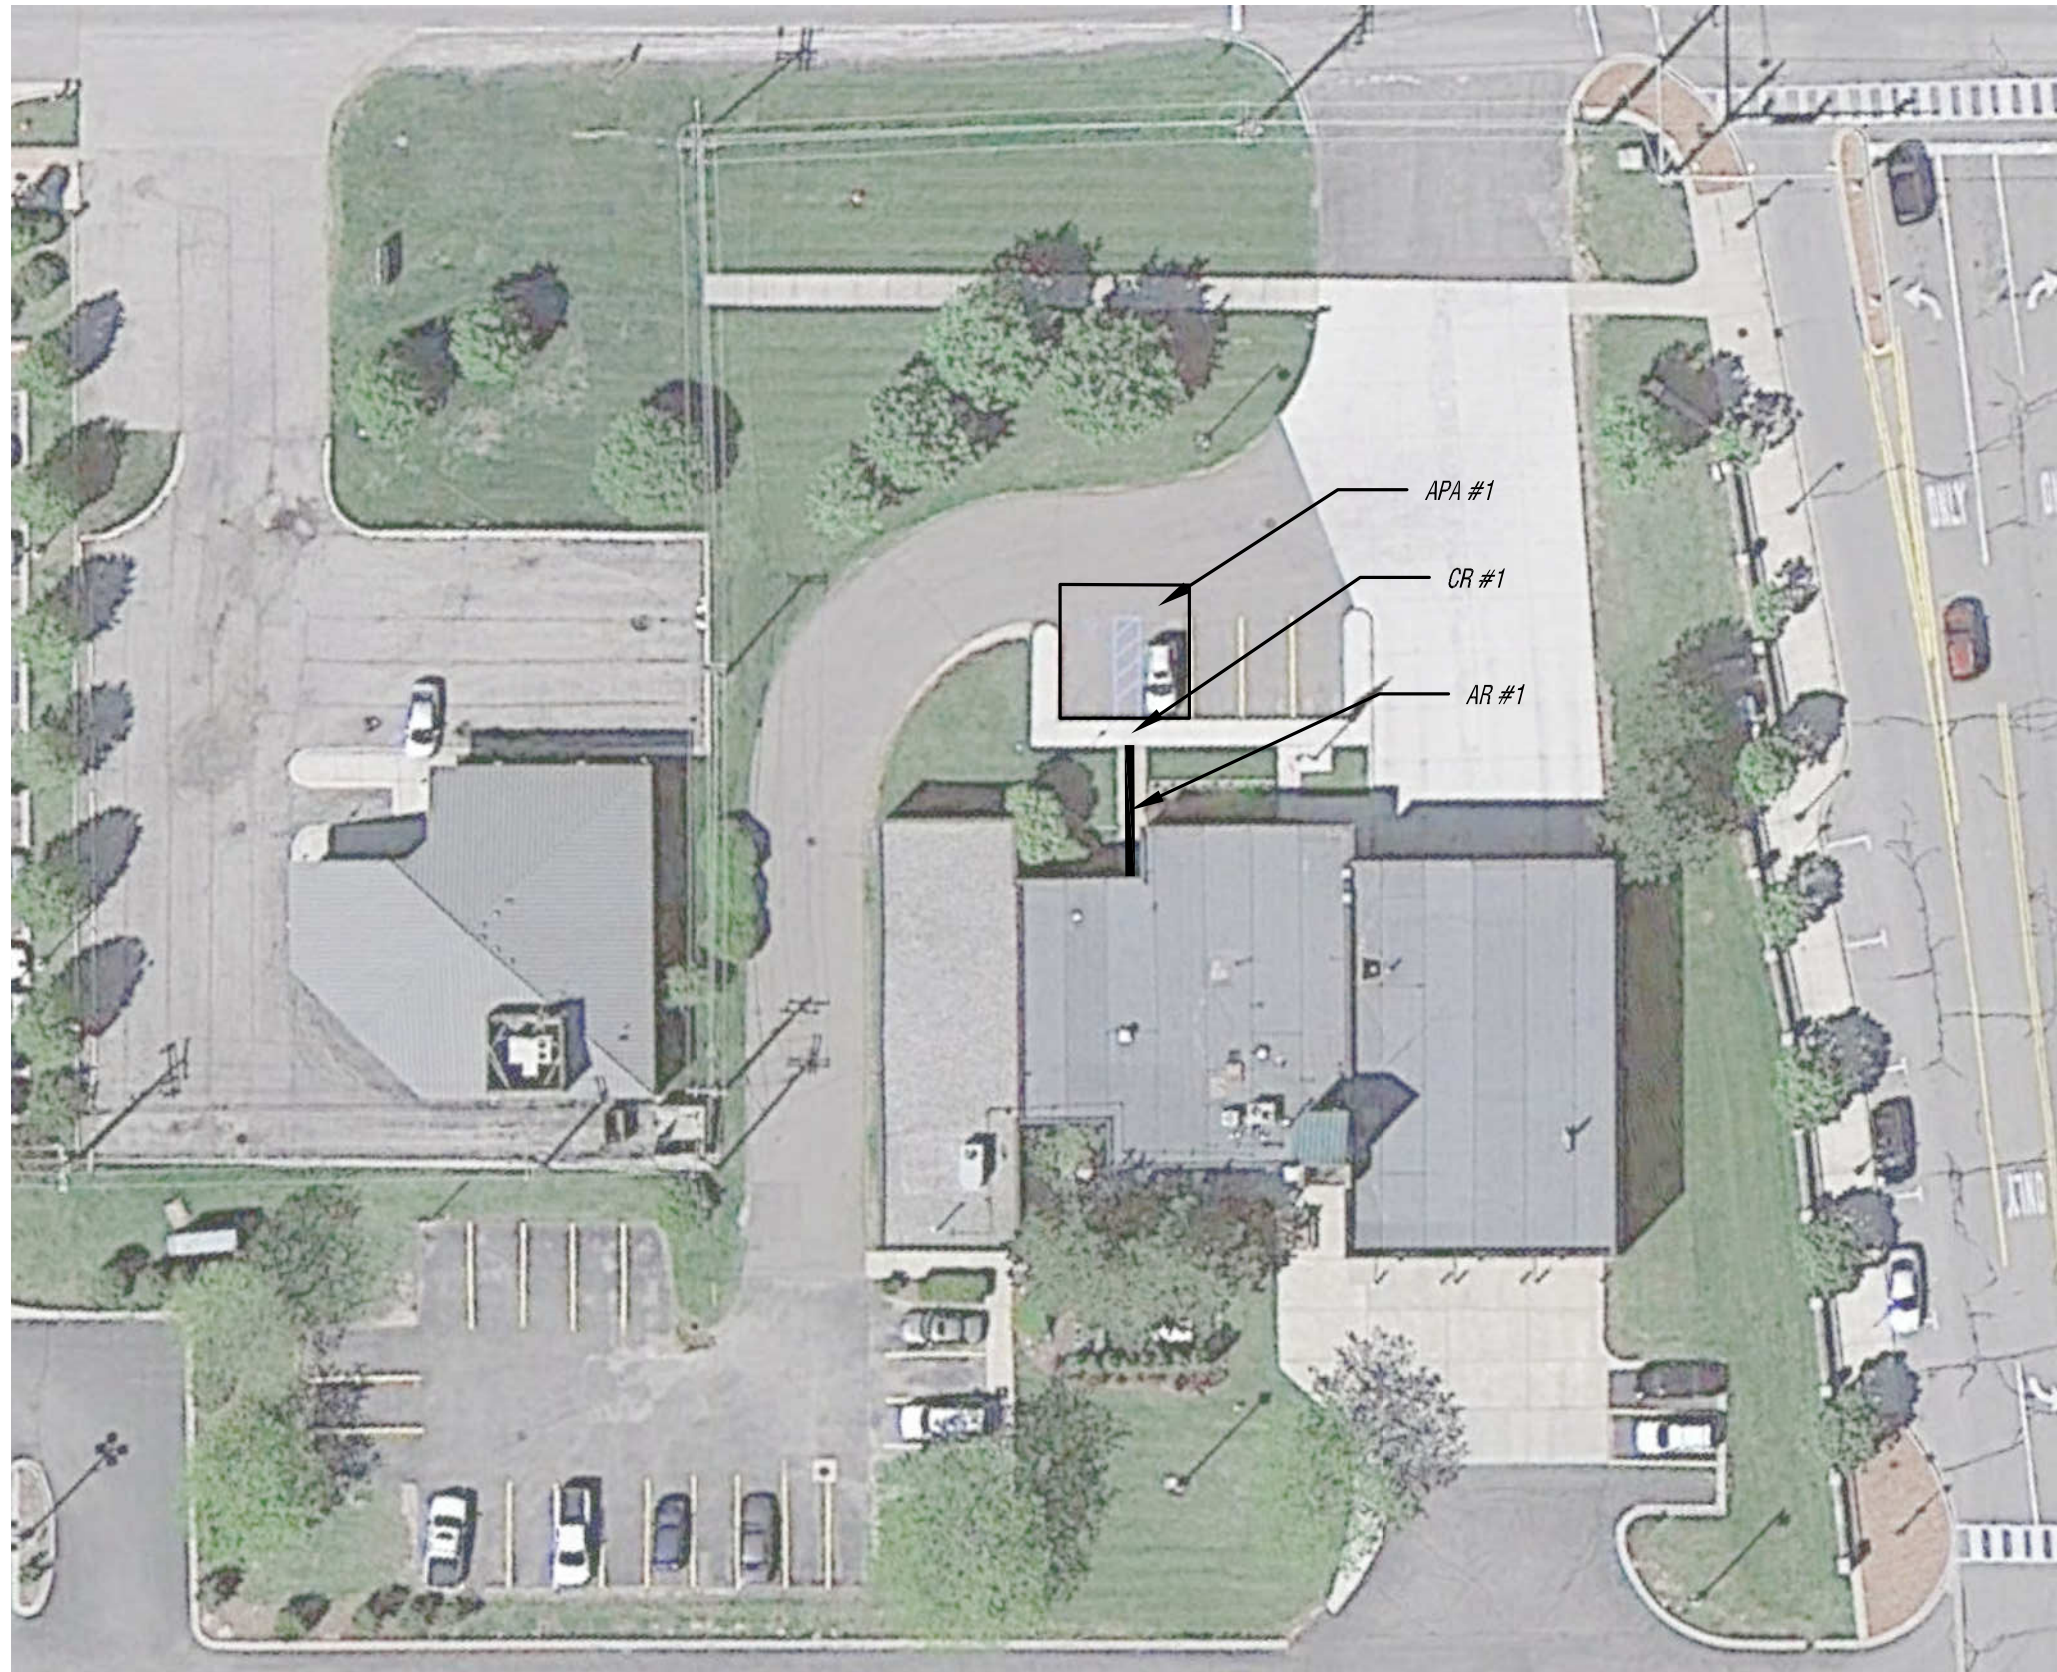
5	Accessible Parking Area APA#1 - Parking Space P2	Parking Space	A second required accessible parking stall is currently not provided at this site.	Stripe a new van accessible space with a minimum width of 96 inches directly adjacent to the revised access aisle if existing slopes are at or below 2.0% in all directions. If slopes are greater than 2.0%, re-grade pavement to provide compliant slopes.	502.2 & 502.4
6	Accessible Parking Area APA#1 - P1 Signage	Signage	The existing sign has a clearance of 57 inches from the ground surface to the bottom of the lowest sign.	Adjust existing sign to provide a minimum clearance of 60 inches from the ground surface to the bottom of the lowest sign.	502.6
7	Accessible Parking Area APA#1 - P2 Signage	Signage	A second sign is currently not provided at this site.	Install a second ADA sign unit including a van accessible sign at proposed parking space P2 with a minimum clearance of 60 inches from the ground surface to the bottom of the lowest sign.	502.6

Accessible Routes					
8	Curb Ramp CR#1	Curb Ramp	The concrete parallel curb ramp was measured to have a level landing within the center of the ramp and running side slopes within the maximum allowable 8.3%. Level landings were also provided at the top of both side slopes.	No action required.	406.1 & 406.4
9	Accessible Route AR#1 - from CR#1 to Building Entrance	Accessible Route	The concrete sidewalk accessible route had one flag that was measured to have a running slope at 6.0%, which exceeds the maximum allowable 5.0%. All other running slopes and cross-slopes are compliant.	Re-grade leg of concrete sidewalk to provide all running slopes at or below 5.0% and cross-slopes at or below 2.0%. If final slopes must exceed 5.0%, provide level landings at the top and bottom of the ramp, and provide compliant handrails on both sides of the sidewalk.	403.3
