CITY OF NOVI
ADA COMPLIANCE TRANSITION PLAN
CITY-OWNED FACILITIES
MARCH 2014

SDA Job No. NV13006.0C

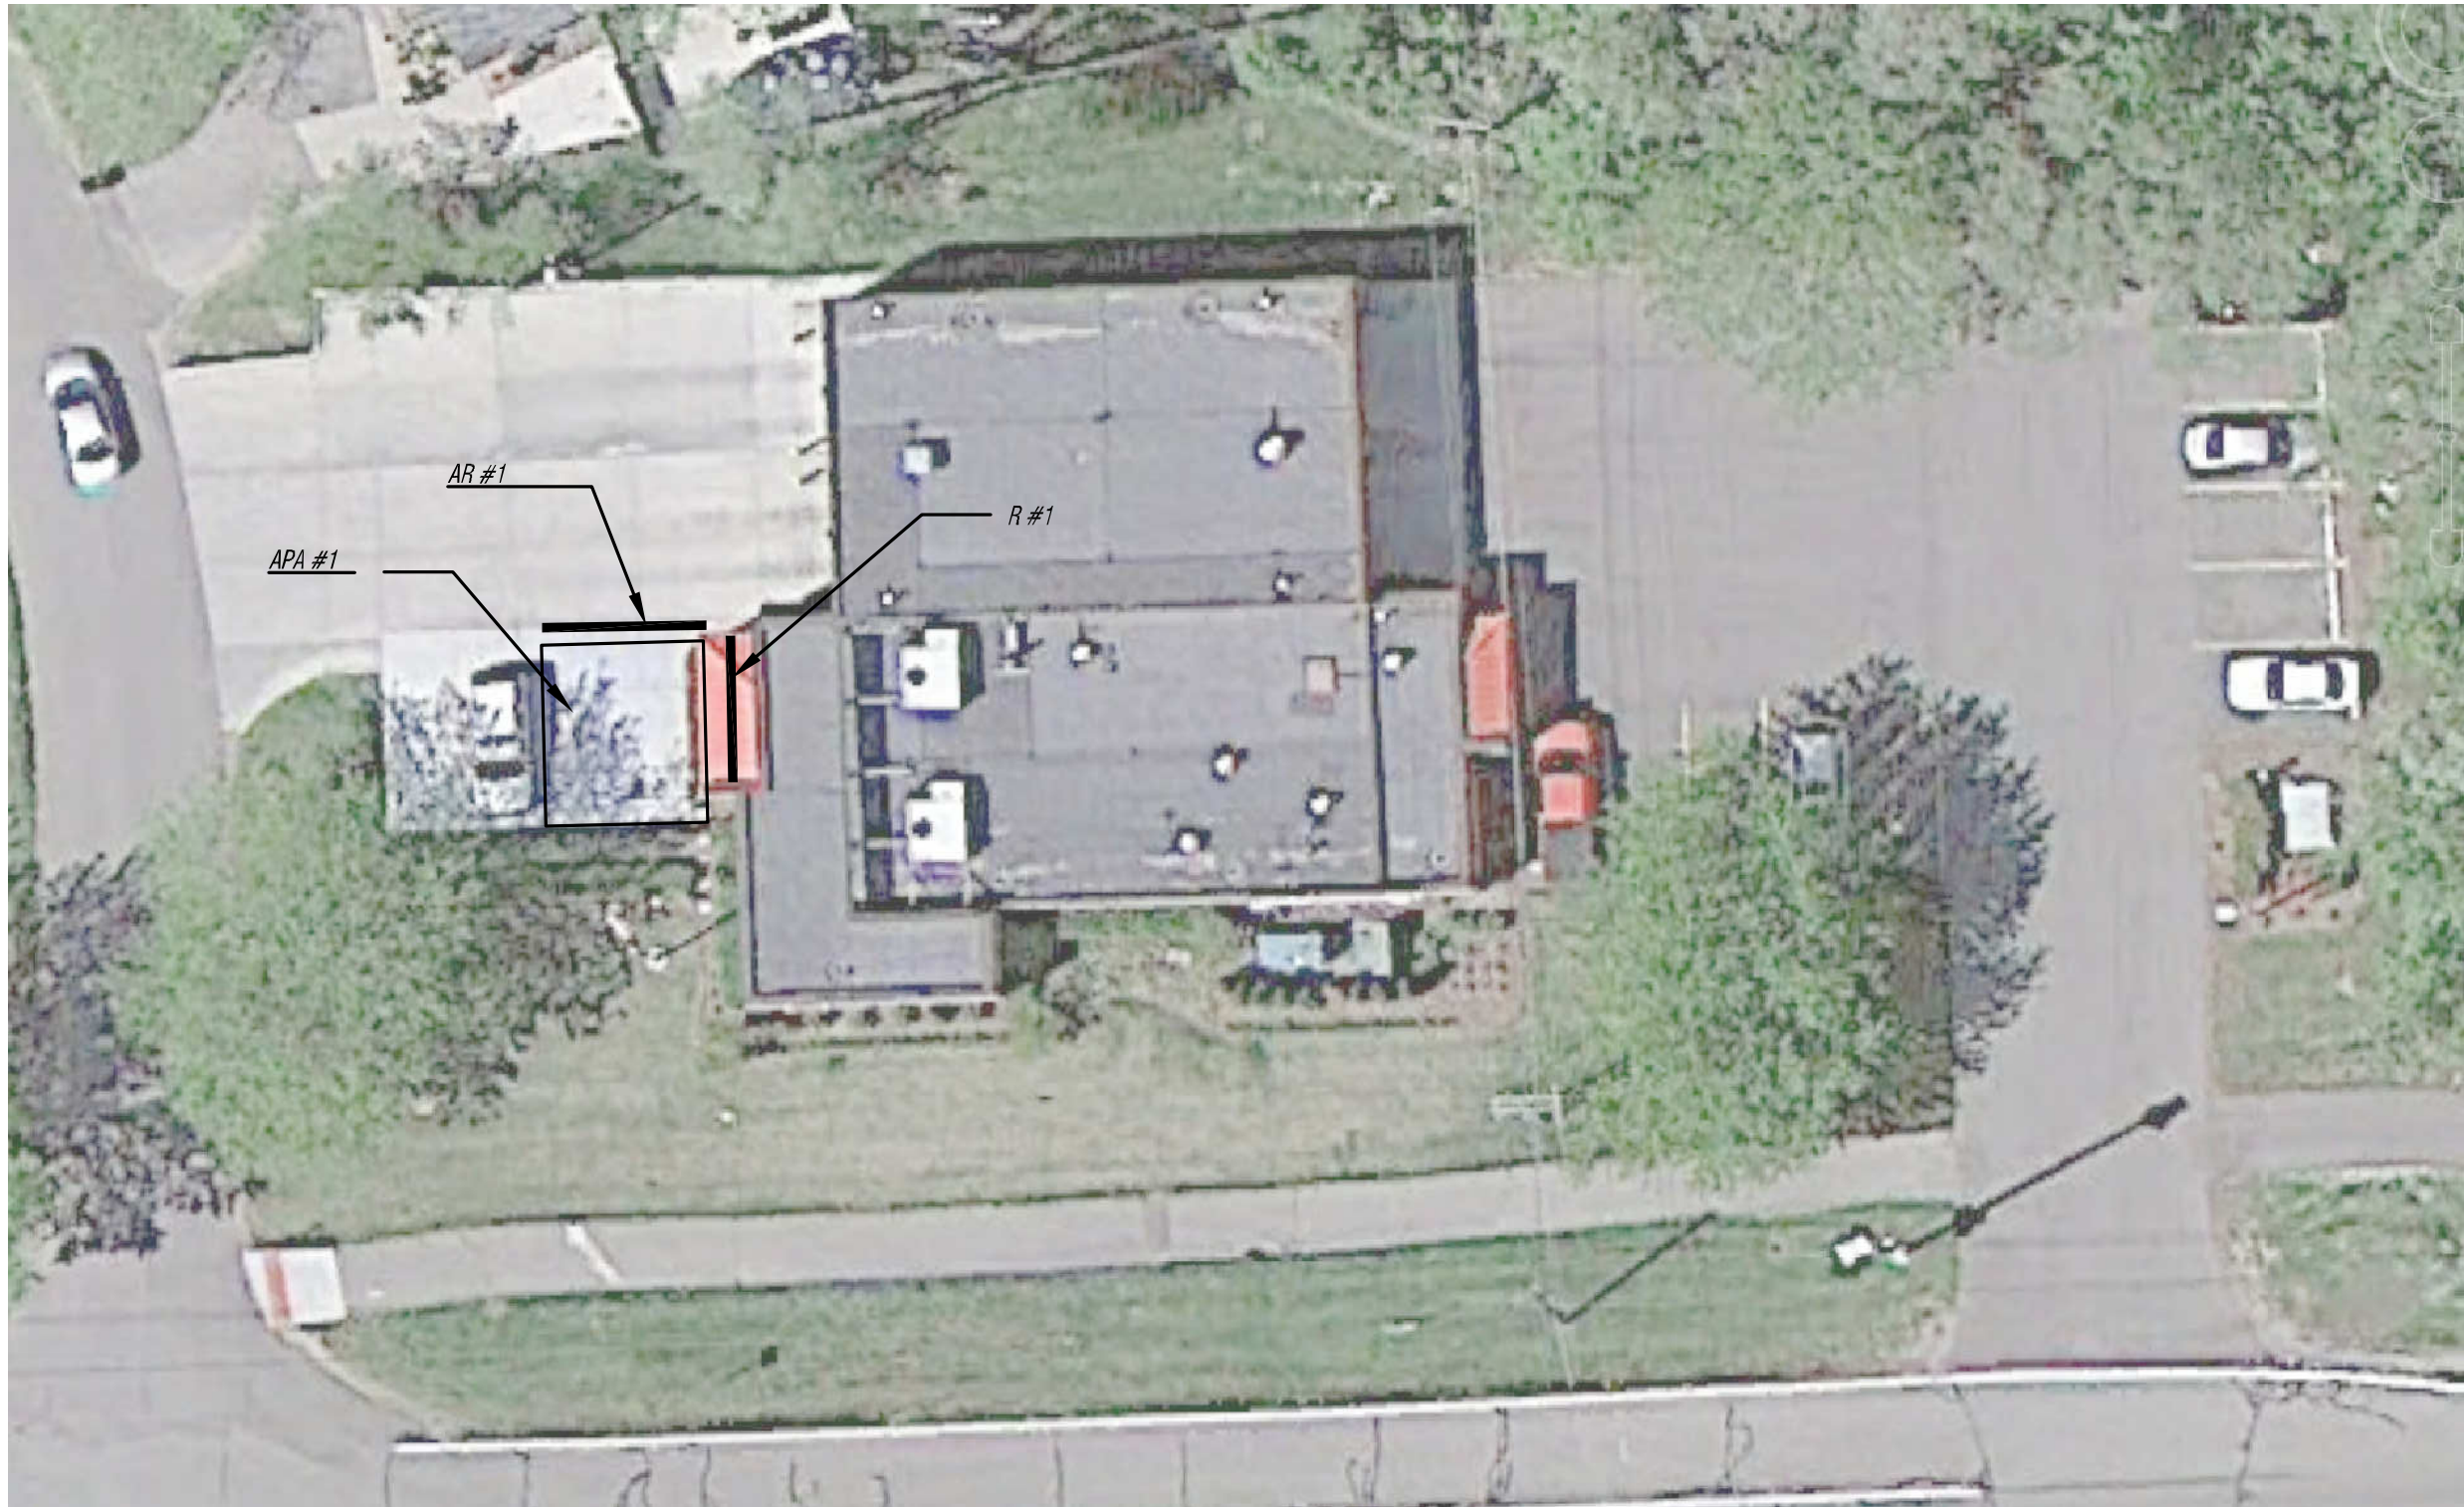
4	Accessible Parking Area APA#1 - Access Aisle A1	Access Aisle	The existing access aisle was measured to be 91 inches wide which is less than the minimum width of 96 inches for a van accessible aisle. Portions of the concrete pavement had slopes in excess of the maximum allowable 2.0%, measured up to 2.4%.	Remove the existing concrete pavement, re-grade and replace to provide maximum slopes of 2.0% in all directions. Revise striping layout to provide a 96 inch wide access aisle.	502.2, 502.3 & 502.4
5	Accessible Parking Area APA#1 - P1 Signage	Signage	The existing sign includes a van accessible sign and has a clearance of 75 inches from the ground surface to the bottom of the lowest sign.	No action required.	502.6
Accessible Routes					
6	Accessible Route AR#1 - from APA#1 to R#1	Accessible Route	The concrete pavement accessible route leading from accessible parking area APA#1 to ramp R#1 was measured to have cross-slopes above the maximum allowable 2.0%, measured up to 3.0%.	Remove the existing concrete pavement, re-grade and replace to provide maximum running slopes of 5.0% and maximum cross-slopes of 2.0%.	403.3

7	Ramp R#1	Ramp	The concrete ramp was measured to have running slopes ranging from 4.6% to 6.2%, which is compliant with ADA standards. However, handrails are not provided along the edges of the ramp. An existing level landing is provided at the top of the ramp, but not at the bottom.	Install ADA compliant handrails along both sides of the existing ramp. Remove and replace the existing concrete pavement at the bottom of the ramp to provide a level landing.	405.1

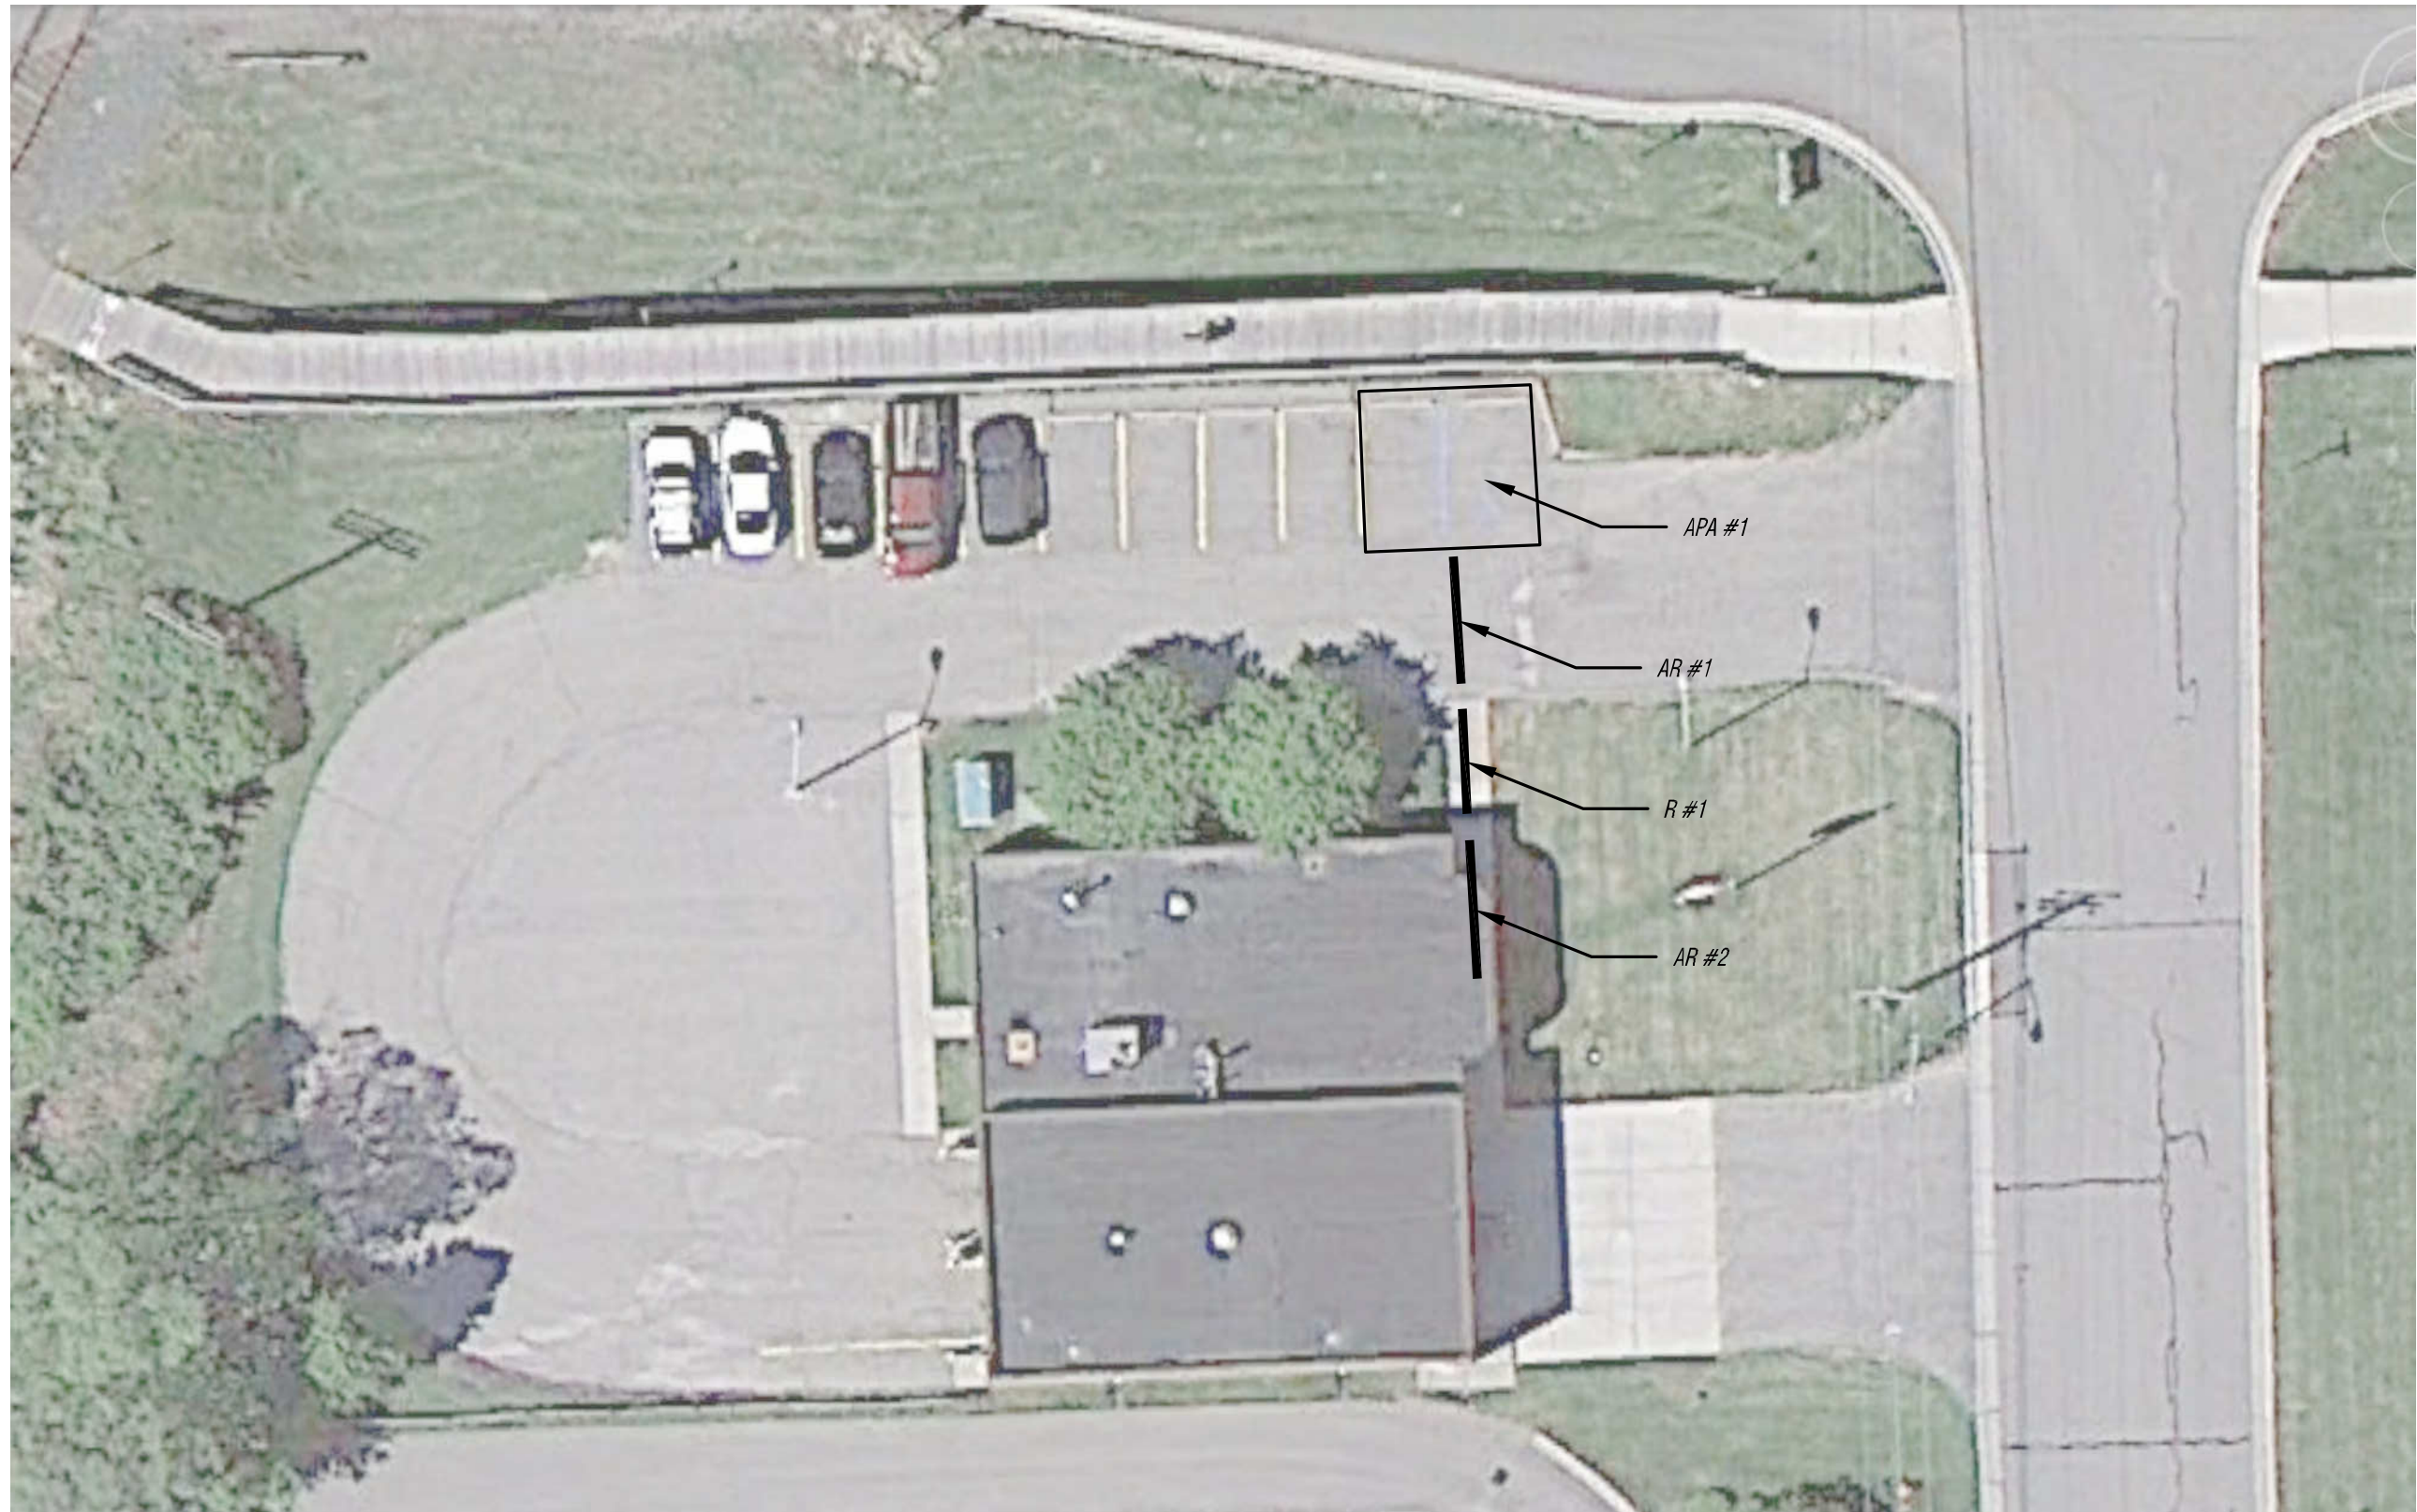
4	Accessible Parking Area APA#1 - Access Aisle A1	Access Aisle	No access aisle is provided for parking space P1.	Stripe an adjacent access aisle with a minimum width of 96 inches to designate P1 as a van accessible space if existing slopes are at or below 2.0% in all directions. If existing slopes are above 2.0%, remove the existing asphalt pavement, re-grade and replace to provide maximum slopes of 2.0% in all directions prior to striping.	502.2, 502.3 & 502.4
5	Accessible Parking Area APA#1 - P1 Signage	Signage	No sign is currently provided for parking space P1.	Install ADA sign unit including a van accessible sign at parking space P1 with a minimum clearance of 60 inches from the ground surface to the bottom of the lowest sign.	502.6
Accessible Routes					
6	Accessible Route AR#1 - from APA#1 to R#1	Accessible Route	The asphalt pavement path from the existing ADA stall P1 to the existing ramp has running slopes at or below 5.0%, but has cross-slopes exceeding the maximum allowable 2.0%, measured up to 3.0%.	Remove the existing asphalt pavement, re-grade and replace to provide maximum running slopes of 5.0% and maximum cross-slopes of 2.0%.	403.3

7	Ramp R#1	Ramp	The concrete sidewalk ramp was measured to have running slopes ranging from 4.8% to 7.2%, which is compliant with ADA standards. However, the measured cross-slopes of the ramp are above the maximum allowable 2.0% at 3.1%. Furthermore, handrails are not provided along the edges of the ramp and level landings are not provided at the top and bottom of the ramps.	Remove and replace existing ramp with ADA compliant slopes, level landings at the top and bottom of the ramp, and ADA compliant handrails along both sides.	405.1
8	Accessible Route AR#2 - from R#1 to Building Entrance	Accessible Route	Cross-slopes of the concrete sidewalk path exceed the maximum allowable 2.0%, measured up to 3.0%. Furthermore, there is no level landing provided at the building entrance door.	Replace the existing concrete sidewalk to provide ADA compliant slopes while maintaining positive drainage. Provide a level landing at the entrance door with a maximum slope of 2.0% in all directions.	403.3

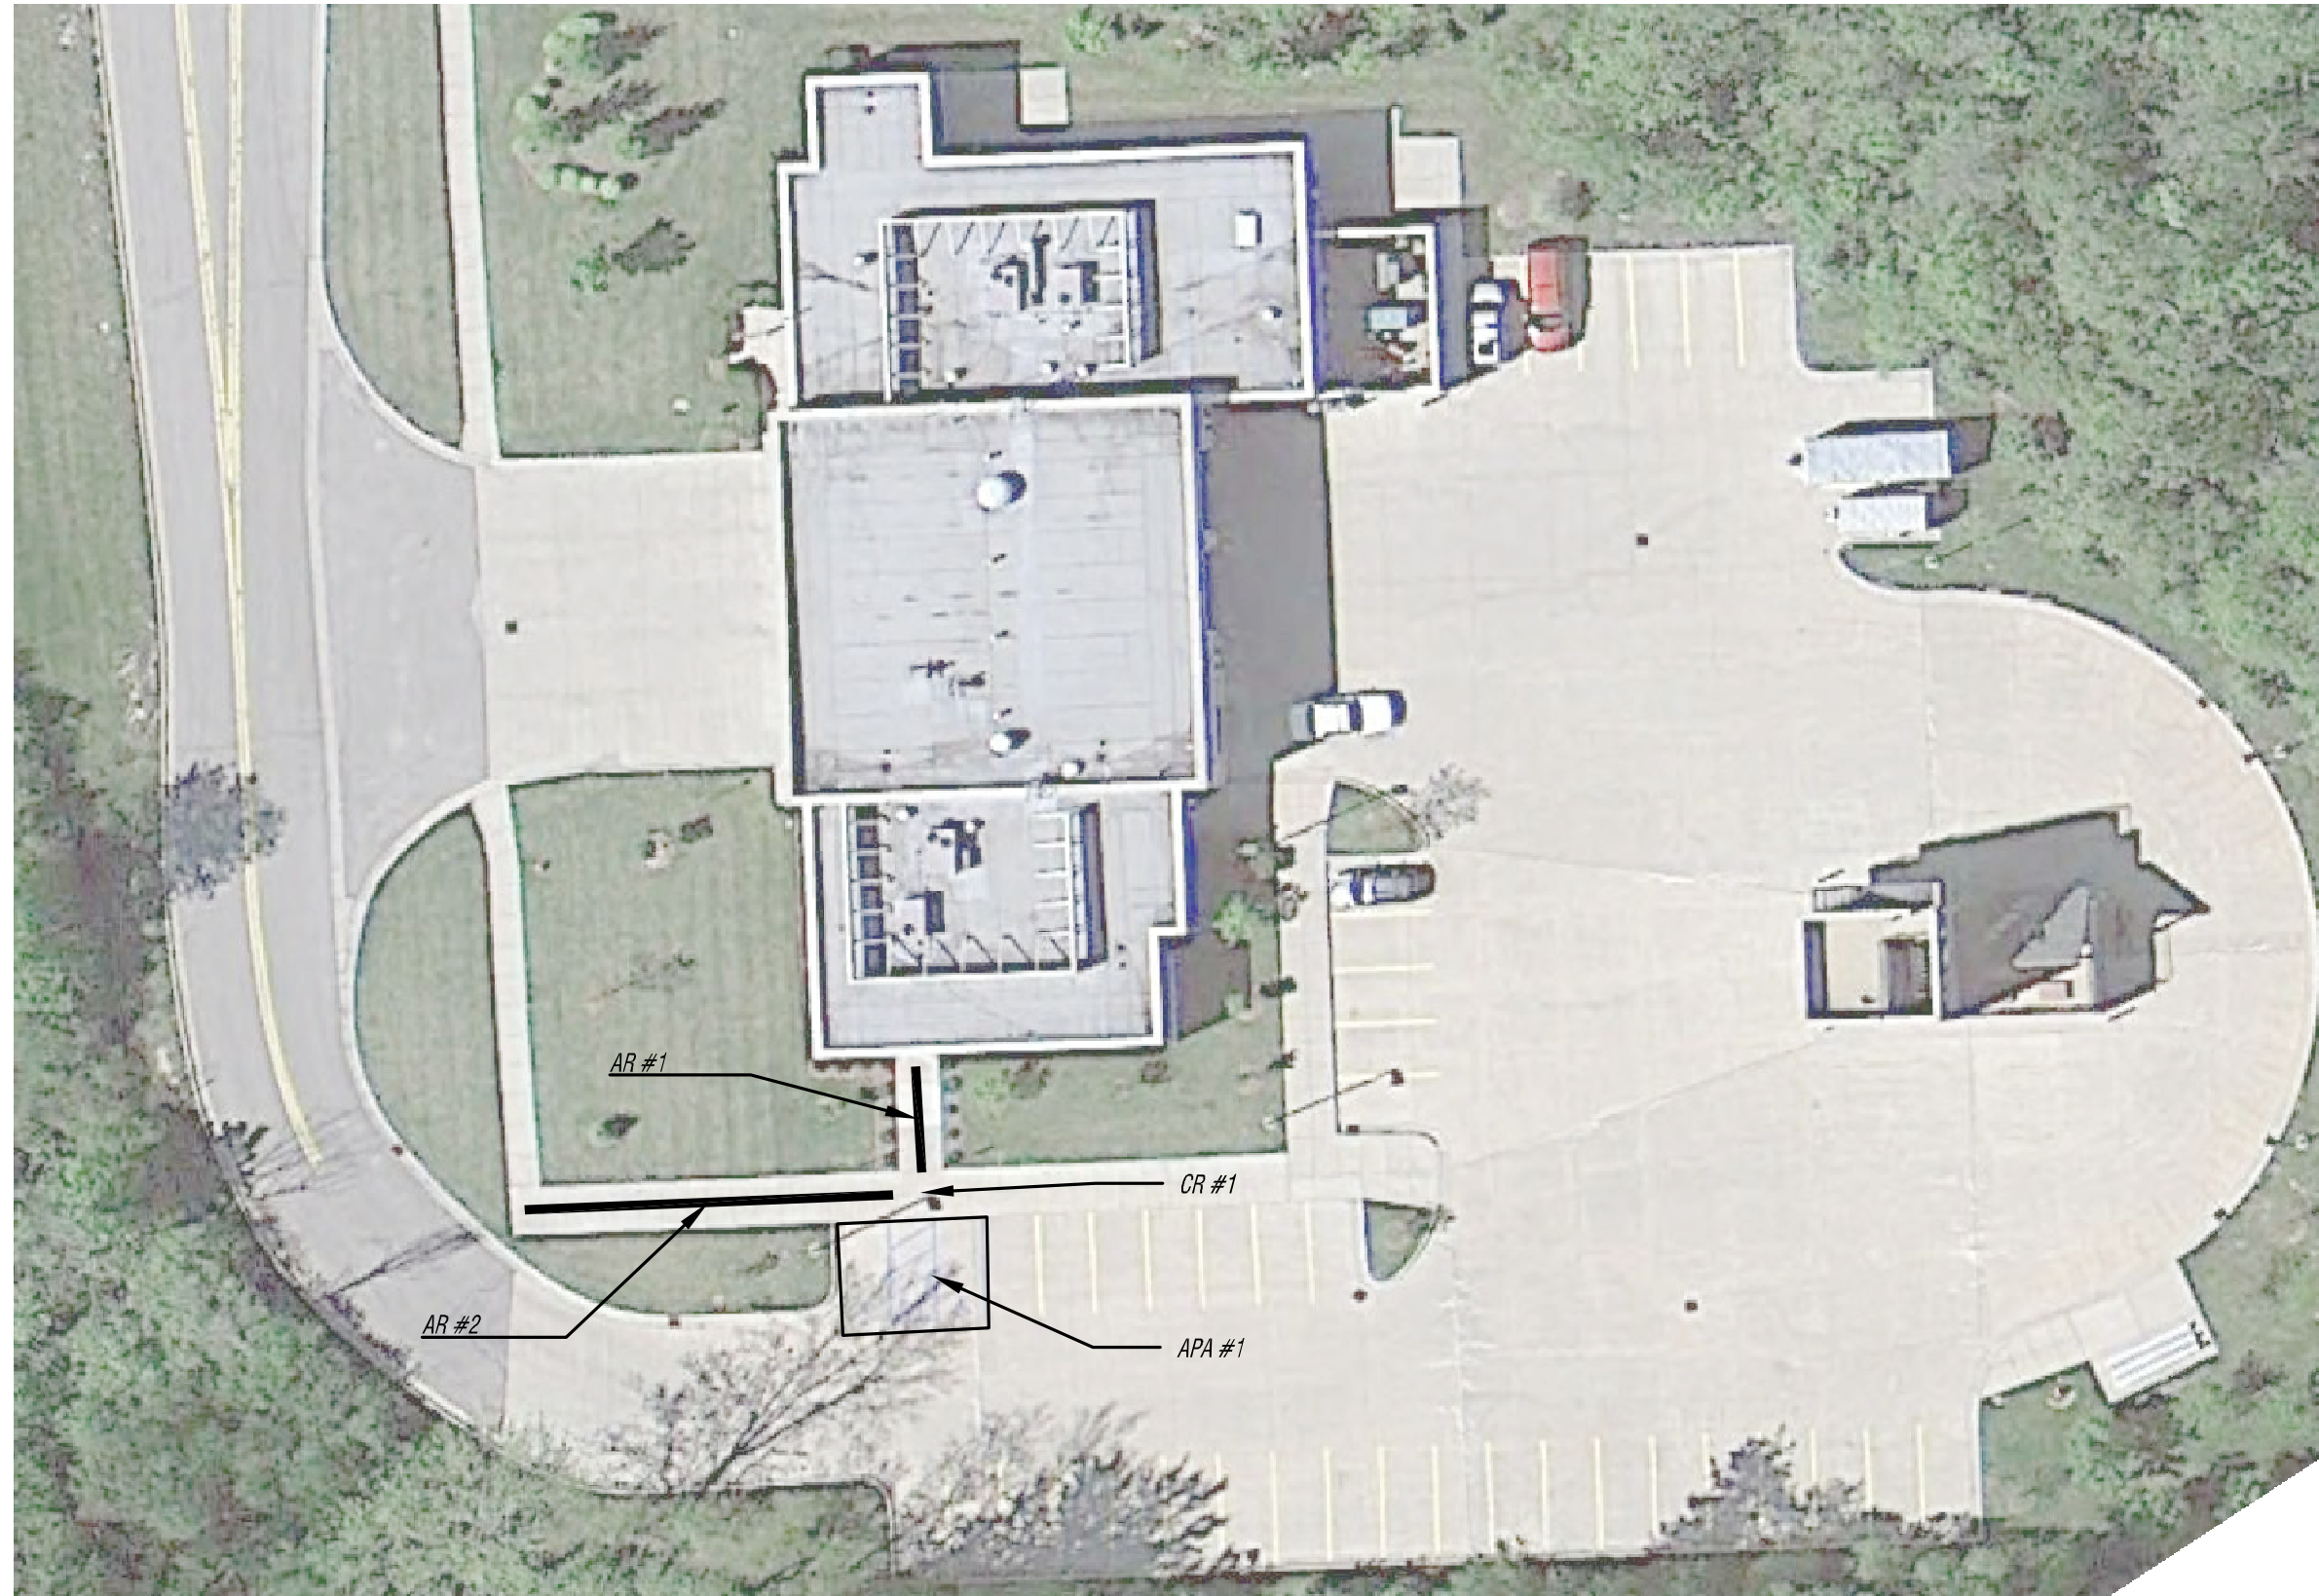
7	Accessible Parking Area APA#1 - P2 Signage	Signage	The existing sign includes a van accessible sign and has a clearance of 76 inches from the ground surface to the bottom of the lowest sign.	No action required.	502.6
Accessible Routes					
8	Curb Ramp CR#1	Curb Ramp	The concrete curb ramp has running slopes above the maximum allowable 8.3%, measured up to 9.2%. The side flares were also measured to be too steep, and no level landing is provided at the top of the curb ramp.	Replace existing ramp with curb ramp with ADA compliant slopes and a level landing at the top of the ramp.	406.1 & 406.4
9	Accessible Route AR#1 - from CR#1 to Building Entrance	Accessible Route	Running slopes are at or below 5.0% and cross-slopes are at or below 2.0%. However, there is no level landing provided at the door entrance.	Re-grade sidewalk to provide level landing at the building entrance door while maintaining ADA compliant running slopes and cross-slopes.	403.3

10	Accessible Route AR#2 - from Public Right-of-Way to AR#1	Accessible Route	Running slopes are at or below 5.0% and cross-slopes are at or below 2.0%. However, the concrete sidewalk surface is experiencing minor heaves and joint spalls that are creating non-compliant changes in level and openings.	Seal all spalled joints/cracks and isolated flag replacement to correct heaved changes in level.	403.3

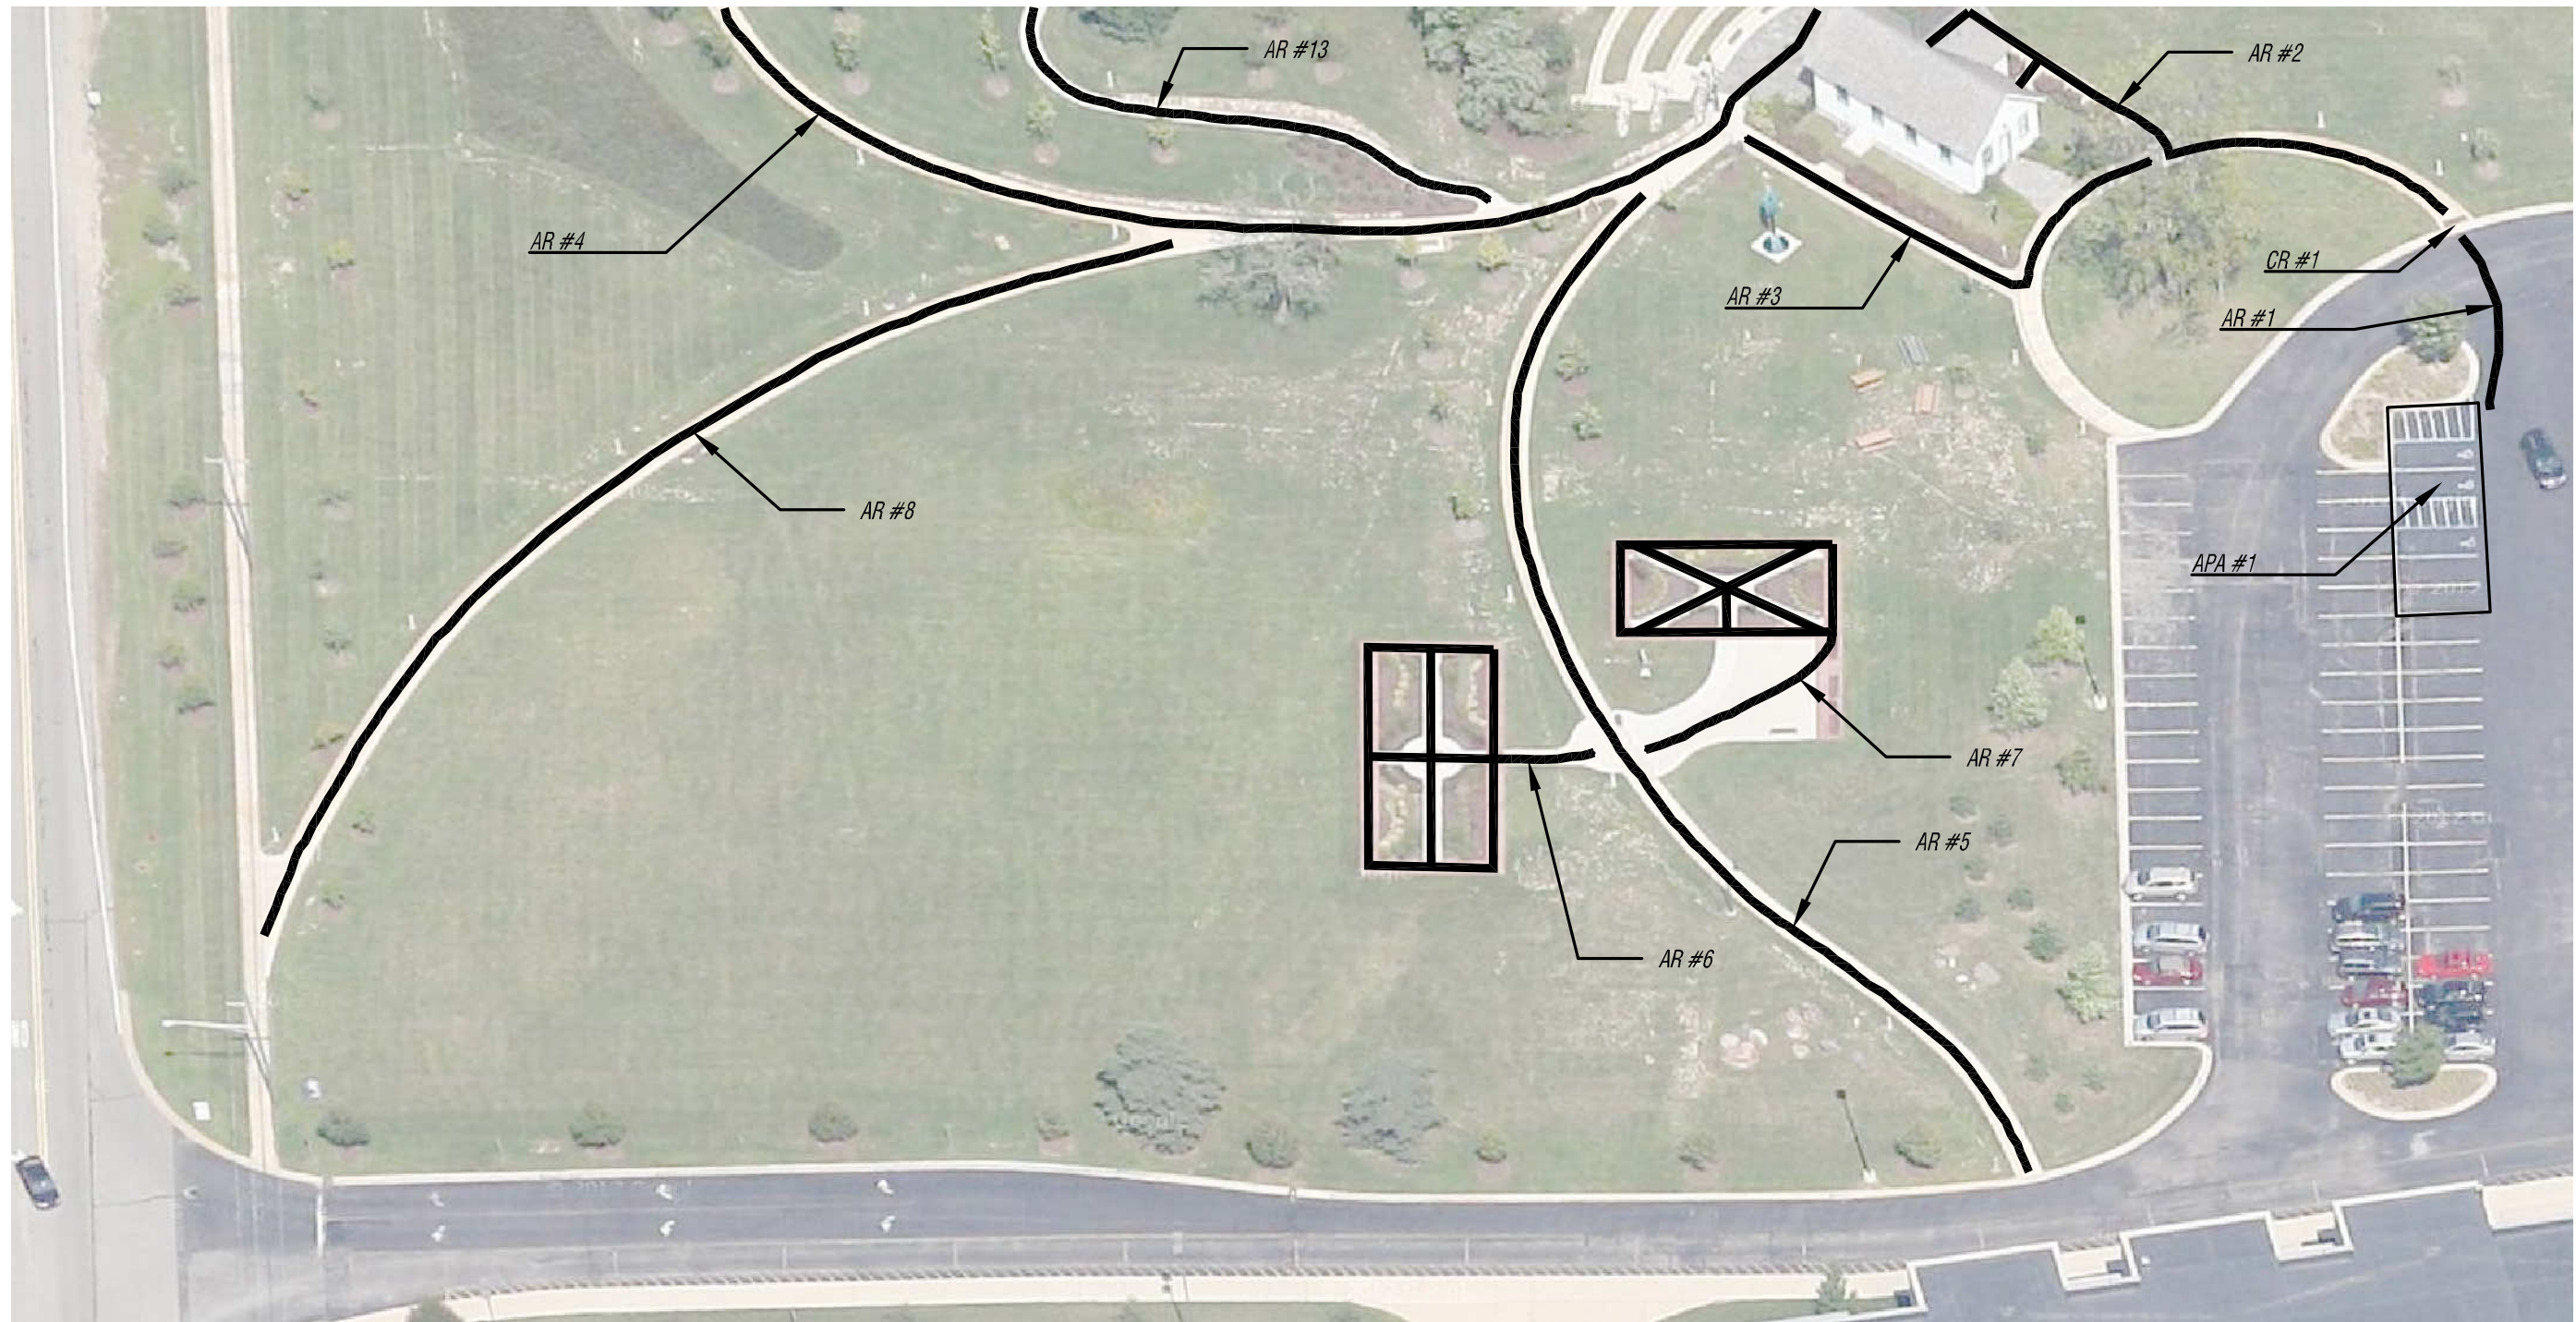
24	Accessible Route AR#10 - from 10 Mile Road Public Right-of-Way to AR#4	Accessible Route	Running slopes within the concrete sidewalk route are at or below 5.0% and cross-slopes are at or below 2.0%.	No action required.	403.3
25	Accessible Route AR#11 - from AR#4 to North Novi Library Sidewalk Path	Accessible Route	Running slopes within the concrete sidewalk route are at or below 5.0% and cross-slopes are at or below 2.0%.	No action required.	403.3
26	Accessible Route AR#12 - from AR#4 to South Novi Library Sidewalk Path	Accessible Route	Portions of the concrete sidewalk have cross-slopes ranging from 2.1% to 3.5%.	Re-grade the isolated areas of concrete sidewalk to provide maximum cross-slopes of 2.0%.	403.3
27	Accessible Route AR#13 - from AR#4 to Center Gravel Pathway	Accessible Route	Portions of the concrete sidewalk have running slopes ranging from 5.4% to 6.6%.	Re-grade the isolated areas of concrete sidewalk to provide maximum running slopes of 5.0%. If 5.0% cannot be achieved, re-grade the concrete sidewalk ramp to a maximum slope of 8.3% while providing level landings at the top and bottom of the ramp as well as every 30 feet. Install ADA compliant handrails along both sides of the ramp.	403.3

28	Accessible Route AR#14 - from AR#4 to Center Gravel Pathway	Accessible Route	Running slopes within the concrete sidewalk route are at or below 5.0% and cross-slopes are at or below 2.0%.	No action required.	403.3
29	Accessible Route AR#15 - from AR#4 to Center Gravel Pathway	Accessible Route	Running slopes within the concrete sidewalk route are at or below 5.0% and cross-slopes are at or below 2.0%.	No action required.	403.3

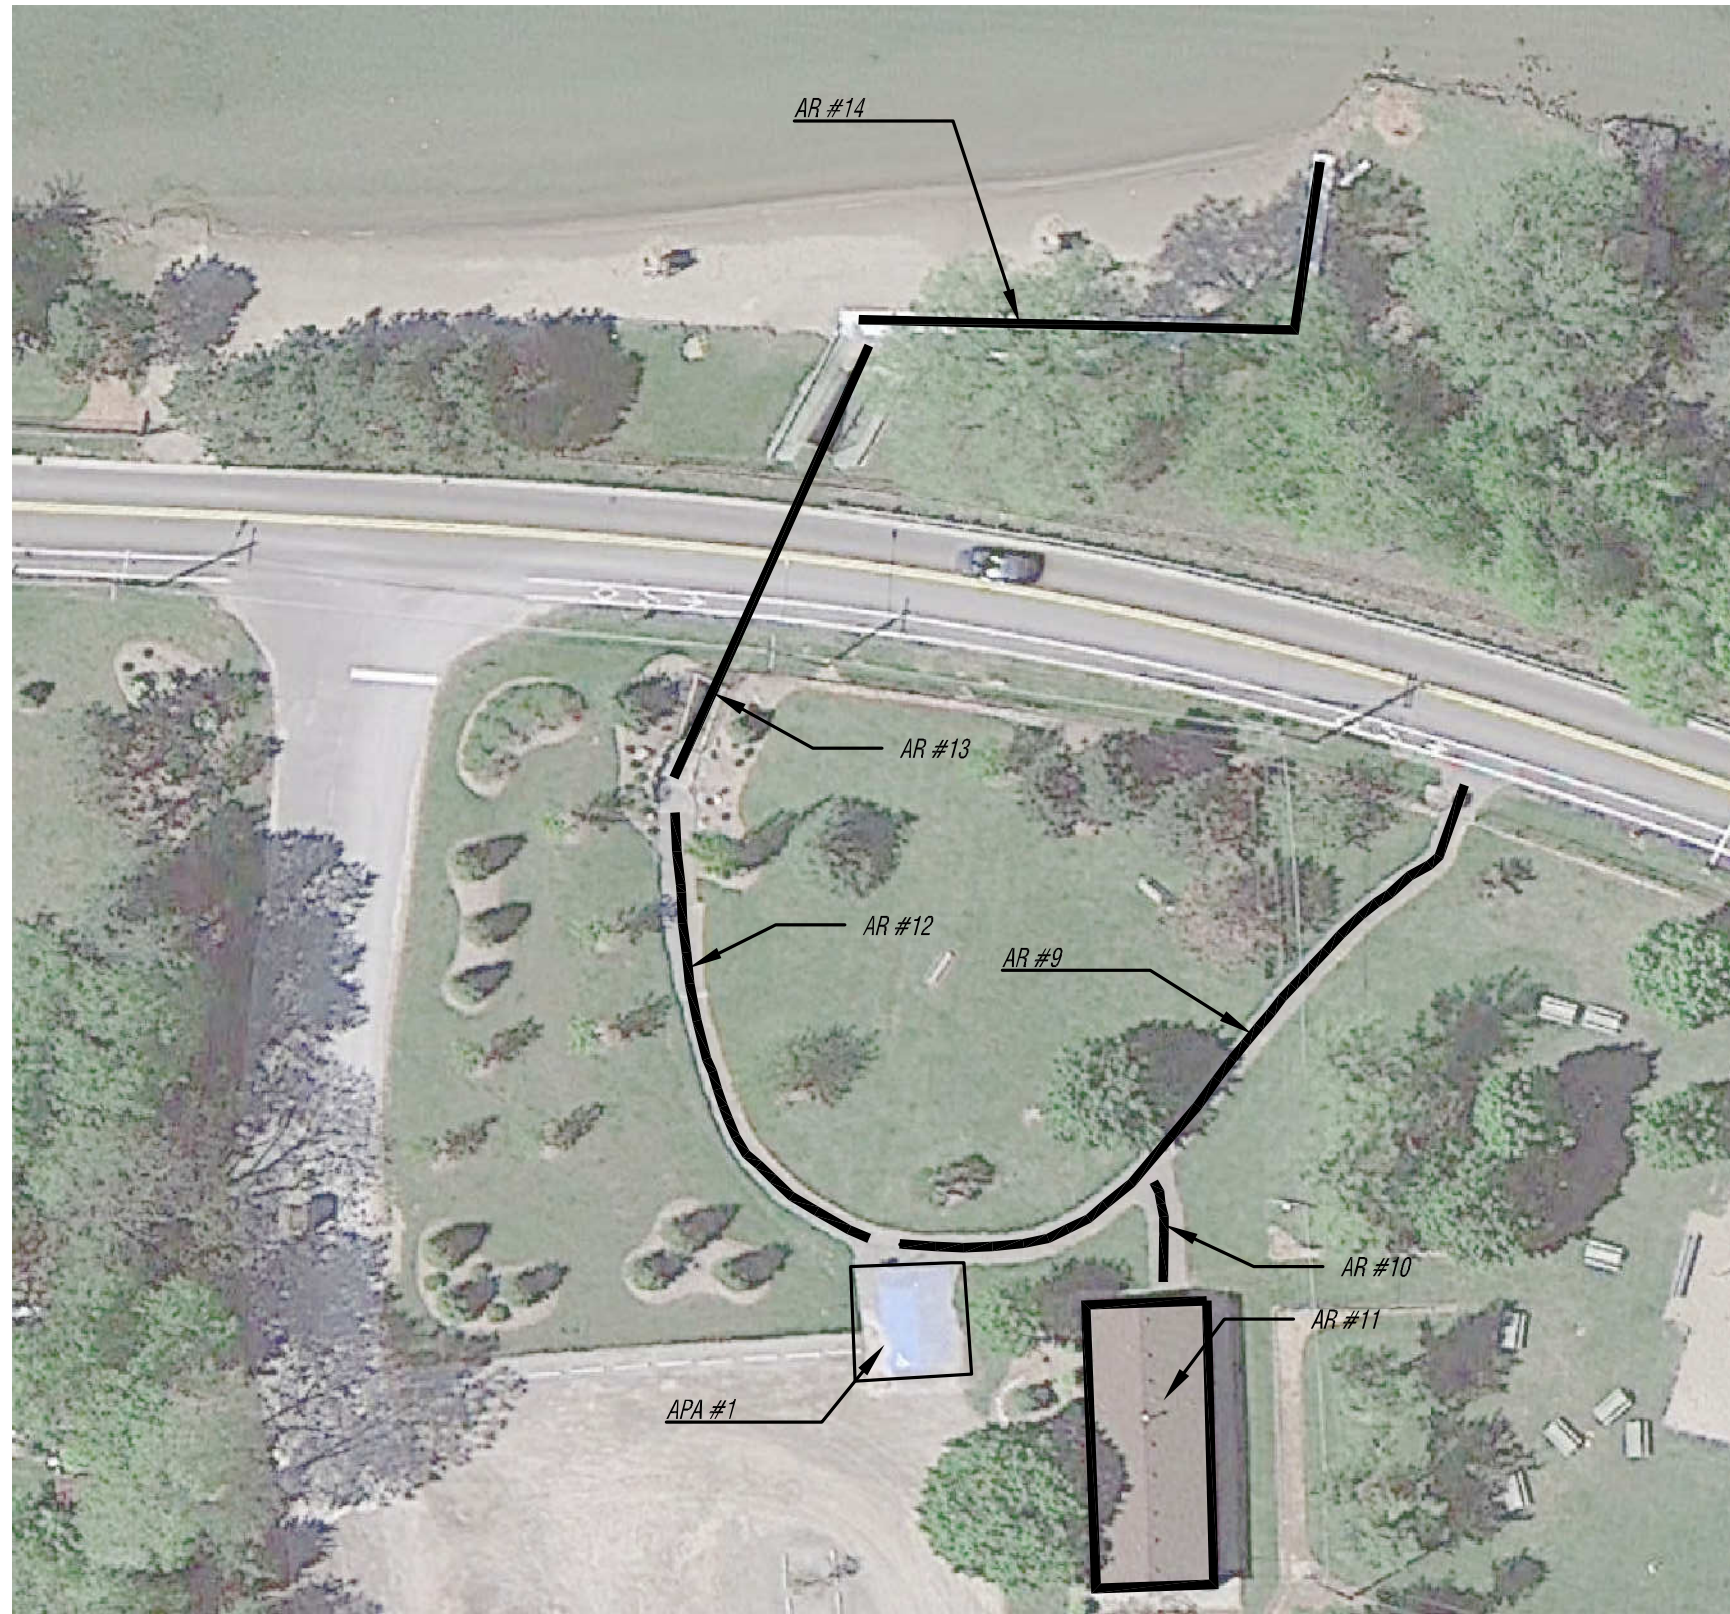
37	Accessible Route AR#11 - from AR#10	Accessible Route	The concrete sidewalk providing access around the main park building was found to have cross-slopes exceeding 2.0%, measured up to 5.0%.	Replace the concrete sidewalk to provide a maximum cross-slope of 2.0%.	403.3
38	Accessible Route AR#12 - from APA#1 to AR#13	Accessible Route	Portions of the asphalt pathway were measured to have running slopes exceeding 5.0%, up to 7%. Additional areas of the pathway have cross-slopes exceeding 2.0%, measured up to 4%.	Replace the asphalt pathway to provide a maximum running slope of 5.0% and a maximum cross-slope of 2.0%. If a 5.0% running slope cannot be achieved, provide a ramp with a maximum running slope of 8.3%, level landings at the top and bottom of the ramp, and handrails along both sides of the pathway.	403.3
39	Accessible Route AR#13 - from AR#12 to AR#14	Accessible Route	The asphalt pathway within the tunnel underneath South Lake Drive leading from the park to the beach has slopes at or below 2.0% in all directions.	No action required.	403.3

40	Accessible Route AR#14 - from AR#13	Accessible Route	The concrete sidewalk leading from the tunnel to the beach shore contains isolated areas with cross-slopes exceeding 2.0%, measured up to 5%.	Replace the concrete sidewalk to provide a maximum cross-slope of 2.0% along entire route.	403.3
Play Areas					
41	Play Area PA#1	Play Area	Play area surface is comprised of sand and woodchips and is level with surrounding surfaces with no borders. However, the play area surface material is not level with the asphalt pathway that leads into the play area, creating a steep, abrupt change in level at the play area's entrance.	Re-grade play area or add additional material to provide level surface where play area material meets asphalt pathway at entrance.	1008.1
42	Play Area PA#2	Play Area	Play area surface is comprised of woodchips and is level with surrounding surfaces with no borders, providing an accessible route into the area.	No action required.	1008.1

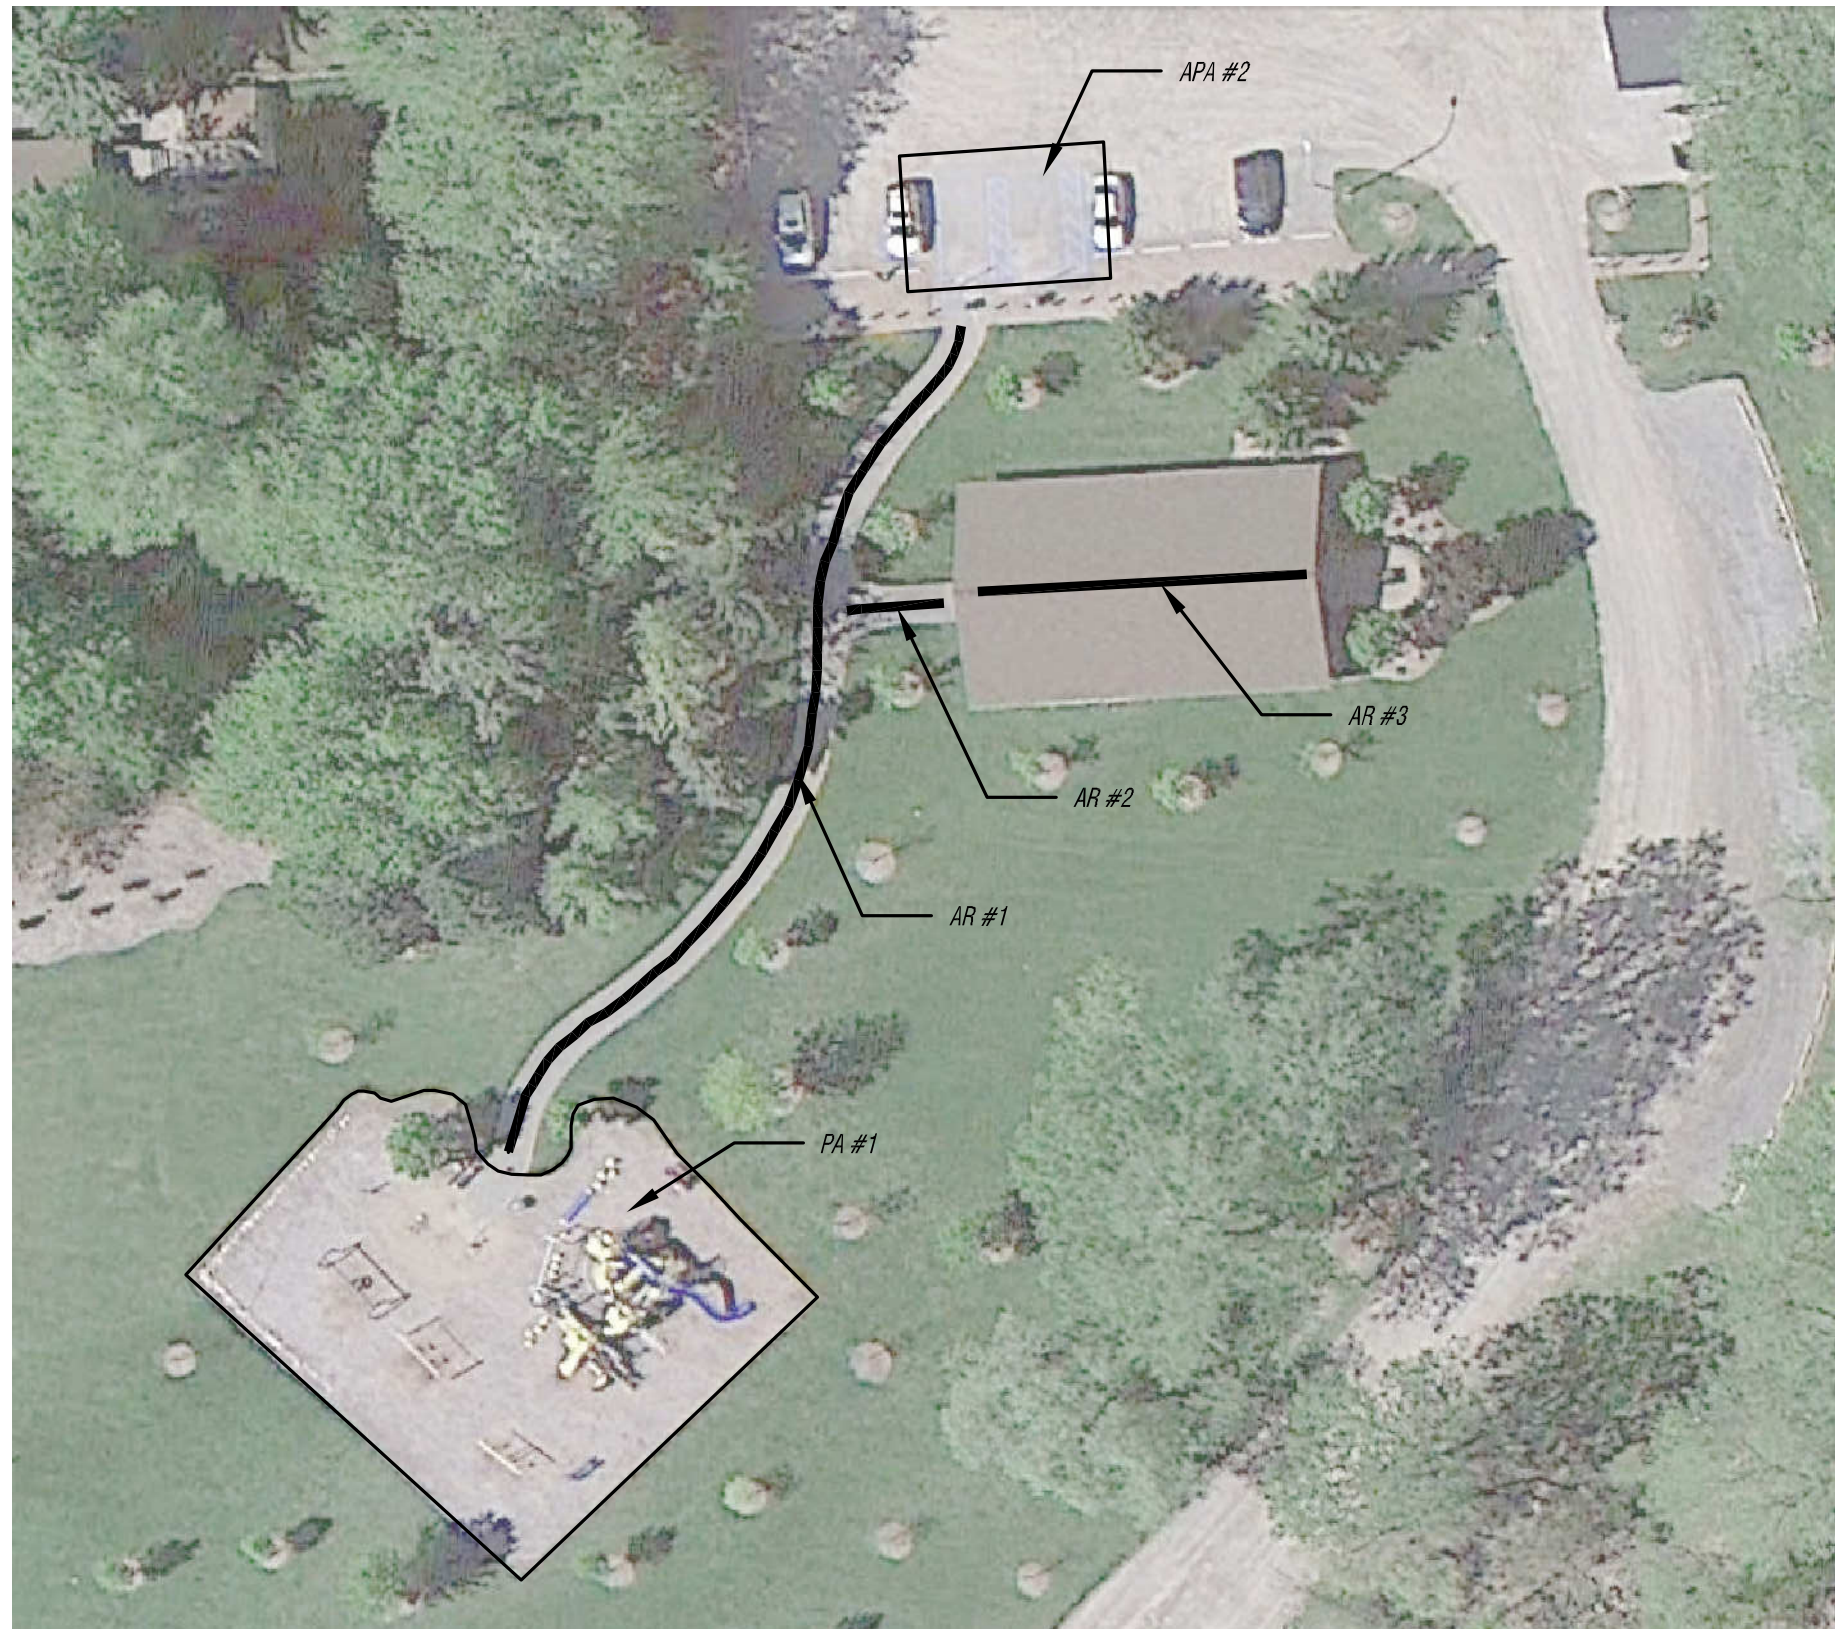
JOB No. NV13006	DRAWING No. LAKESHORE PARK
SCALE: NONE	SHEET LSP-1

ADA - NORTH					
ITEM CODE	PLAN QUANTITY	UNIT	DESCRIPTION	UNIT PRICE	ITEM PRICE
571	763	S.F.	REMOVE, RE-GRADE AND REPLACE ASPHALT PAVEMENT	\$7.00	\$5,341.00
572	1723	S.F.	REMOVE, RE-GRADE AND REPLACE CONCRETE SIDEWALK	\$7.00	\$12,061.00
573	2616	S.F.	REMOVE, RE-GRADE AND REPLACE ASPHALT PATHWAY	\$7.00	\$18,312.00
637	1	L.S.	STRIPING	\$250.00	\$250.00
647	1	EA.	REMOVE PLANTER BOX	\$150.00	\$150.00
TOTAL ADA - NORTH					\$36,114.00
15% CONTINGENCY					\$5,417.10
