CITY OF NOVI
ADA COMPLIANCE TRANSITION PLAN
CITY-OWNED FACILITIES
MARCH 2014

SDA Job No. NV13006.0C

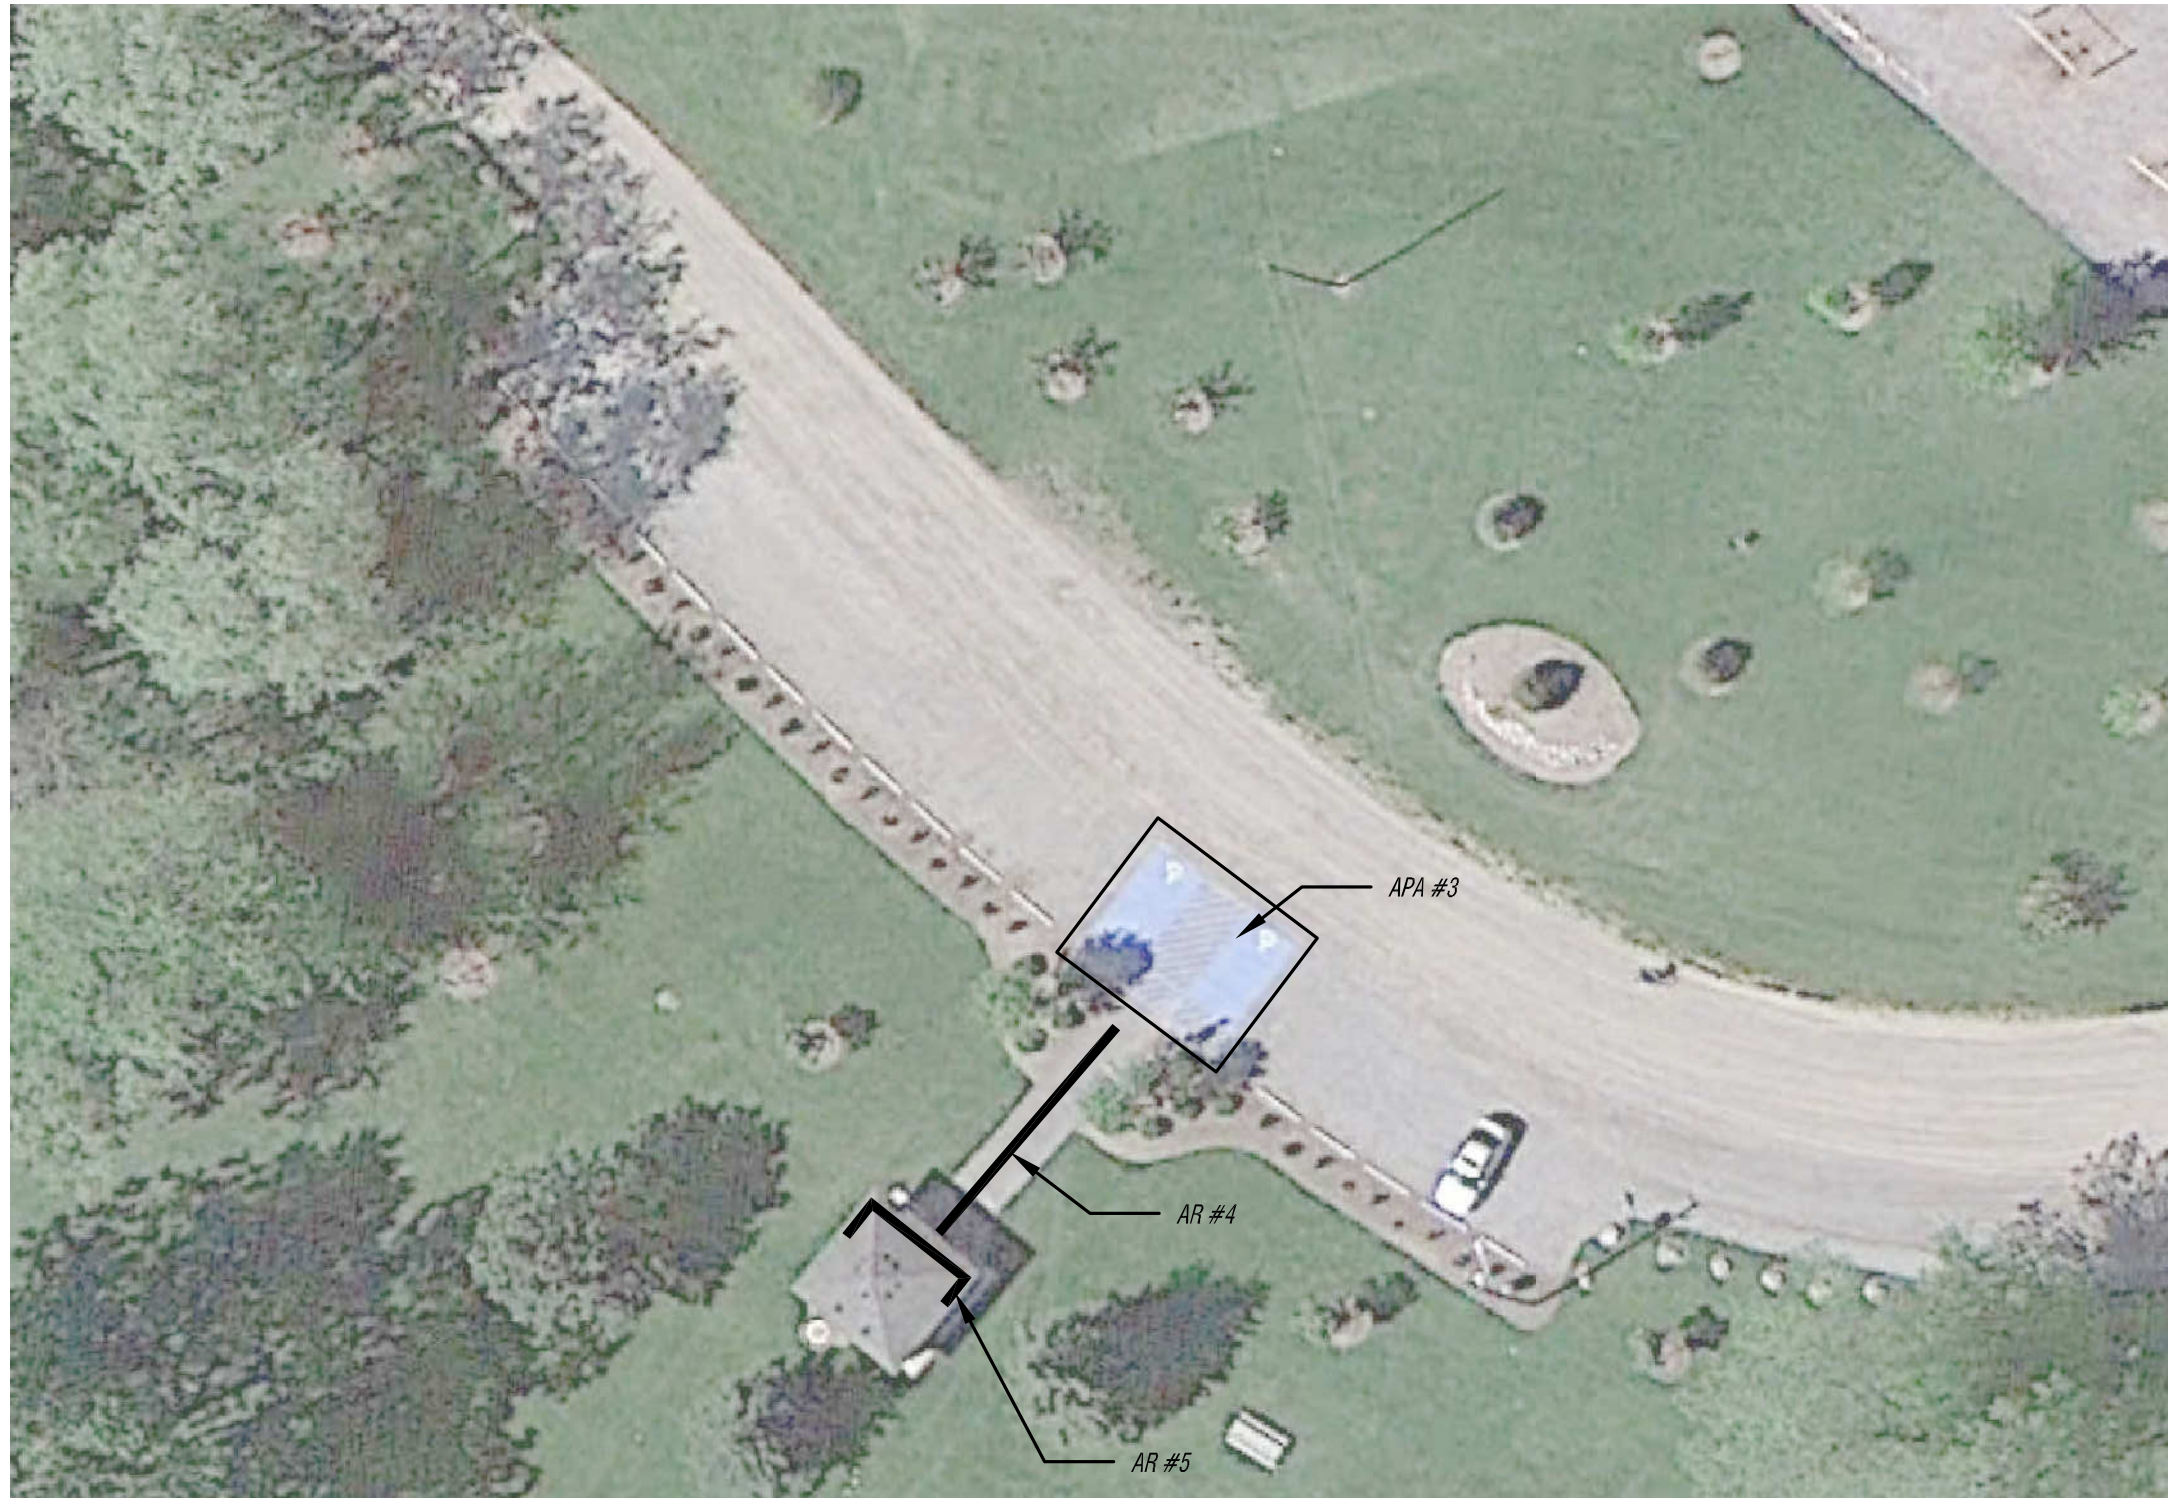
JOB No. NV13006	DRAWING No. LAKESHORE PARK
SCALE: NONE	SHEET LSP-2

ADA - MIDDLE NORTH					
ITEM CODE	PLAN QUANTITY	UNIT	DESCRIPTION	UNIT PRICE	ITEM PRICE
573	2054	S.F.	REMOVE, RE-GRADE AND REPLACE ASPHALT PATHWAY	\$7.00	\$14,378.00
637	1	L.S.	STRIPING	\$250.00	\$250.00
634	1	EA.	INSTALL SIGN	\$450.00	\$450.00
574	331	S.F.	NEW ASPHALT PAVEMENT	\$4.50	\$1,489.50
649	1	EA.	REGRADE PLAY AREA TO MATCH ASPHALT ENTRY	\$500.00	\$500.00
TOTAL ADA - MIDDLE NORTH					\$17,067.50
15% CONTINGENCY					\$2,560.13

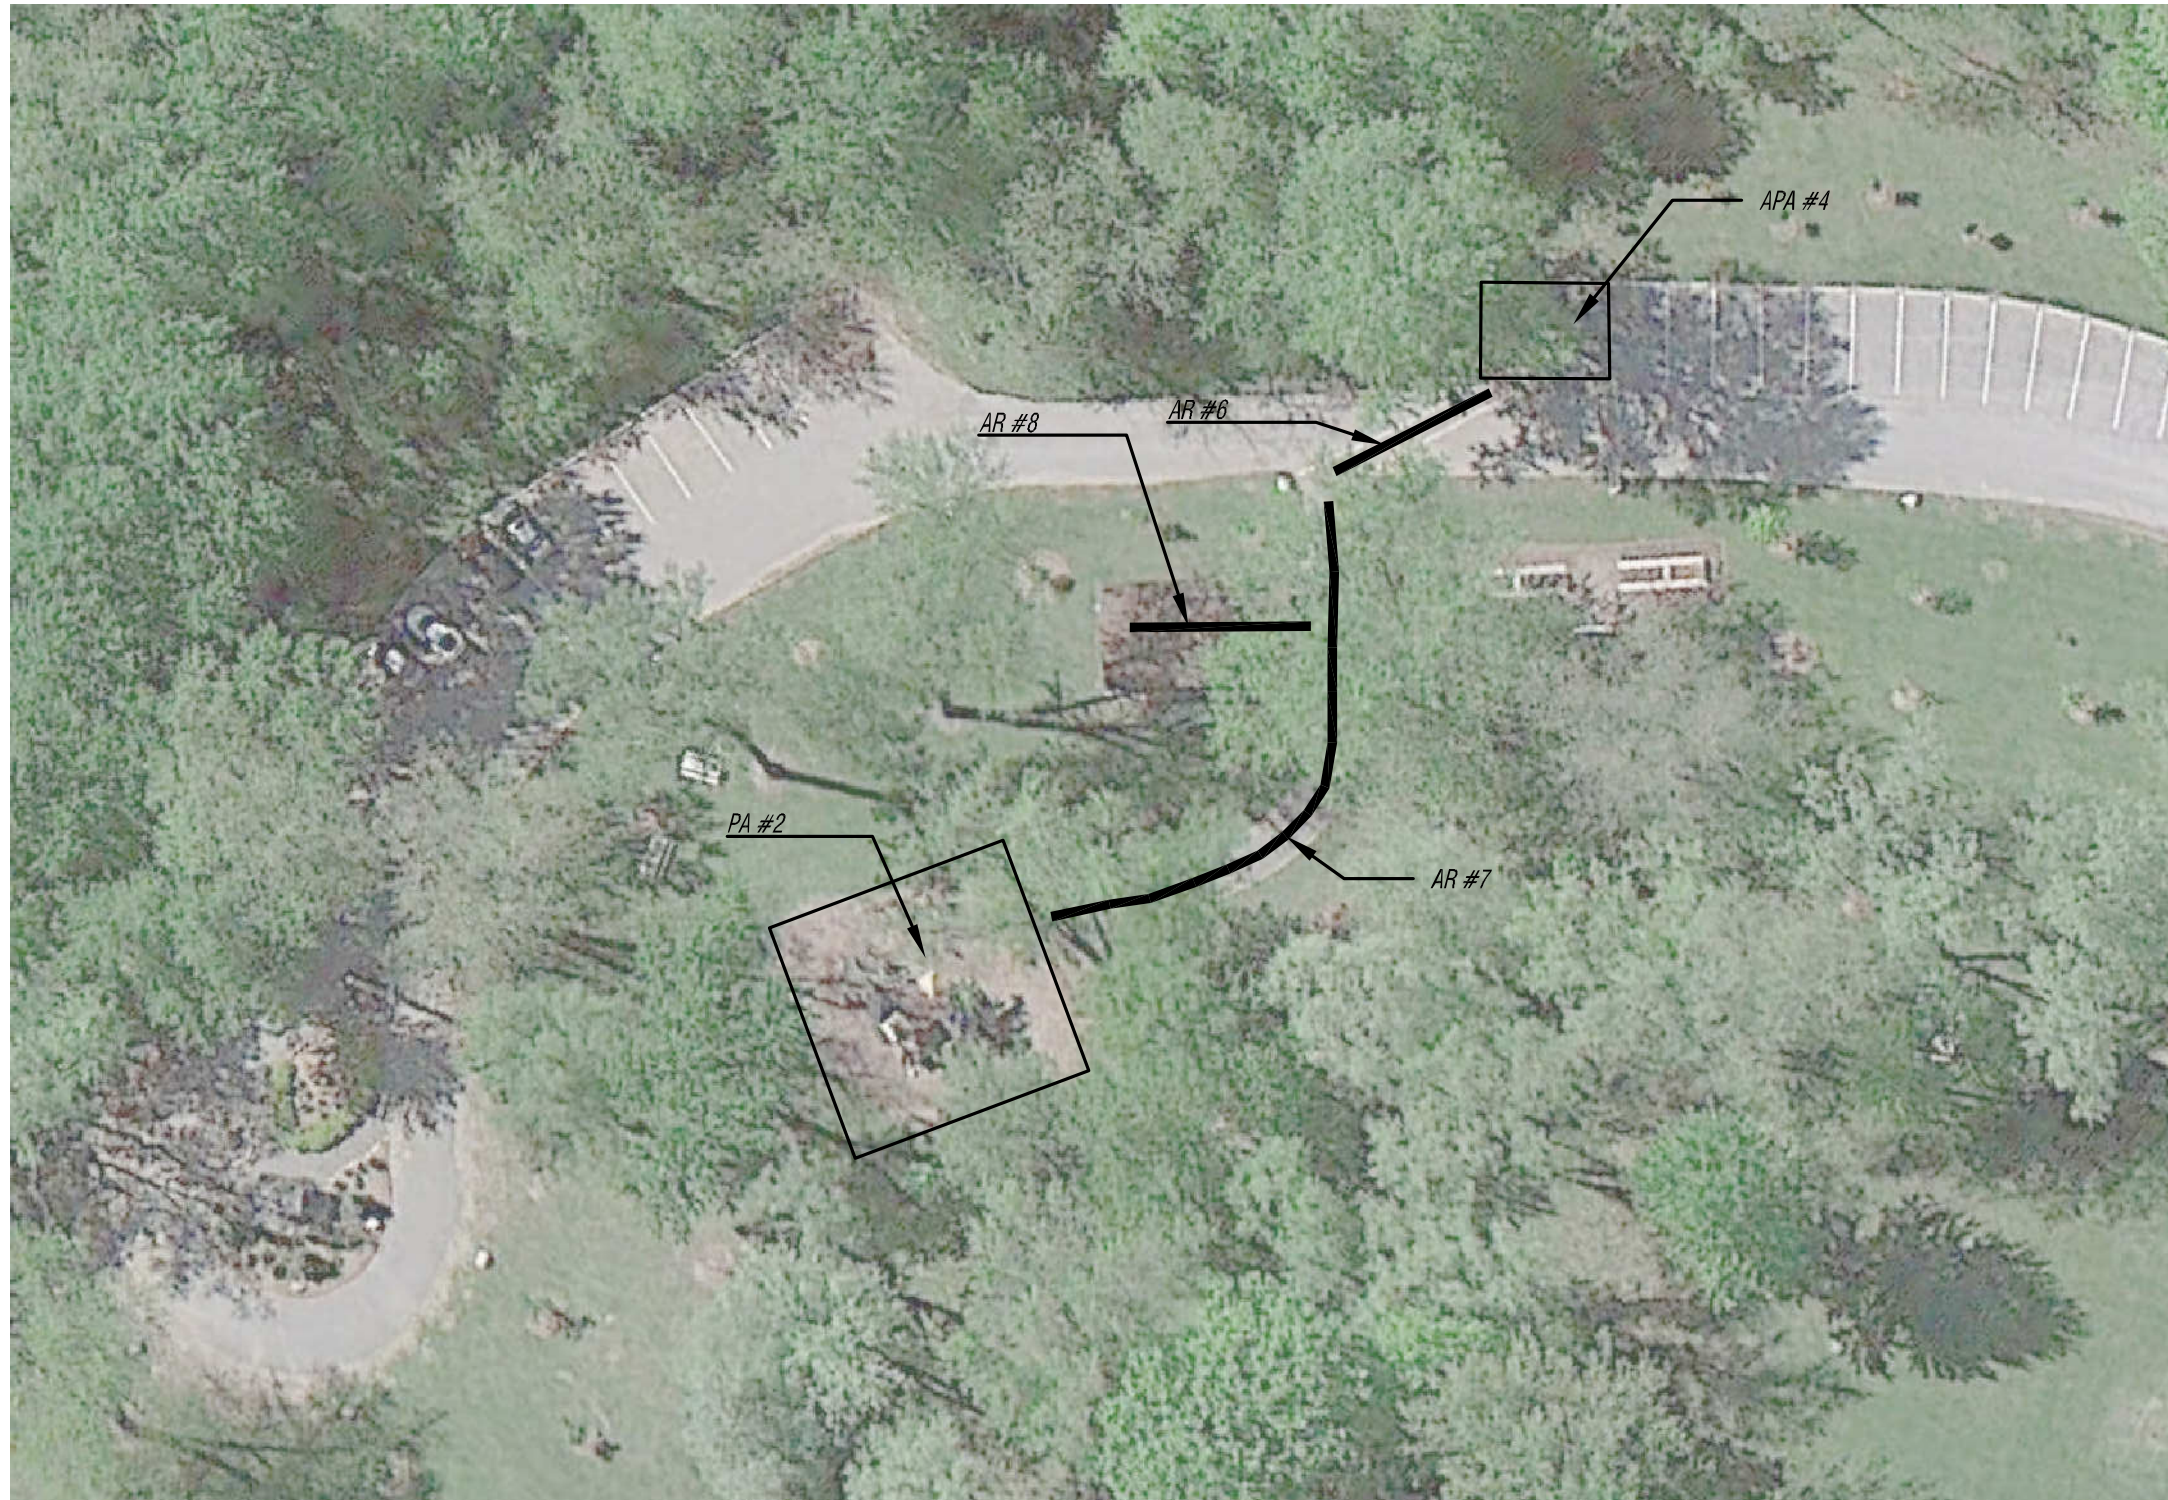
JOB No. NV13006	DRAWING No. LAKESHORE PARK
SCALE: NONE	SHEET LSP-3

ADA - MIDDLE SOUTH					
ITEM CODE	PLAN QUANTITY	UNIT	DESCRIPTION	UNIT PRICE	ITEM PRICE
573	371	S.F.	REMOVE, RE-GRADE AND REPLACE ASPHALT PATHWAY	\$7.00	\$2,597.00
642	128	S.F.	INTERMITTENT CONC. SIDEWALK REPAIR AND/OR LEVELING	\$3.00	\$384.00
643	148	S.F.	INTERMITTENT ASPHALT PATHWAY REPAIR AND/OR LEVELING	\$5.00	\$740.00
574	182	S.F.	NEW ASPHALT PAVEMENT	\$4.50	\$819.00
TOTAL ADA - MIDDLE SOUTH					\$4,540.00
15% CONTINGENCY					\$681.00

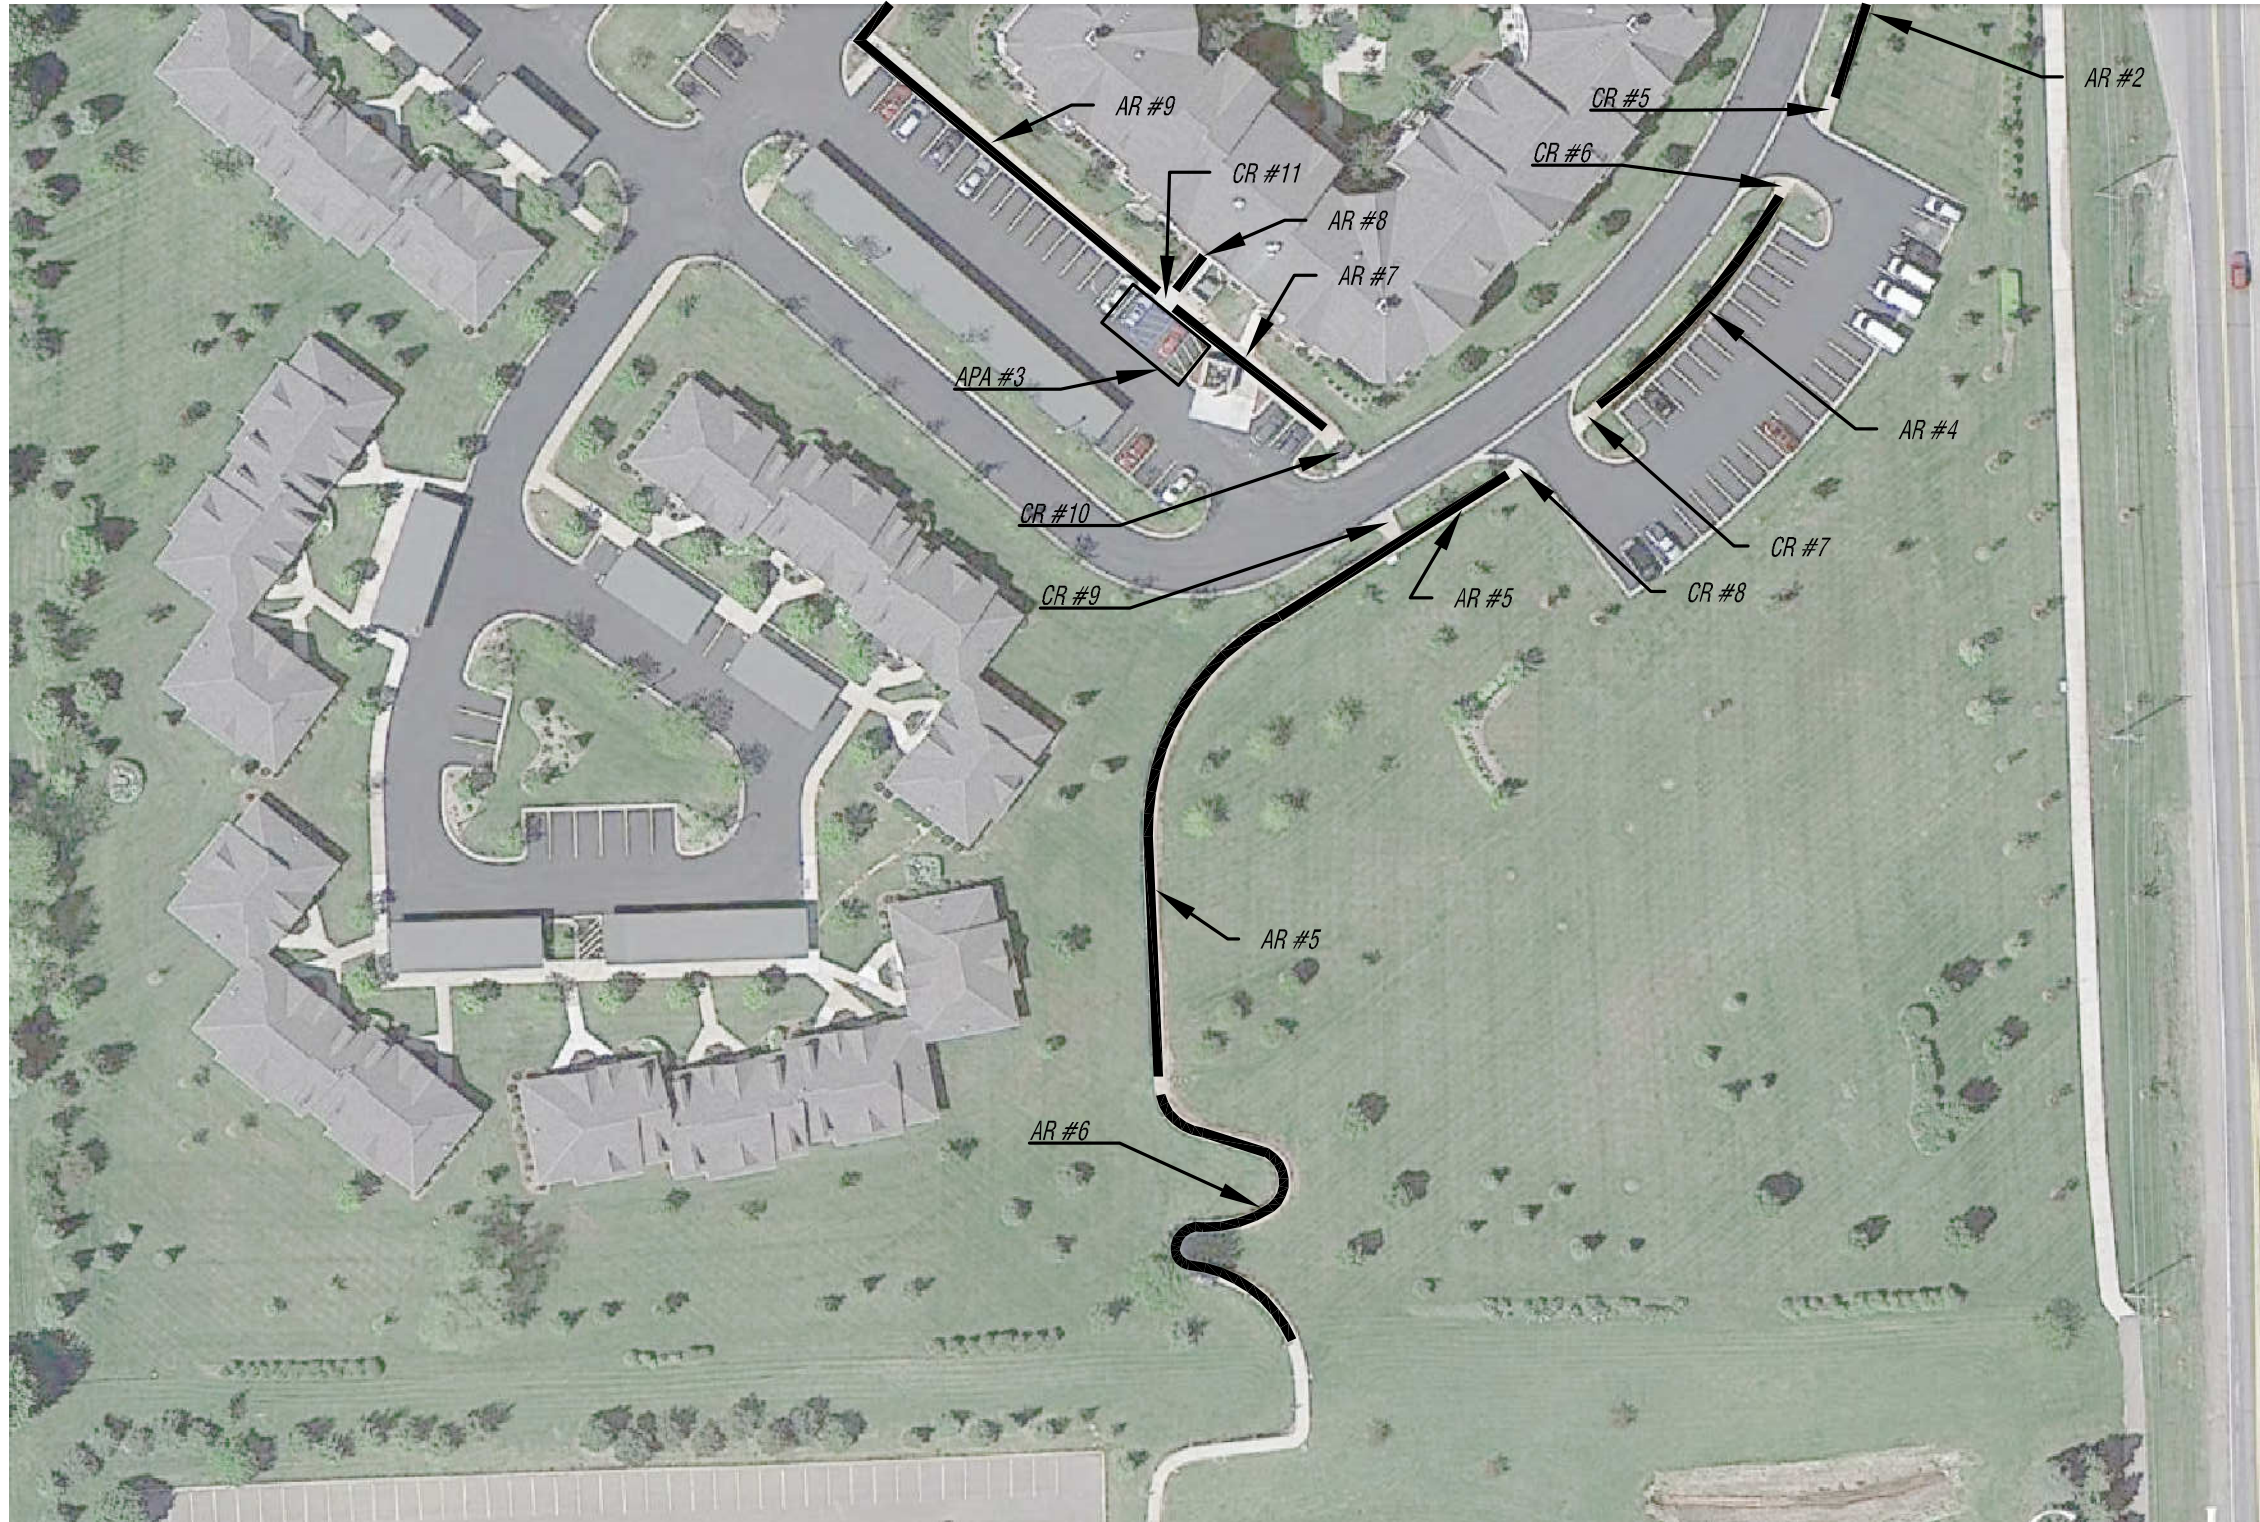
JOB No. NV13006	DRAWING No. MEADOWBROOK
SCALE: NONE	SHEET MC-1

Item #	Location	Element	Notes	Solution	2010 ADA Standards
Accessible Parking					
1	Accessible Parking - Main Multi-Floor Building	Quantity	The site includes multiple building structures that can be broken down into two separate categories: 1) the main Meadowbrook Activity Center Building which also includes a multiple floor apartment complex, and 2) the multiple attached single floor dwelling unit buildings. The main building onsite containing multiple floors was found to have a total of 152 parking stalls currently serving the building, 13 of which are accessible stalls. None of the 13 accessible stalls are noted as being van accessible. Based on this count, six (6) accessible parking spaces are required for this area, one (1) of which must be designated as van accessible.	Revise striping layout to provide one (1) van accessible stall and van accessible sign for every six (6) accessible parking stalls. See APA#1, APA#2 and APA#3 notes below.	208.2

2	Accessible Parking - Attached Single-Floor Dwelling Units	Quantity	There are also nine (9) separate single-floor residential building structures that contain a total of 60 attached living spaces for lease. There is a total of 89 parking stalls serving these attached dwelling units, but none of the 89 parking stalls are noted as being accessible.	See residential dwelling units notes below.	N/A
3	General	Site Accessibility	See site plan for locations of accessible parking areas and accessible routes.		
Accessible Parking Area APA#1					
4	Accessible Parking Area APA#1 - Parking Space P1	Parking Space	The existing parking space was measured to be 116 inches wide. Isolated asphalt pavement slopes were measured to be above the maximum allowable 2.0%, measured up to 2.6%.	Remove the existing asphalt pavement, re-grade and replace to provide maximum slopes of 2.0% in all directions.	502.2 & 502.4

5	Accessible Parking Area APA#1 - Access Aisle A1	Access Aisle	The existing access aisle serving parking spaces P1 and P2 was measured to be 93 inches wide. Isolated asphalt pavement slopes were measured to be above the maximum allowable 2.0%, measured up to 2.9%.	Remove the existing asphalt pavement, re-grade and replace to provide maximum slopes of 2.0% in all directions. Revise striping layout to provide a van accessible access aisle with a minimum width of 96 inches.	502.2, 502.3 & 502.4
6	Accessible Parking Area APA#1 - Parking Space P2	Parking Space	The existing parking space was measured to be 123 inches wide. Isolated asphalt pavement slopes were measured to be above the maximum allowable 2.0%, measured up to 3.2%.	Remove the existing asphalt pavement, re-grade and replace to provide maximum slopes of 2.0% in all directions.	502.2 & 502.4
7	Accessible Parking Area APA#1 - Parking Space P3	Parking Space	The existing parking space was measured to be 102 inches wide. Isolated asphalt pavement slopes were measured to be above the maximum allowable 2.0%, measured up to 2.3%.	Remove the existing asphalt pavement, re-grade and replace to provide maximum slopes of 2.0% in all directions.	502.2 & 502.4

8	Accessible Parking Area APA#1 - Access Aisle A2	Access Aisle	The existing access aisle serving parking spaces P3 and P4 was measured to be 92 inches wide. Isolated asphalt pavement slopes were measured to be above the maximum allowable 2.0%, measured up to 2.6%.	Remove the existing asphalt pavement, re-grade and replace to provide maximum slopes of 2.0% in all directions.	502.2, 502.3 & 502.4
9	Accessible Parking Area APA#1 - Parking Space P4	Parking Space	The existing parking space was measured to be 100 inches wide. Isolated asphalt pavement slopes were measured to be above the maximum allowable 2.0%, measured up to 4.3%.	Remove the existing asphalt pavement, re-grade and replace to provide maximum slopes of 2.0% in all directions.	502.2 & 502.4
10	Accessible Parking Area APA#1 - P1 Signage	Signage	The existing sign unit has a clearance of 79 inches from the ground surface to the bottom of the lowest sign. There is no van accessible sign at this sign location.	Attach van accessible sign to existing sign unit and provide a minimum clearance of 60 inches from the ground surface to the bottom of the lowest sign.	502.6

15	Accessible Parking Area APA#2 - Access Aisle A1	Access Aisle	The existing access aisle serving parking spaces P1 and P2 was measured to be 56 inches wide. Isolated asphalt pavement slopes were measured to be above the maximum allowable 2.0%, measured up to 2.9%.	Remove the existing asphalt pavement, re-grade and replace to provide maximum slopes of 2.0% in all directions. Revise striping layout to provide an access aisle with a minimum width of 60 inches.	502.2, 502.3 & 502.4
16	Accessible Parking Area APA#2 - Parking Space P2	Parking Space	The existing parking space was measured to be 97 inches wide. Isolated asphalt pavement slopes were measured to be above the maximum allowable 2.0%, measured up to 5.0%.	Remove the existing asphalt pavement, re-grade and replace to provide maximum slopes of 2.0% in all directions.	502.2 & 502.4
17	Accessible Parking Area APA#2 - Parking Space P3	Parking Space	The existing parking space was measured to be 99 inches wide. Isolated asphalt pavement slopes were measured to be above the maximum allowable 2.0%, measured up to 2.9%.	Remove the existing asphalt pavement, re-grade and replace to provide maximum slopes of 2.0% in all directions.	502.2 & 502.4

18	Accessible Parking Area APA#2 - Access Aisle A2	Access Aisle	The existing access aisle serving parking spaces P3 and P4 was measured to be 82 inches wide. Isolated asphalt pavement slopes were measured to be above the maximum allowable 2.0%, measured up to 2.6%.	Remove the existing asphalt pavement, re-grade and replace to provide maximum slopes of 2.0% in all directions.	502.2, 502.3 & 502.4
19	Accessible Parking Area APA#2 - Parking Space P4	Parking Space	The existing parking space was measured to be 97 inches wide. Isolated asphalt pavement slopes were measured to be above the maximum allowable 2.0%, measured up to 2.5%.	Remove the existing asphalt pavement, re-grade and replace to provide maximum slopes of 2.0% in all directions.	502.2 & 502.4
20	Accessible Parking Area APA#2 - Parking Space P5	Parking Space	The existing parking space was measured to be 99 inches wide. Isolated asphalt pavement slopes were measured to be above the maximum allowable 2.0%, measured up to 2.9%.	Remove the existing asphalt pavement, re-grade and replace to provide maximum slopes of 2.0% in all directions.	502.2 & 502.4

21	Accessible Parking Area APA#2 - Access Aisle A3	Access Aisle	The existing access aisle serving parking spaces P5 and P6 was measured to be 87 inches wide. Isolated asphalt pavement slopes were measured to be above the maximum allowable 2.0%, measured up to 3.3%.	Remove the existing asphalt pavement, re-grade and replace to provide maximum slopes of 2.0% in all directions. Revise striping layout to provide a van accessible access aisle with a minimum width of 96 inches.	502.2, 502.3 & 502.4
22	Accessible Parking Area APA#2 - Parking Space P6	Parking Space	The existing parking space was measured to be 99 inches wide. Isolated asphalt pavement slopes were measured to be above the maximum allowable 2.0%, measured up to 2.6%.	Remove the existing asphalt pavement, re-grade and replace to provide maximum slopes of 2.0% in all directions.	502.2 & 502.4
23	Accessible Parking Area APA#2 - P1 Signage	Signage	The existing sign unit has a clearance of 81 inches from the ground surface to the bottom of the lowest sign. There is no van accessible sign at this sign location.	No action required.	502.6

28	Accessible Parking Area APA#2 - P6 Signage	Signage	The existing sign unit has a clearance of 79 inches from the ground surface to the bottom of the lowest sign. There is no van accessible sign at this sign location.	No action required.	502.6
Accessible Parking Area APA#3					
29	Accessible Parking Area APA#3 - Parking Space P1	Parking Space	The existing parking space was measured to be 108 inches wide. Asphalt pavement slopes were measured to be above the maximum allowable 2.0%, measured up to 5.2%.	Remove the existing asphalt pavement, re-grade and replace to provide maximum slopes of 2.0% in all directions.	502.2 & 502.4
30	Accessible Parking Area APA#3 - Access Aisle A1	Access Aisle	The existing access aisle serving parking spaces P1 and P2 was measured to be 108 inches wide. Asphalt pavement slopes were measured to be above the maximum allowable 2.0%, measured up to 5.4%.	Remove the existing asphalt pavement, re-grade and replace to provide maximum slopes of 2.0% in all directions.	502.2, 502.3 & 502.4

31	Accessible Parking Area APA#3 - Parking Space P2	Parking Space	The existing parking space was measured to be 109 inches wide. Asphalt pavement slopes were measured to be above the maximum allowable 2.0%, measured up to 5.2%.	Remove the existing asphalt pavement, re-grade and replace to provide maximum slopes of 2.0% in all directions.	502.2 & 502.4
32	Accessible Parking Area APA#3 - Access Aisle A2	Access Aisle	The existing access aisle serving parking spaces P2 and P3 was measured to be 105 inches wide. Asphalt pavement slopes were measured to be at or below 2.0%.	No action required.	502.2, 502.3 & 502.4

71	Accessible Parking	Accessible Parking	There are nine (9) separate single-floor residential building structures that contain a total of 60 attached living spaces for lease. There is a total of 89 parking stalls serving these attached dwelling units, but none of the 89 parking stalls are noted as being accessible.	Provide an accessible parking stall and access aisle for each dwelling unit. Slopes shall be a maximum of 2.0% in all directions for all accessible parking stalls and access aisles. Provide an accessible sign unit for each accessible parking stall.	502.2, 502.3, 502.4 & 502.6
72	Accessible Routes	Accessible Route	There are multiple concrete sidewalk accessible routes that contain cross-slopes exceeding the maximum allowable 2.0% within the residential dwelling unit sections of the site.	Re-grade the isolated areas of non-compliant concrete sidewalk to provide maximum running slopes of 5.0% and cross-slopes of 2.0%. Provide level landings directly in front of all building entrance doors.	403.3

73	Curb Ramps	Curb Ramp	The site contains a total of 22 existing concrete curb ramps within the residential dwelling unit sections of the site in addition to those noted above for the main multi-floor building portion of the site. Many of these ramps contain non-compliant slopes: running slopes exceeding the 8.3% maximum, cross-slopes exceeding the 2.0% maximum, and side flare slopes exceeding the 8.3% maximum.	Re-grade the non-compliant concrete curb ramps to provide a maximum running slope of 8.3% and a maximum cross-slope of 2.0%. Side flares should be installed at a maximum slope of 8.3%. Provide level landings at the tops of all ramps.	406.1 & 406.4

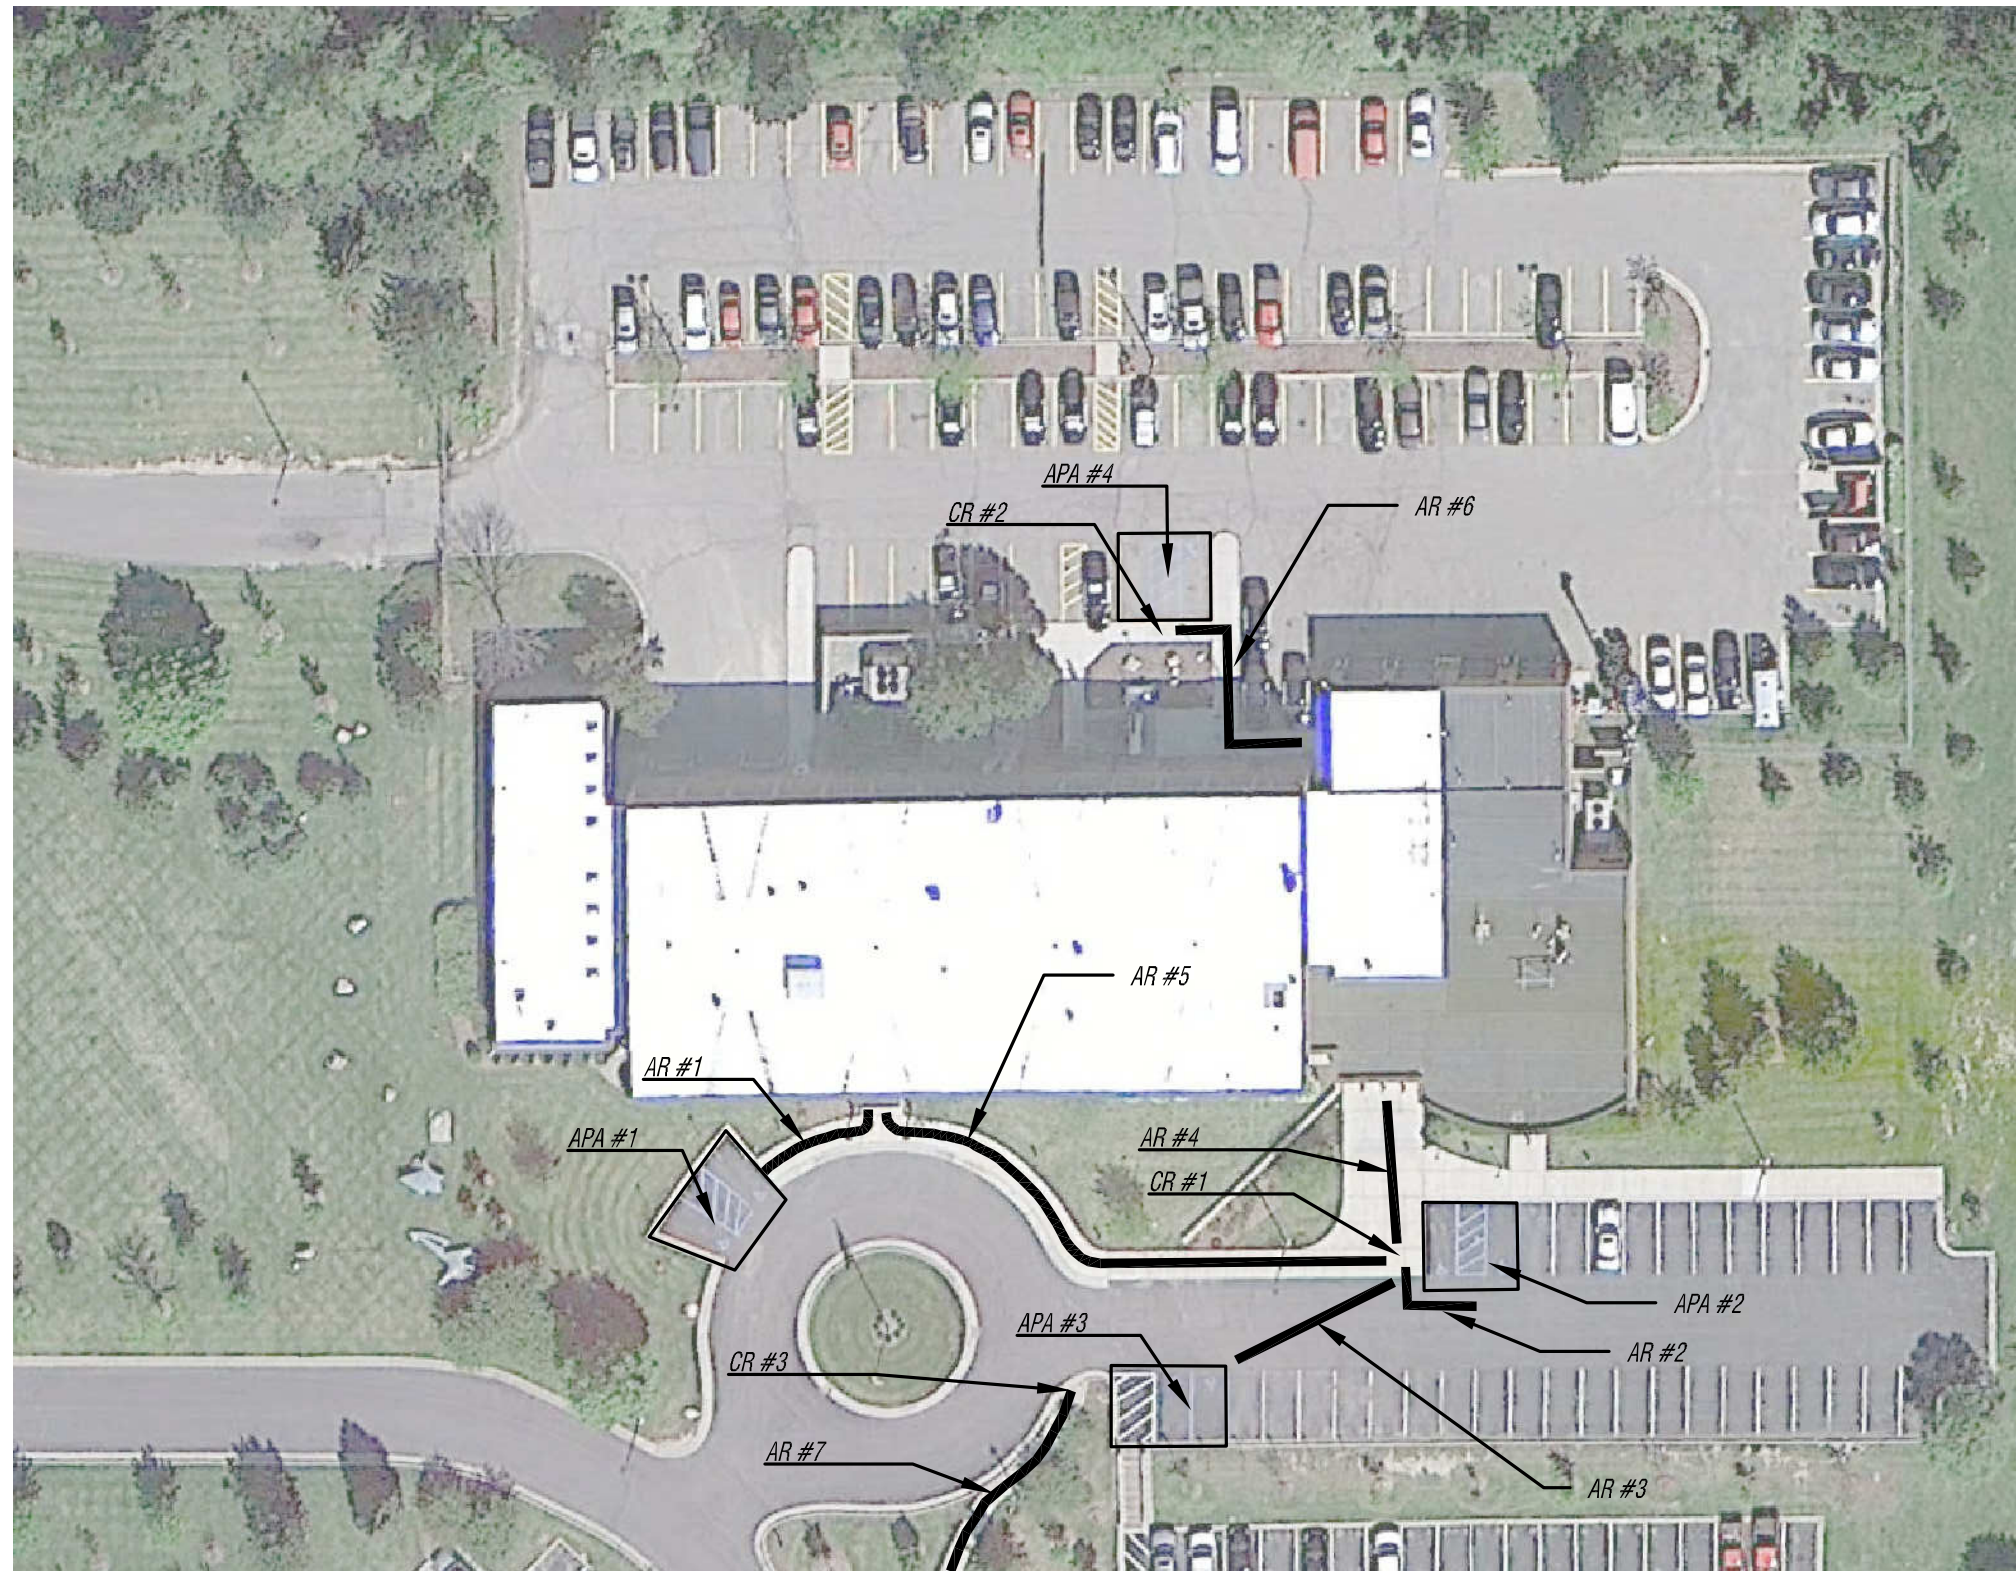
31	CR#3 - from AR#7	Curb Ramp	The concrete curb ramp has ADA compliant slopes. However, the concrete surface of the ramp has deteriorated, creating large openings and changes in level.	Replace concrete curb ramp to match existing compliant slopes. Replacing ramp will remove openings and changes in level.	406.1 & 406.4
----	------------------	-----------	--	--	---------------

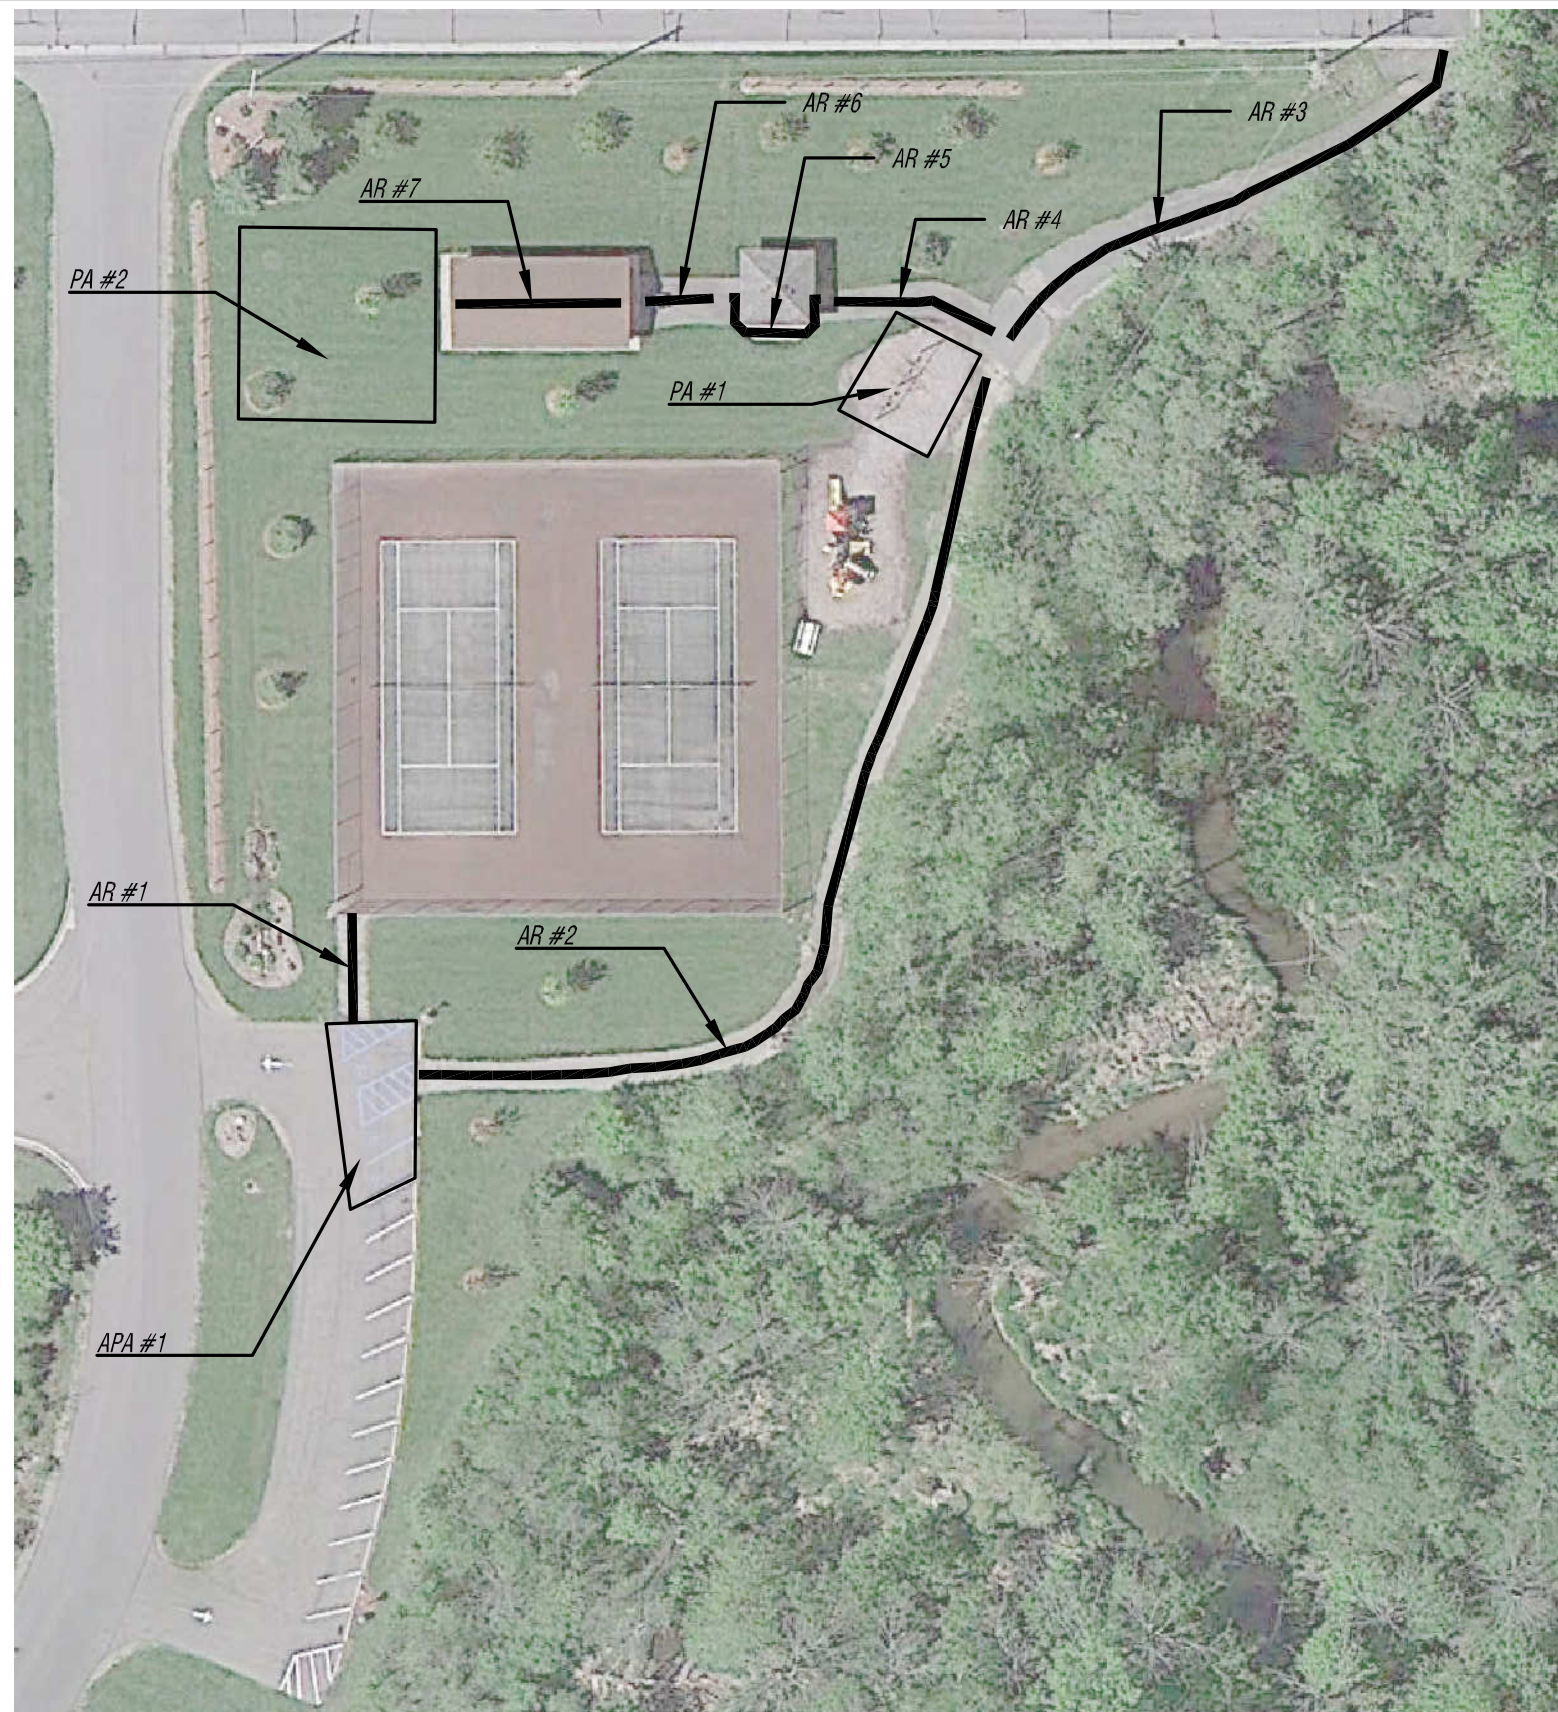
15	Accessible Route AR#7 - from AR#6 to PA#2	Accessible Route	The concrete pavement underneath the canopy is level with slopes at or below 2.0% in all directions. However, there longitudinal joint running down the center of the pavement contains a slight lip which leads to a non-compliant change in level.	Diamond grind the existing lip at the joint or use concrete leveling techniques to provide a smooth surface while maintaining compliant slopes.	403.3

Play Areas					
16	Play Area PA#1	Play Area	Play area surface is comprised of woodchips and is level with surrounding surfaces with no borders, providing an accessible route into the area.	No action required.	1008.1
17	Play Area PA#2	Play Area	Play area surface is comprised of woodchips and is surrounded by a plastic border. A 4' wide concrete ramp is provided leading from the concrete canopy area to the play area, but has running slopes exceeding 8.3% and side flares that are too steep.	Remove existing ramp and install new ramp with ADA compliant slopes to maintain an accessible route into the play area.	1008.1
