CITY OF NOVI
ADA COMPLIANCE TRANSITION PLAN
CITY-OWNED FACILITIES
MARCH 2014

SDA Job No. NV13006.0C

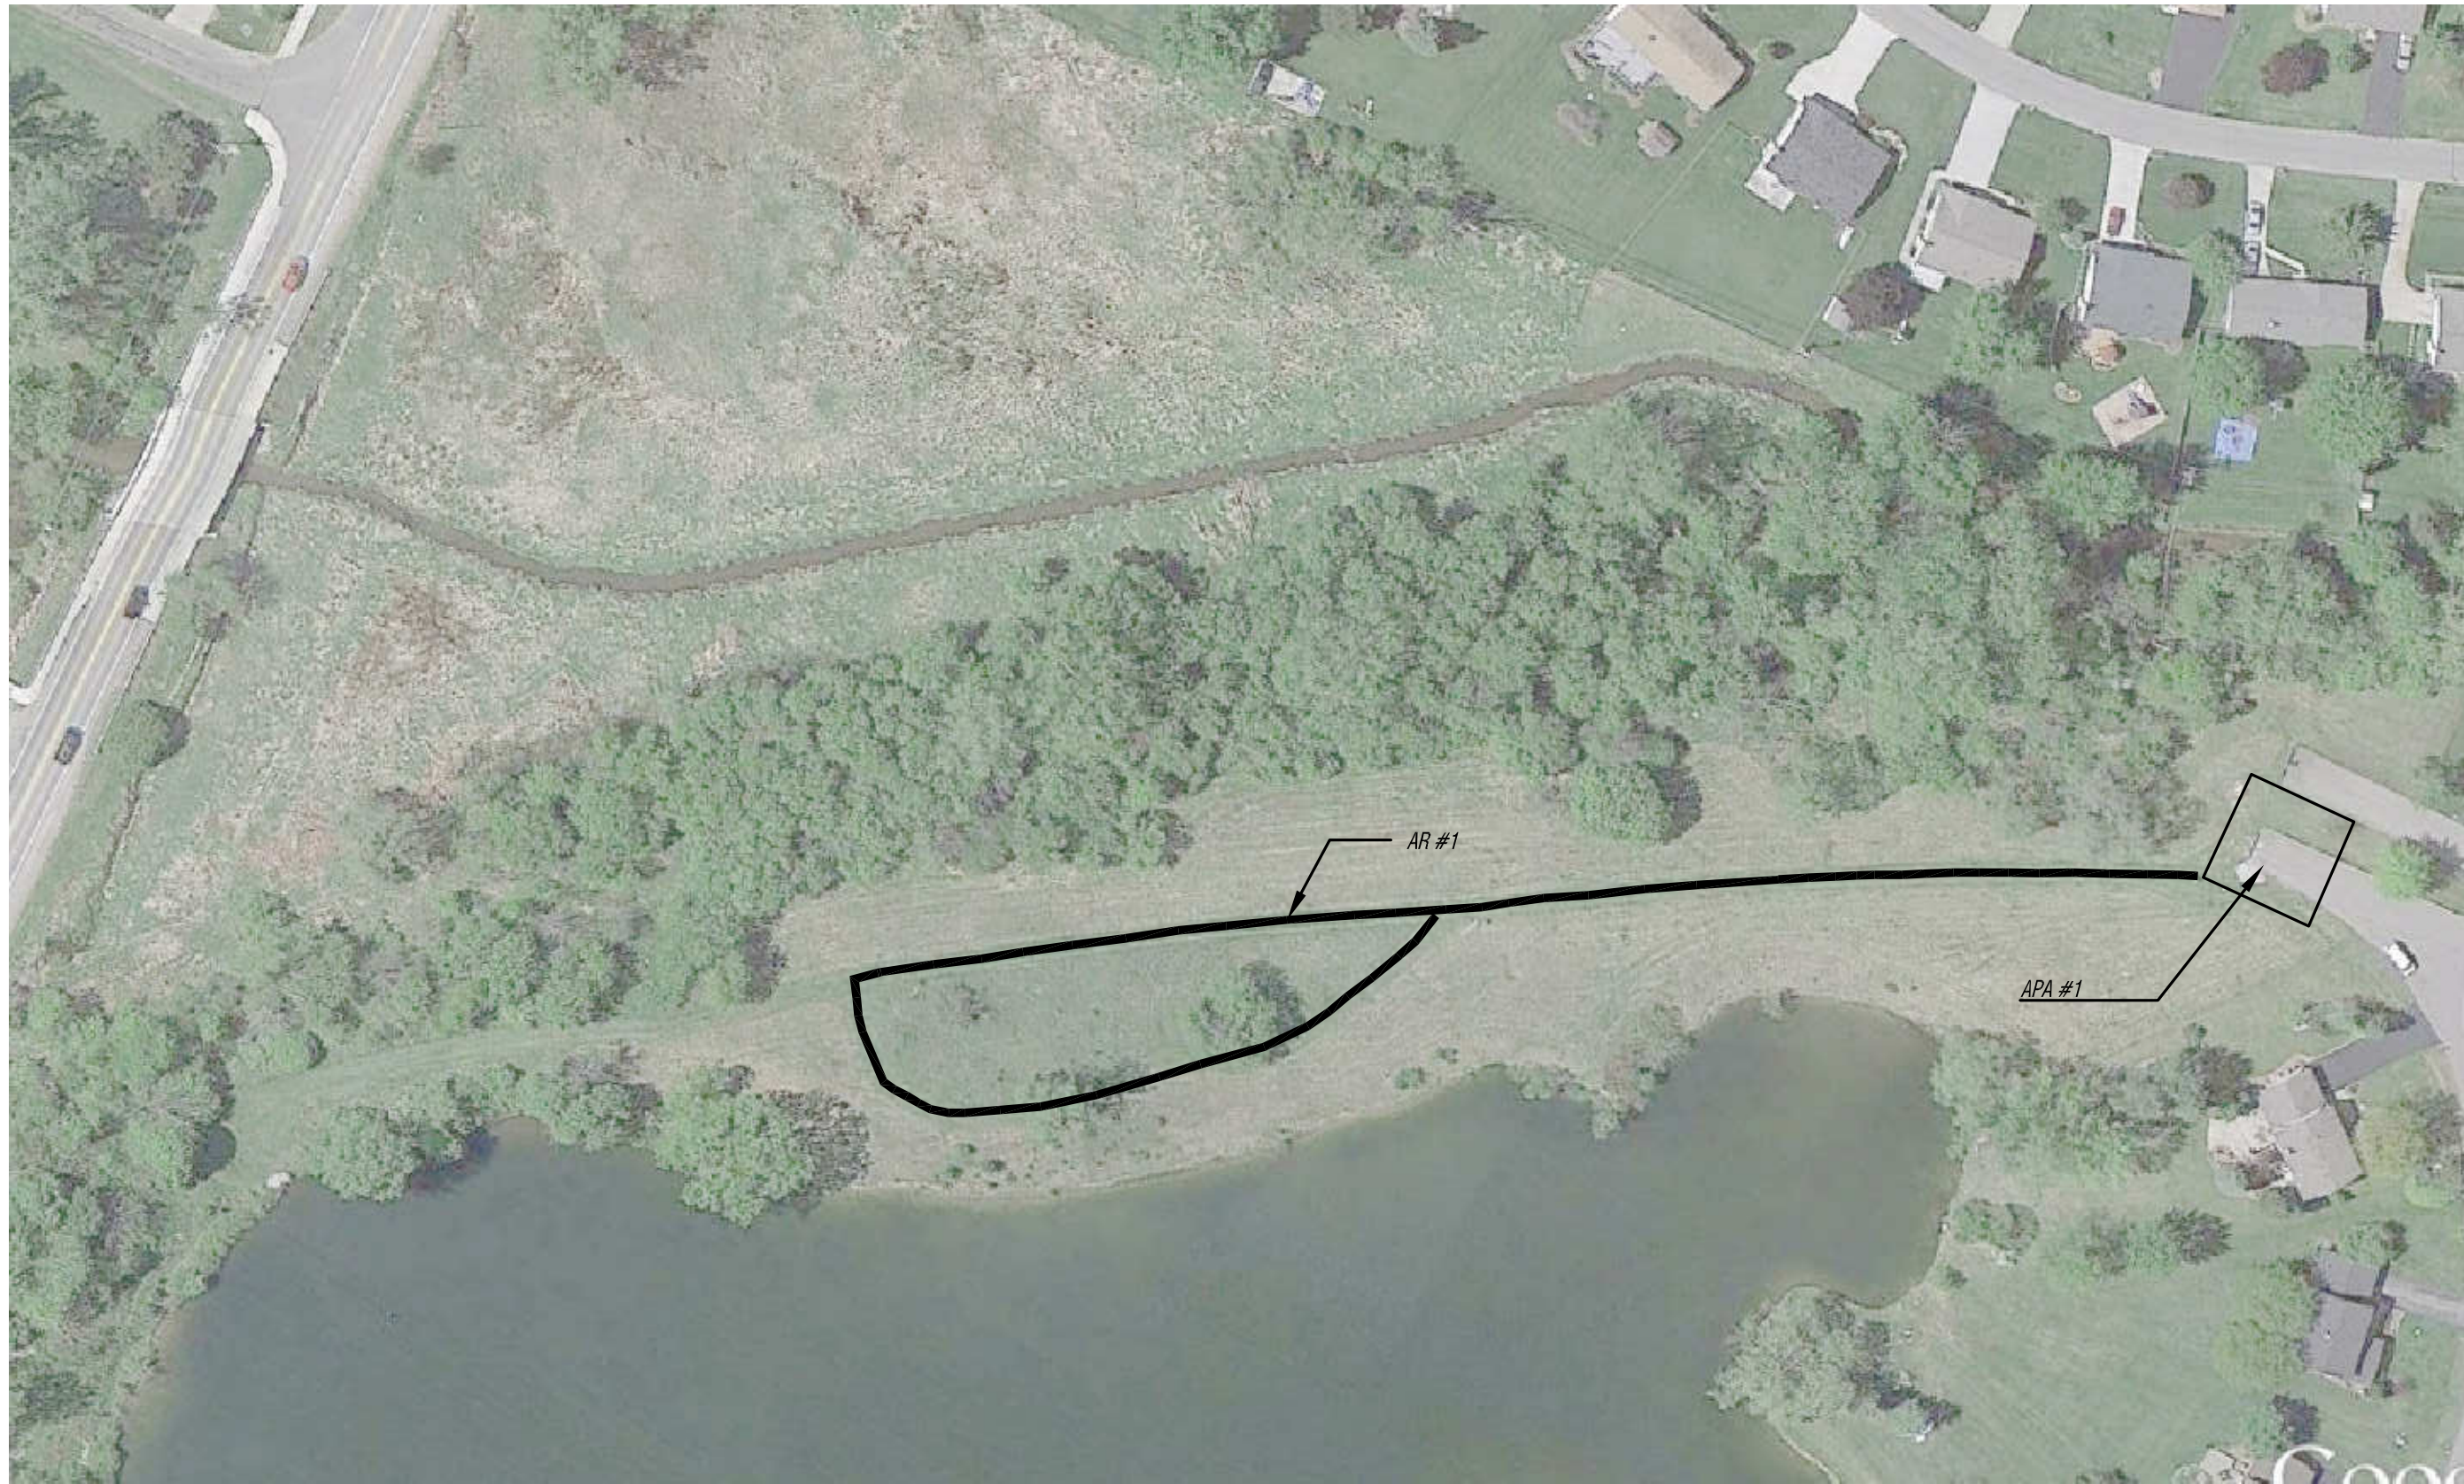
Item #	Location	Element	Notes	Solution	2010 ADA Standards
Accessible Parking					
1	Accessible Parking	Quantity	There were 6 total parking spaces identified at the time of survey, including one (1) accessible parking space which was not designated as van accessible. Based on this count, one (1) accessible parking space is required, which must be designated as van accessible.	Add van accessible sign to existing sign post for existing accessible parking space P1. See APA#1 notes below.	208.2
2	General	Site Accessibility	See site plan for locations of accessible parking areas and accessible routes.		
Accessible Parking Area APA#1					
3	Accessible Parking Area APA#1 - Parking Space P1	Parking Space	The single designated parking space was measured to be 114 inches wide. Portions of the stall has slopes exceeding the maximum allowable 2.0%, measured up to 2.9%. There is no painted symbol of accessibility painted on the pavement.	Remove the existing asphalt pavement, re-grade and replace to provide maximum slopes of 2.0% in all directions. Re-stripe to provide a compliant layout along with a painted symbol of accessibility on the asphalt pavement.	502.2 & 502.4

4	Accessible Parking Area APA#1 - Access Aisle A1	Access Aisle	The existing access aisle serving parking space P1 was measured to be 96 inches wide. However, the aisle's slopes exceed the maximum allowable 2.0% and were measured up to 2.5%.	Remove the existing asphalt pavement, re-grade and replace to provide maximum slopes of 2.0% in all directions. Re-stripe to match existing.	502.2, 502.3 & 502.4
5	Accessible Parking Area APA#1 - P1 Signage	Signage	The existing sign has a clearance of 92 inches from the ground surface to the bottom of the lowest sign. There is no sign designating the space as van accessible.	Add van accessible sign to existing post and maintain a minimum of 60 inches of clearance from the ground surface to the bottom of the lowest sign.	502.6
Accessible Routes					
6	Accessible Route AR#1 - Gravel Path Around Park	Accessible Route	The existing gravel path does not provide a smooth ADA compliant accessible path.	Install an asphalt pathway or concrete sidewalk path with compliant accessible route slopes.	403.3

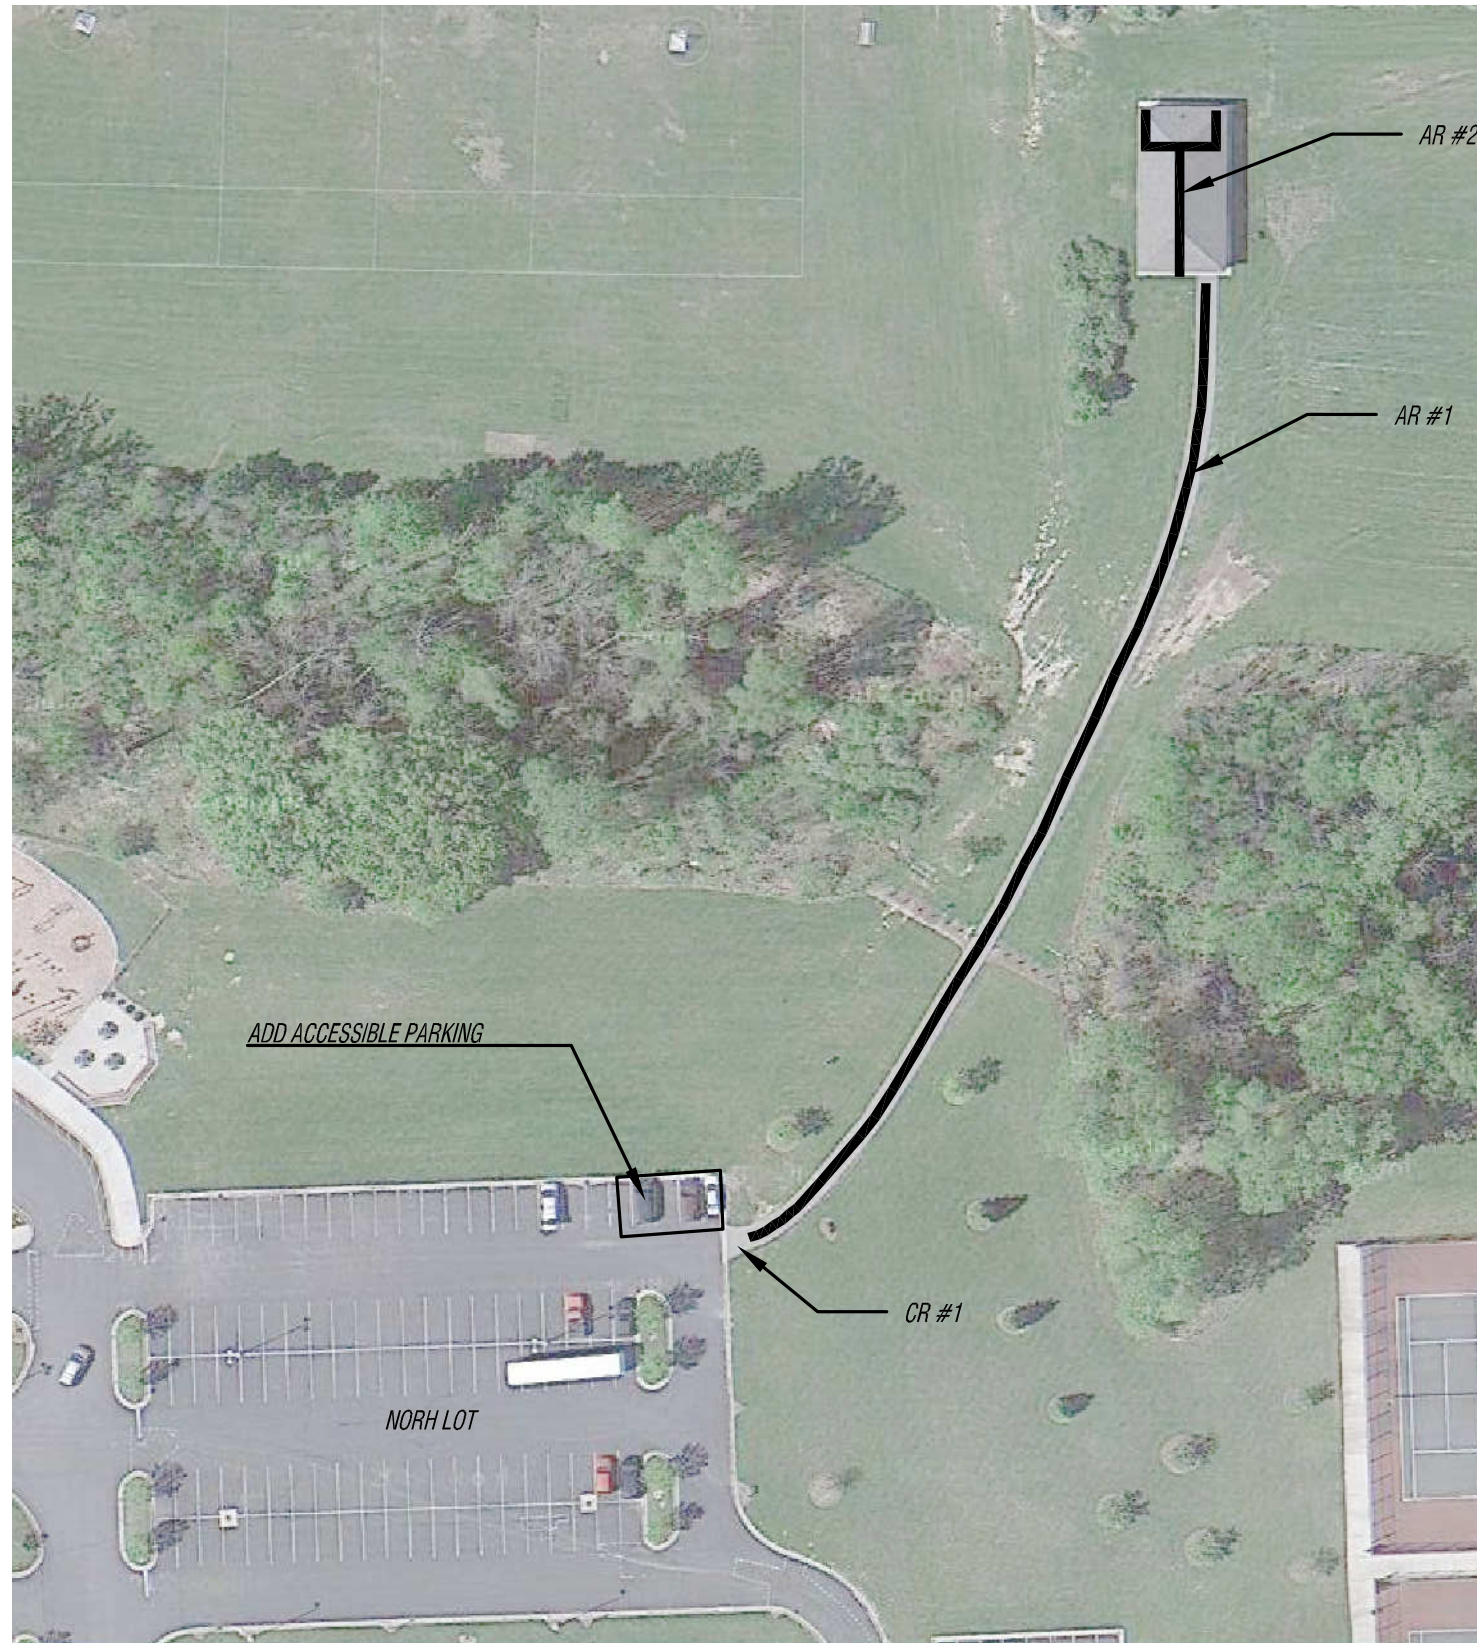
3	General	Site Accessibility	See site plan for locations of accessible parking areas and accessible routes.		
Accessible Routes					
4	Curb Ramp CR#1	Curb Ramp	The existing concrete curb and gutter has been previously sawcut to provide an opening for the existing asphalt curb ramp. The sawcut at the curb has left a change in level of one inch along the curb. The running slopes and cross-slopes of the asphalt curb ramp are within compliance. However, no level landing was provided at the top of the ramp.	Replace existing concrete curb and gutter to provide a smooth transition free of changes in level. This may require re-grading of the ramp to provide flush surface at joint between materials. Install level landing at top of curb ramp.	406.1 & 406.4
5	Accessible Route AR#1 - from CR#1 to AR#2	Accessible Route	Portions of the asphalt pathway were found to have cross-slopes exceeding 2.0%, measured up to 3.6%. Other portions of the asphalt pathway were measured to have running slopes exceeding 5.0%, measured up to 6.8%.	Replace portions of the asphalt pathway to provide a maximum running slope of 5.0% and a maximum cross-slope of 2.0%.	403.3

6	Accessible Route AR#2 - from AR#1	Accessible Route	The concrete pavement underneath the canopy is level with slopes at or below 2.0% in all directions. However, cracked and heaving concrete flags at the northeast and northwest corners of the concrete pad at the two bathrooms entrances are creating significant changes in level.	Replace the concrete flags at the northeast and northwest corners near the bathrooms entrances to provide smooth surfaces free of lips and changes in level.	403.3
